***Town of New Paltz Historic Preservation Commission
Local Historic Landmark Designation***

***Mohonk Testimonial Gateway
1 Gatehouse Road, New Paltz, NY
(Gatehouse Structure and Adjoining Lands)***

15 October 2013

20 June 2013 Condition Assessment (04 September 2013)

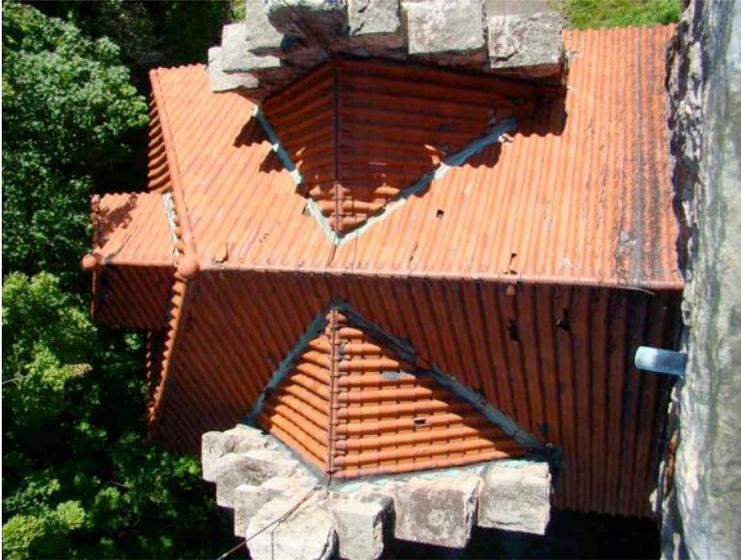
DSC00228

Roof over Archway:

From the observation deck;
Note broken tiles at ridges
and valleys as well as roof
planes.

- Record and remove all tiles, accessories, flashings, sheet materials and nails.
- Repair all roof decks using matching lumber.
- Install an impervious “underlayment” or membrane beneath all the fields (roof planes) of tile, and the sheet copper must be replaced at all valleys, parapet and wall intersections and at the horizontal drip eaves.
- Reinstall sound tiles, using the existing tiles in coherent roof planes such that they are not mixed with new tiles. Install new tiles on tower roofs and in areas where impact from the tower roofs lands on the lower gables and hips.
- Finish with the historic ridge and hip tiles.
- Restore observation deck/waterproof membrane, reactivate south drain scupper and build new hatch cover and install.

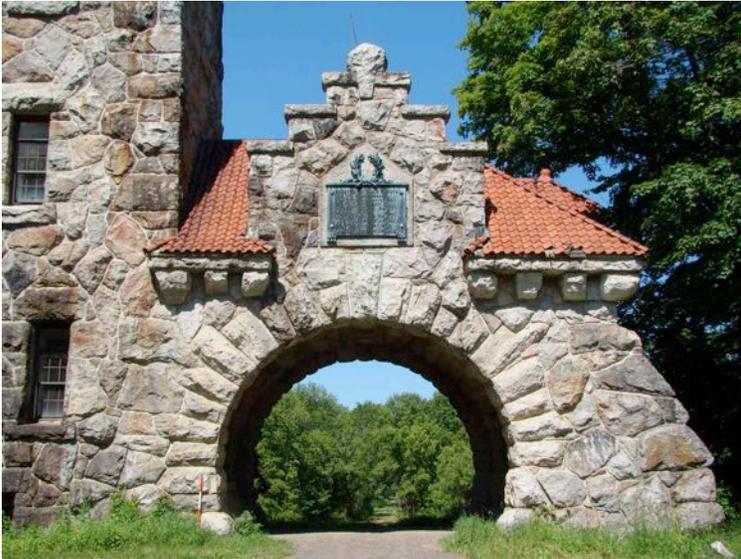
DSC00259

Roof over Archway:

From the east; Note broken
tiles at eaves

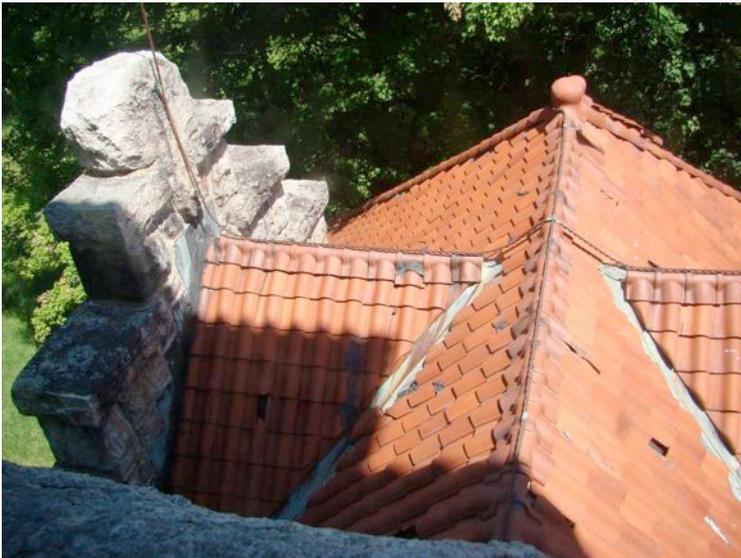
DSC00292

Roof over Archway:

From the third level; Note
broken tiles and lightning
arresting system, west gable
and stepped stone parapet.

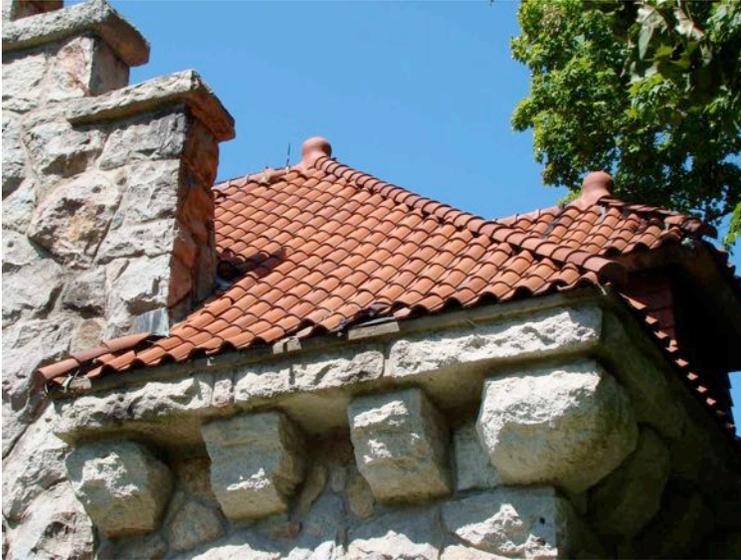
DSC00260

Details:

Broken tiles at East eaves,
north of plaque.

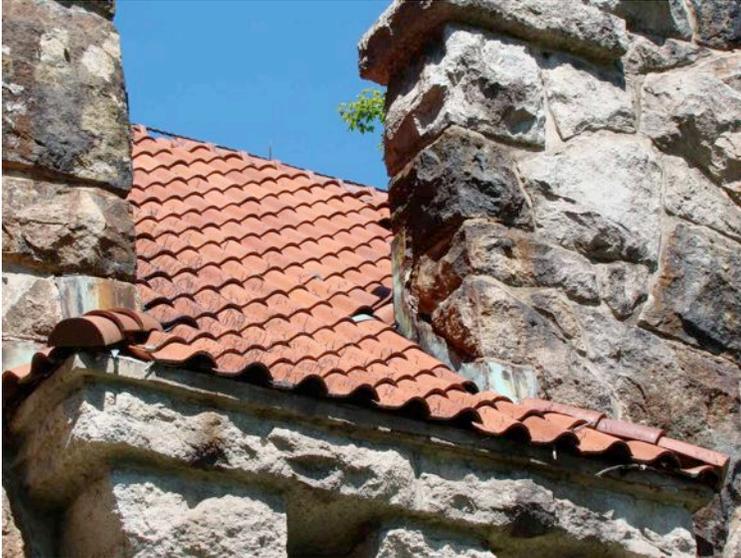
DSC00261

Details:

Broken tiles at East eaves,
South of plaque.

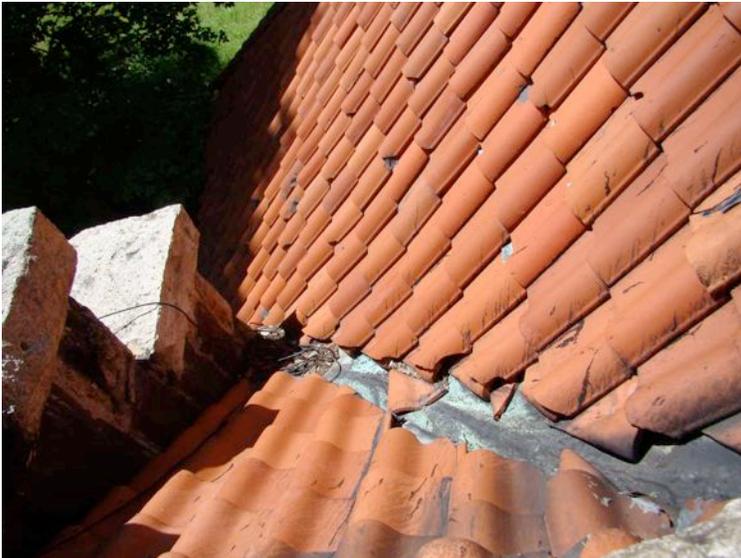
DSC00285

Kitchen Wing Roof:

Detail of valley with broken tiles.

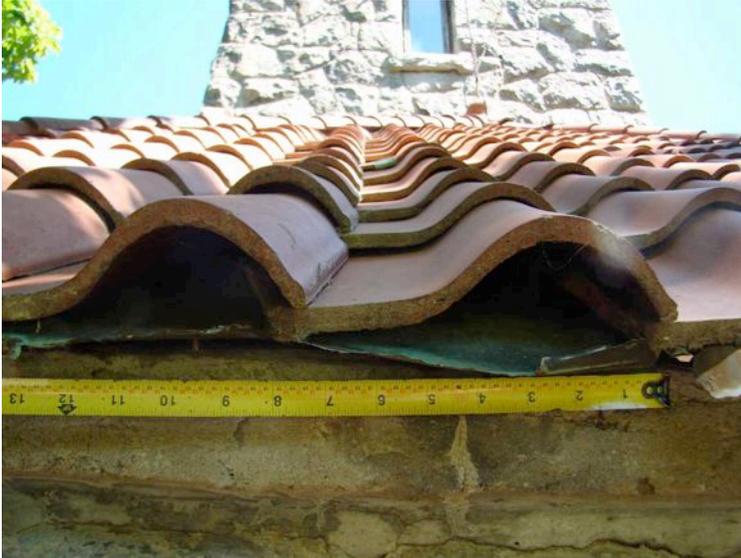
DSC00278

Details:

Worn out copper drip edge of eaves over kitchen door.

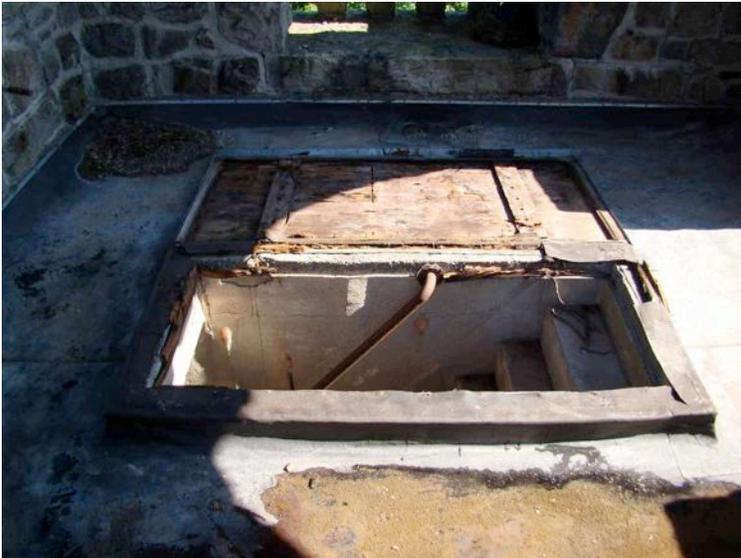
DSC00230

Rotted Hatch:

The wooden and sheet metal hatch cover is deteriorated beyond its useful life.

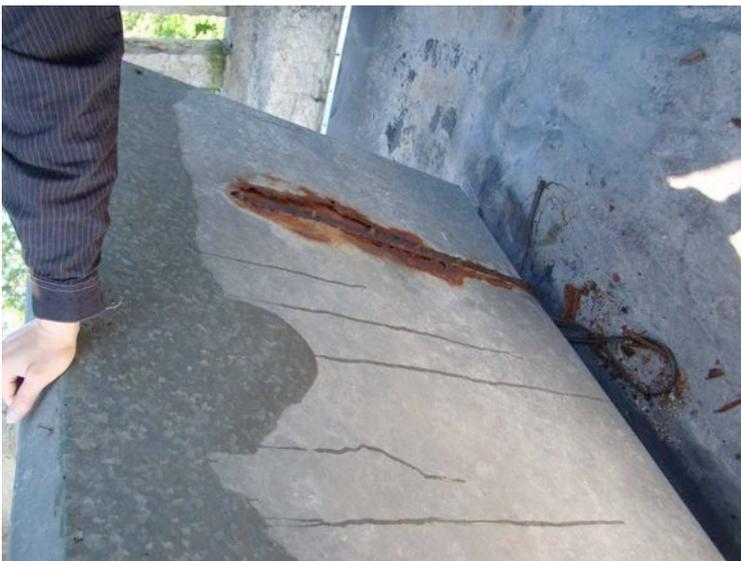
Rotted Hatch:

The sheet metal has rusted through.

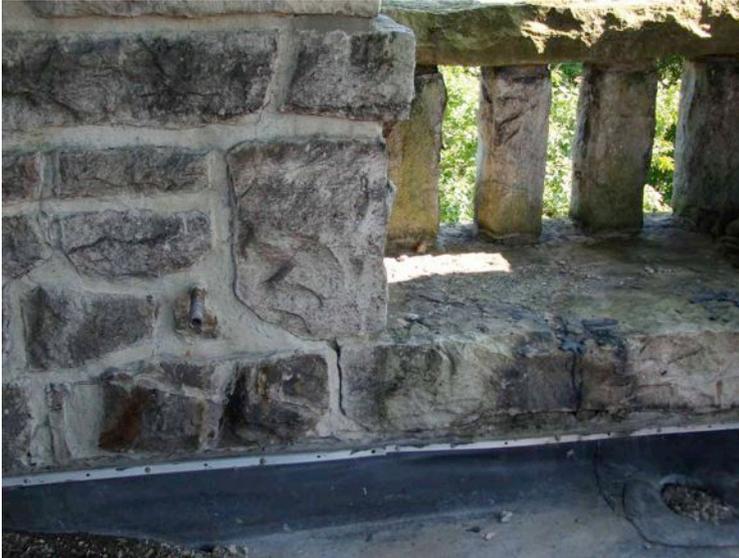
DSC00232

Condition Observation:

Crack in corner pier indicates need for compatible repointing

- Select bedding, repointing and parapet mortars for use in distinct locations.
- Carefully and selectively remove cracked and unbonded mortar.
- Repair voids and repoint mortar joints.
- Clean surfaces affected by repointing operations.

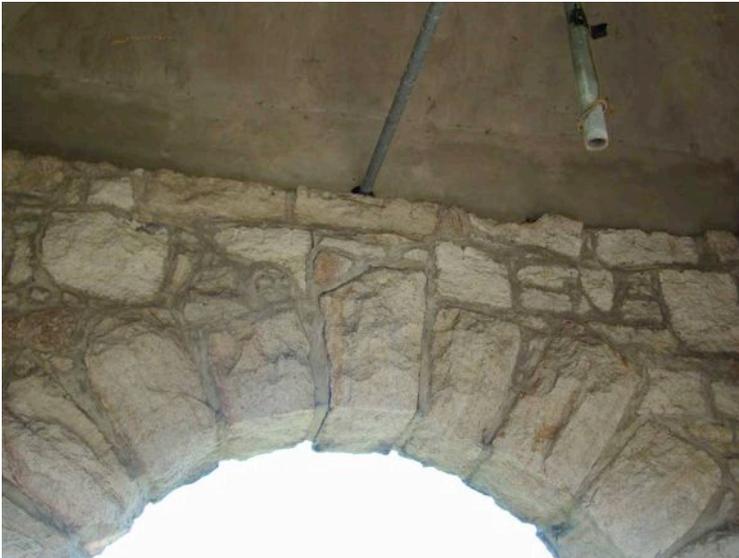
DSC00236

Condition Observation:

Crack in keystone mortar at North observation arch is start of deterioration

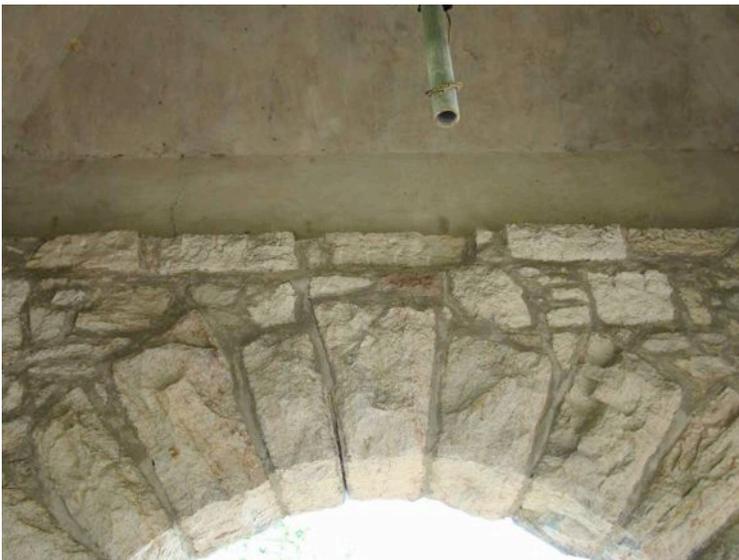
Condition Observation:

Crack in keystone mortar at East arch.

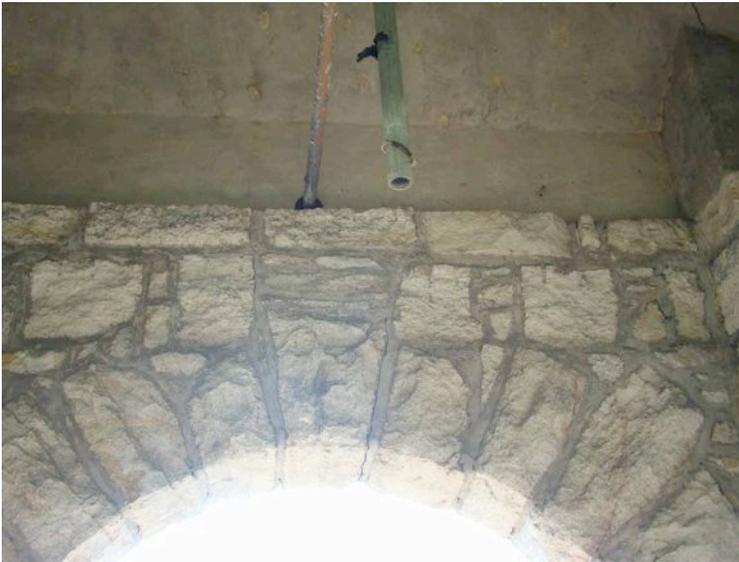
DSC00238

Condition Observation:

Crack in keystone mortar at South arch.

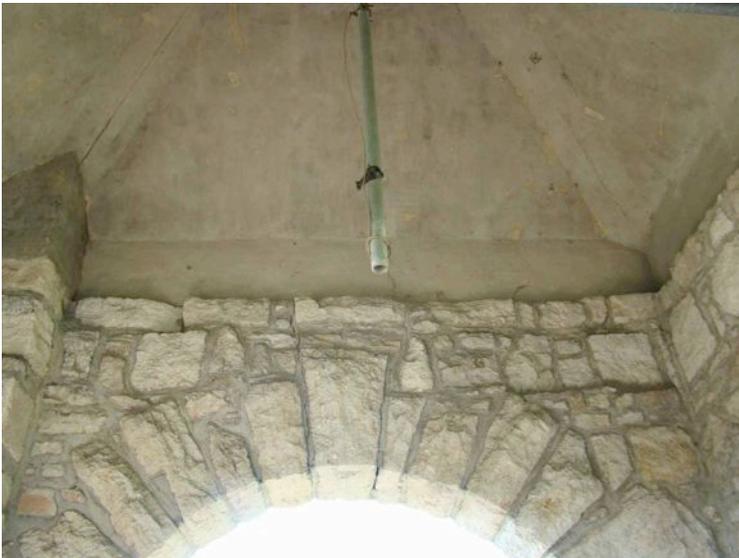
DSC00239

Condition Observation:

Crack in keystone mortar at West arch.

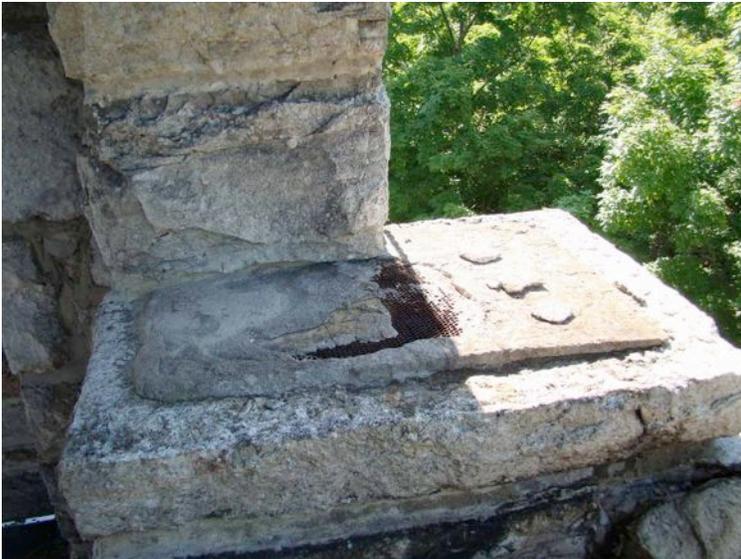
DSC00231

Details: Covered Planter

What appears to have been planters originally have been covered over with wire mesh and mortar, now deteriorated.

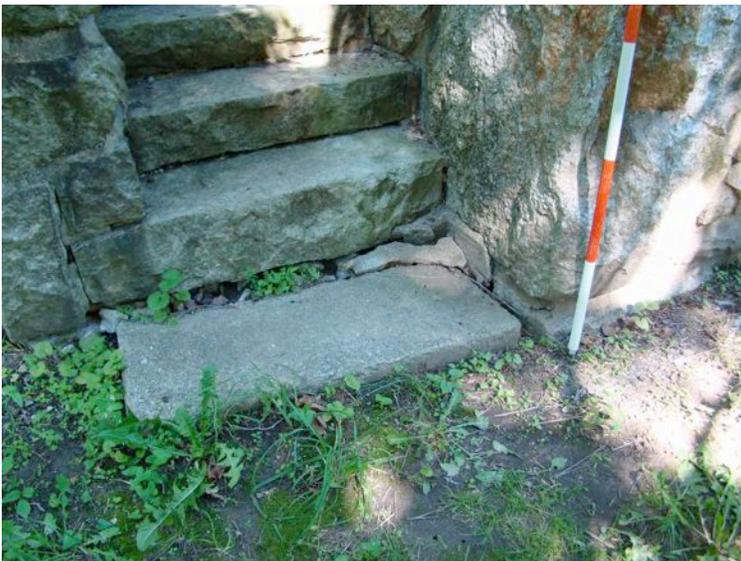
DSC00244

Details: Kitchen Stair

Illustrating need for repair and repointing.

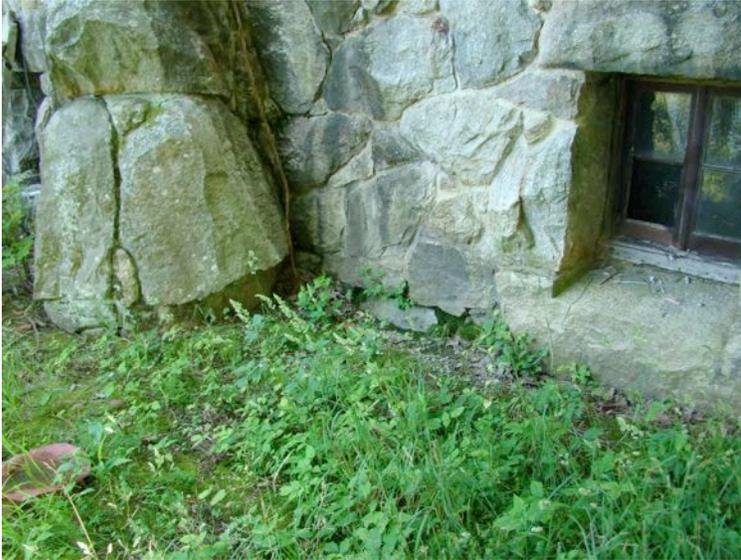
DSC00271

West:

Deterioration of mortar at arch buttress and facade at ground level.

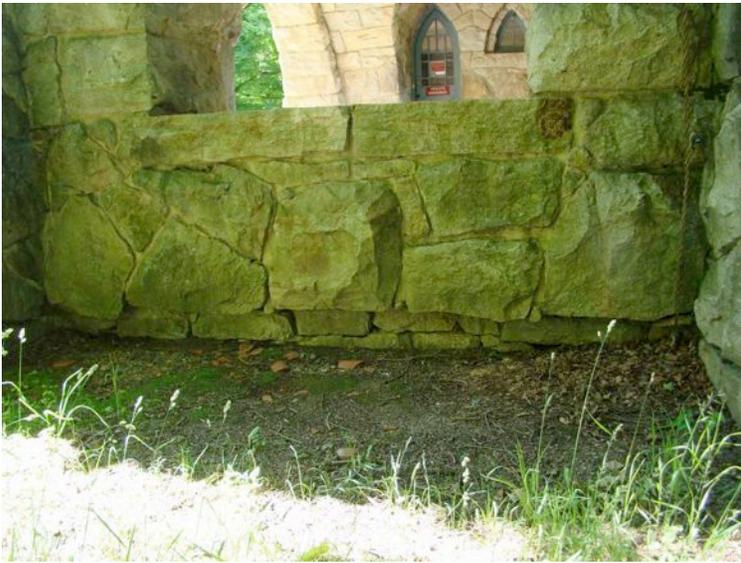
DSC00274

North:

Need for repointing, emphasized at ground level.

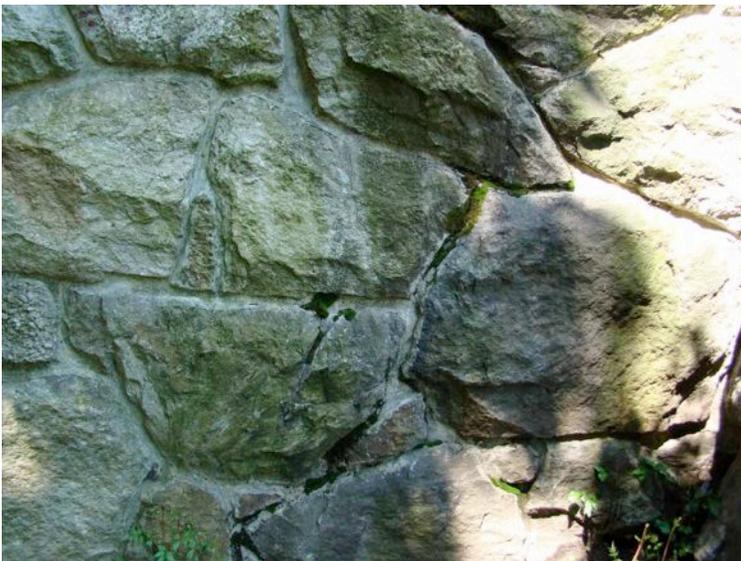
East:

Cracking of mortar joints.

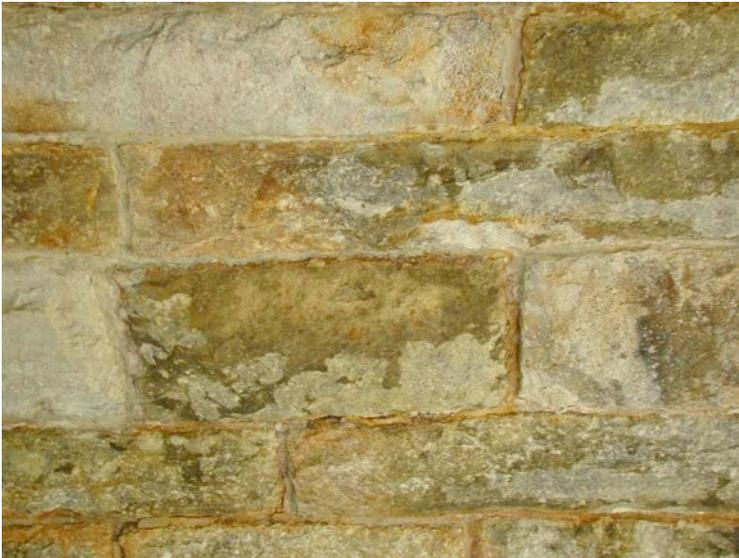
DSC00354

At Archway:

Cracking of mortar in stone barrel vault.

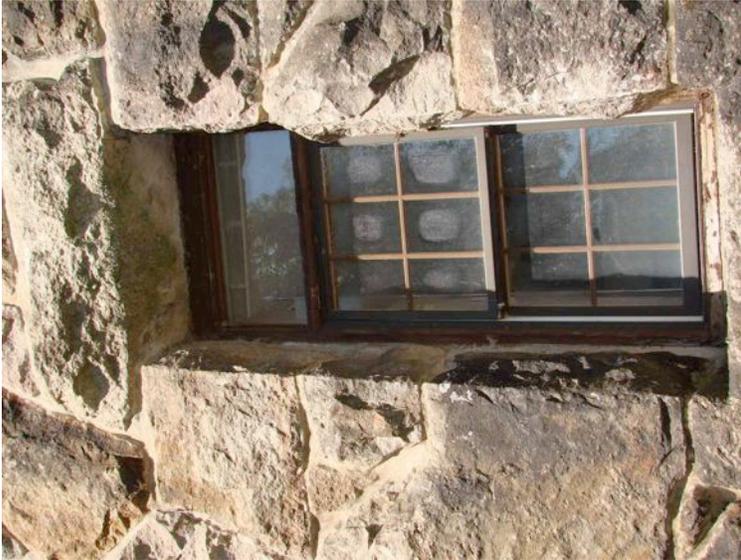
DSC00262

Replace with original transom frames:

Six-over-six pane incompatible sash.

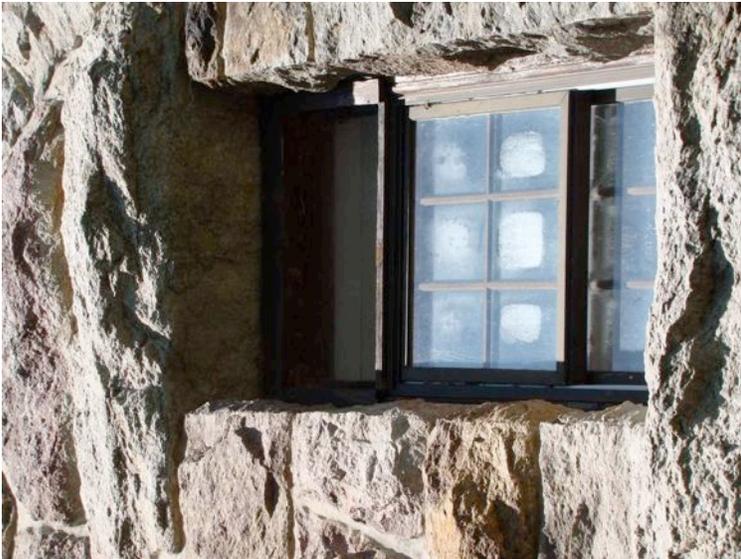
DSC00263

Replace with original transom frames:

Six-over-six

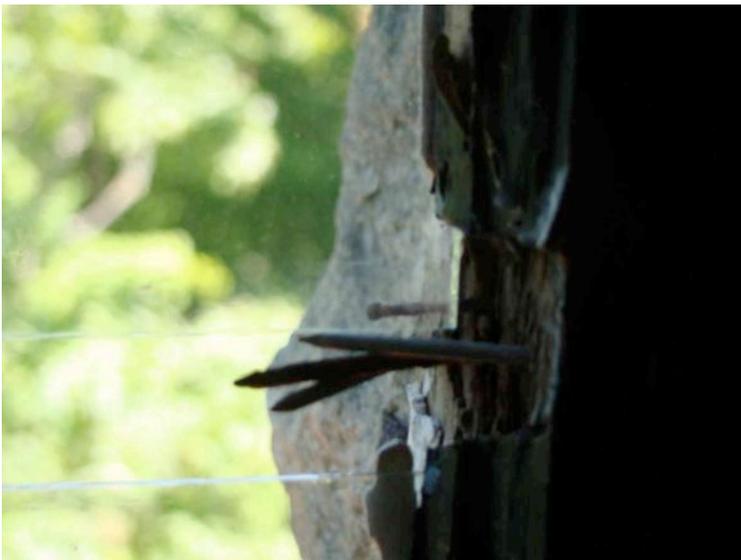
DSC00290

Detail of crude modification:

Apparently, when the original, leaded-glass was replaced, wooden horizontal muntins were set into the original sash stiles, secured rather crudely with nails.

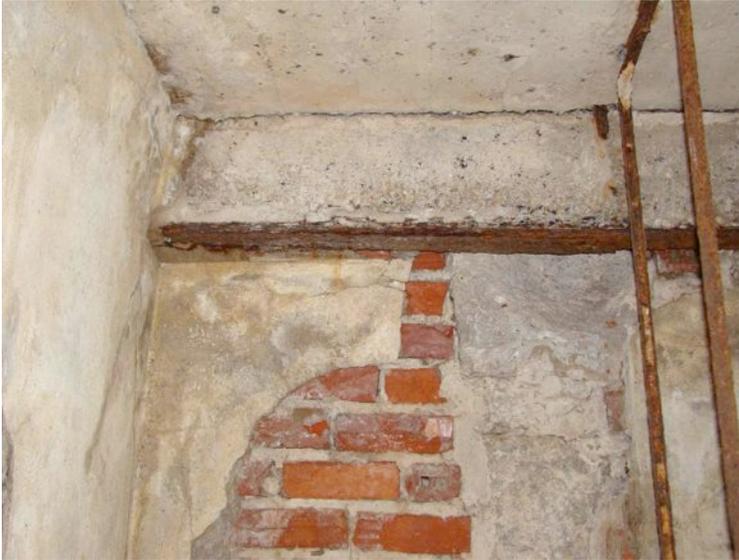
DSC00249

Condition:

Steel is oxidized where exposed to interior moisture. The extensive use of steel in this building is documented in the original drawings.

- Photograph each room and remove all renovations that are less than 50 years of age. Remove gypsum board partitions and all false ceilings.
- Photograph in detail and remove deteriorated portions of historic materials and finishes so that steel beams and metal lath can be further evaluated for condition.
- If condition of steel beams warrants it, have a professional engineer inspect the concrete and steel structural components.
- Repair and stabilize rust on steel components.
- Restore concrete covers and coatings over steel beams.

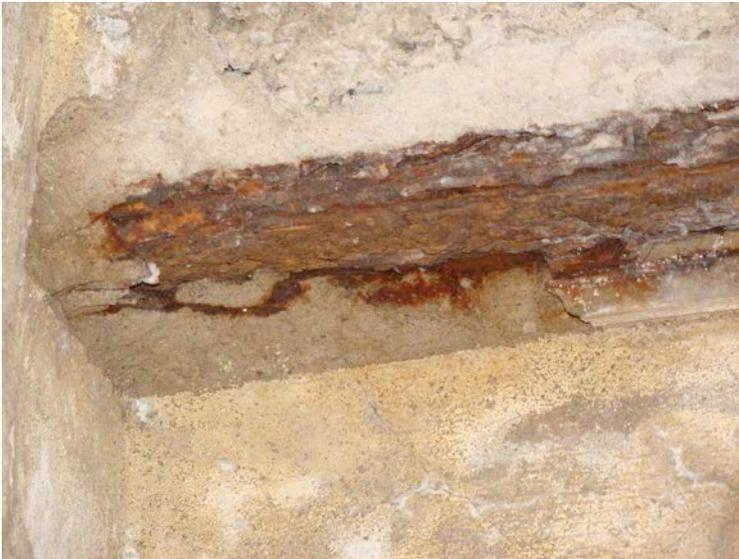
DSC00250

Condition:

Detail of oxidation of steel. "Oxide jacking", that is, the expansion of material which accompanies the formation of rust, has expelled the concrete covering beneath this beam.

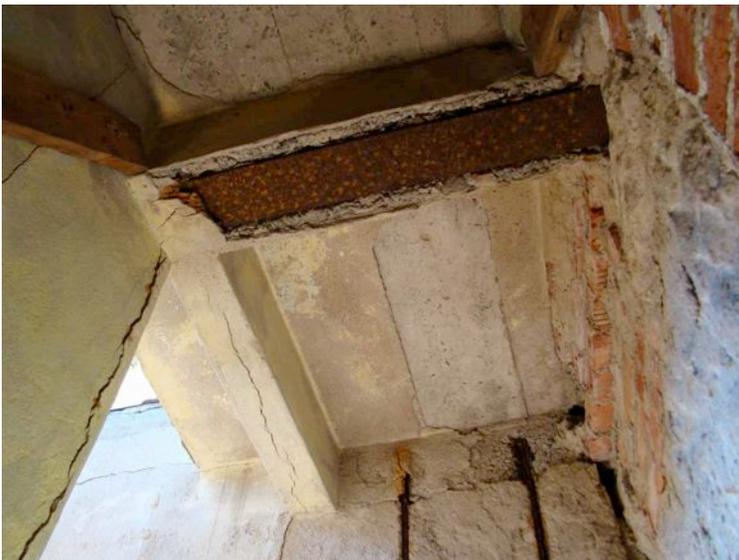
DSC00253

Condition:

Even more dramatic example of "oxide jacking" at beam over upper stairway to observation check. It appears that moisture collects at steel components and migrates to their hollow surfaces, even though they are concealed within concrete and or plaster.

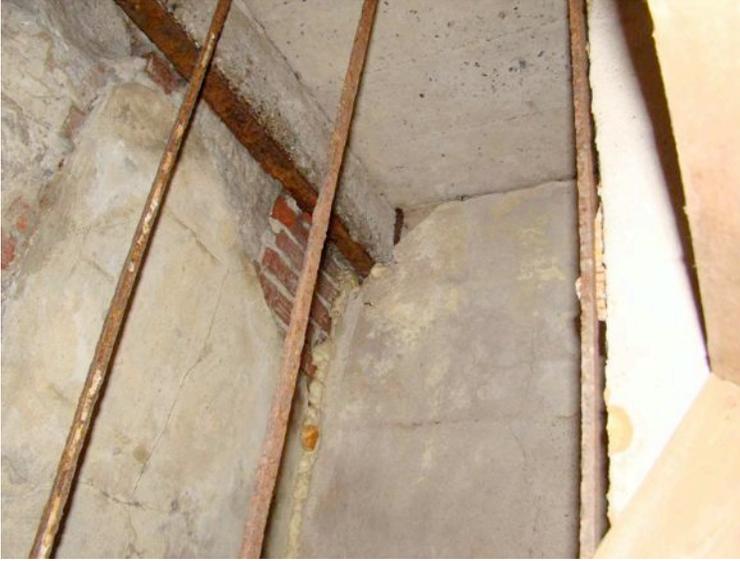
DSC00256

Condition:

The vertical ferrous ribs shown are all that survives of several thin cementitious partitions. The metal mesh is gone as well as the plaster finish.

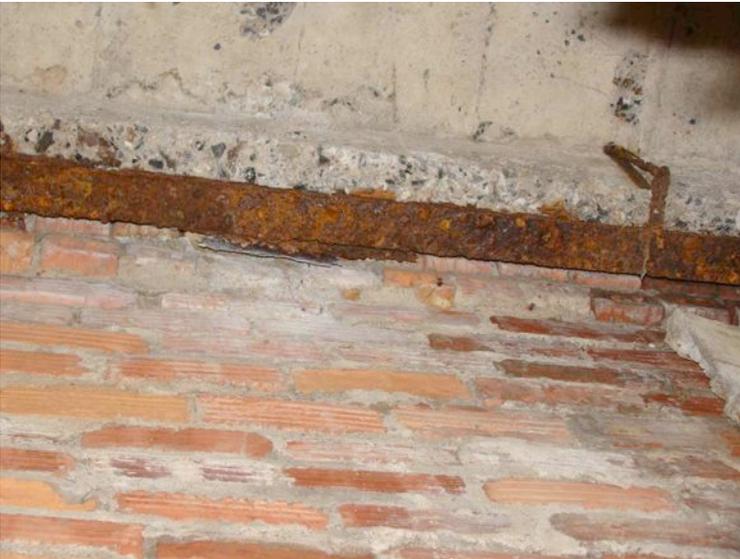
DSC00295

Condition:

More iron oxide (rust).

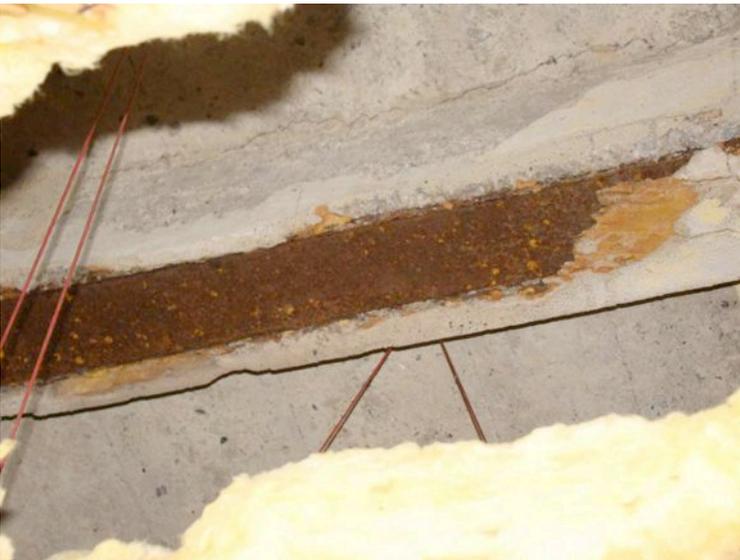
Condition:

Detail of rust.

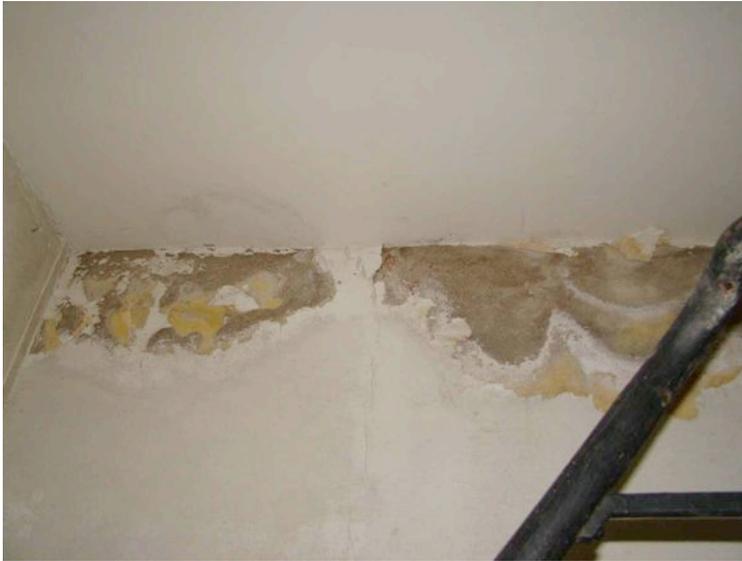
DSC00344

Condition:

Evidence of water intrusion at upper levels.

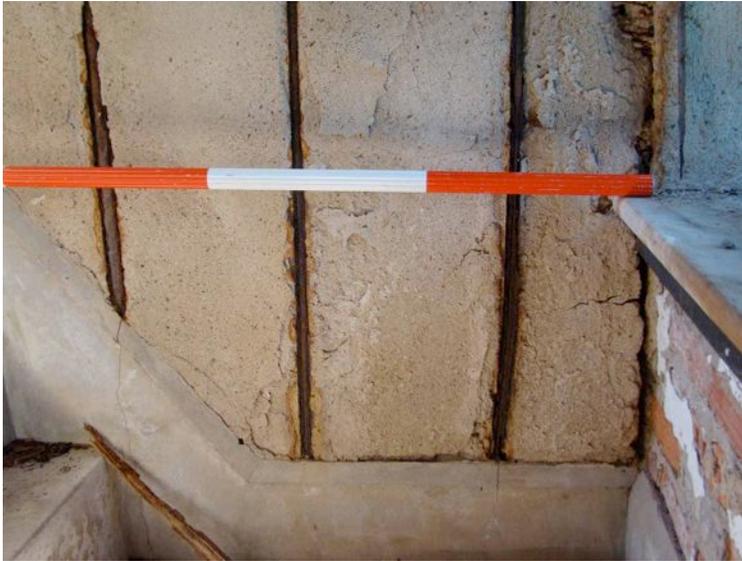
DSC00252

Details at thin walls:

Here in the upper staircase to the observation level the partition survives, but the vertical reinforcing panel ribs have rusted.

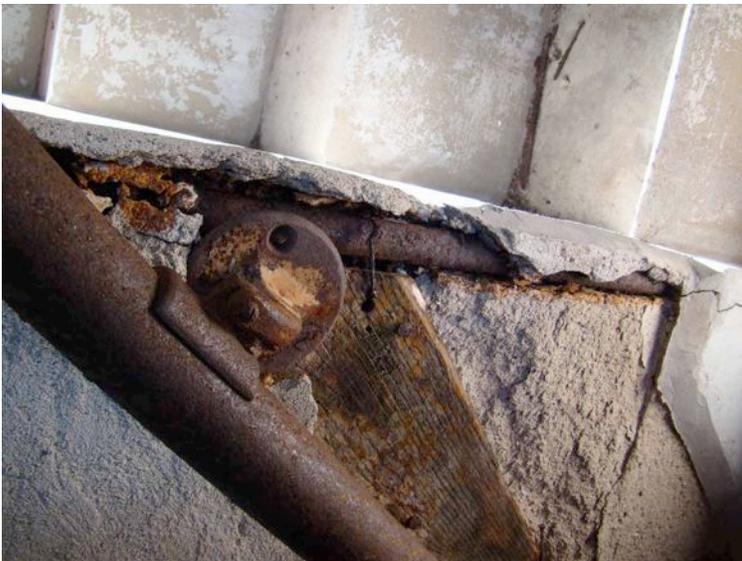
DSC00254

Details at thin walls:

More oxide jacking across staircase from image above. No doubt, roof hatch left open has exasperated this condition.

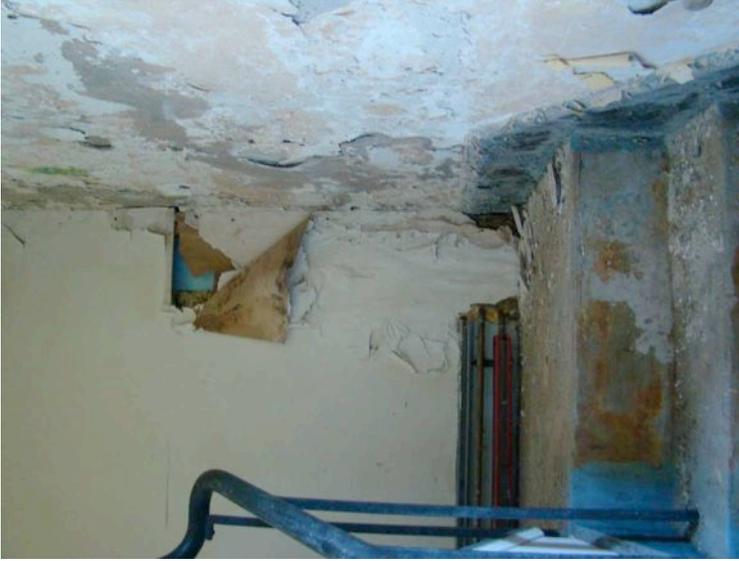
DSC00258

Stair Hall:

Moisture damage to plaster and gypsum board finishes.

- As in the case of concrete and steel components, remove deteriorated plaster and investigate conditions within/behind it.
- Clean the concrete floors and repair cracks as in the case of the floor in the third-level tower room.
- Restore the plaster finishes in conjunction with partitions to be restored and added for an agreed upon new use for the building.

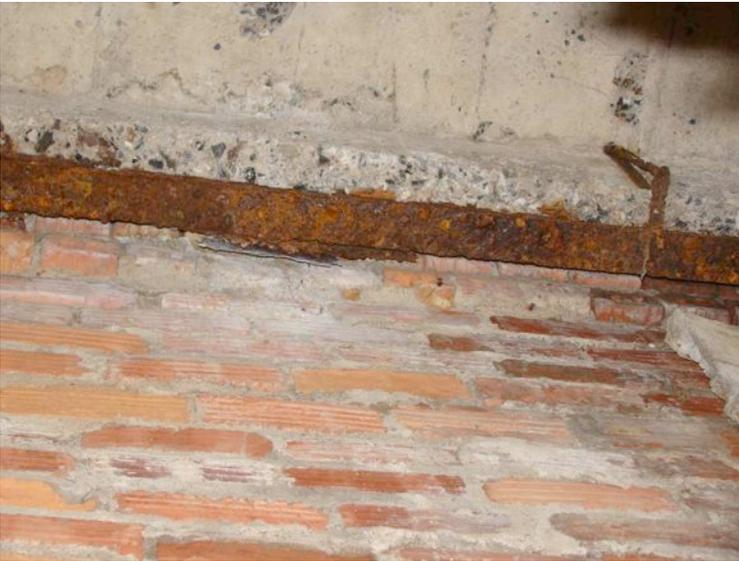
DSC00295

Loss of concrete beam encasement.

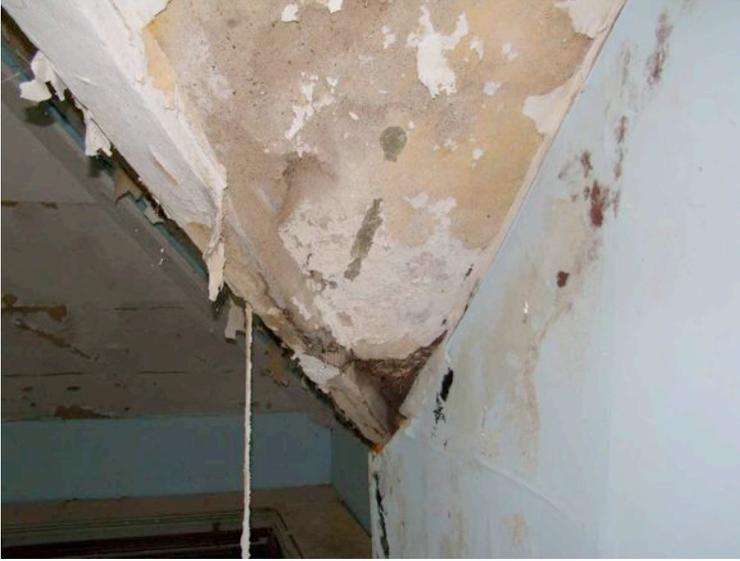
DSC00304

Over Archway:

Water damage. See tile roof images.

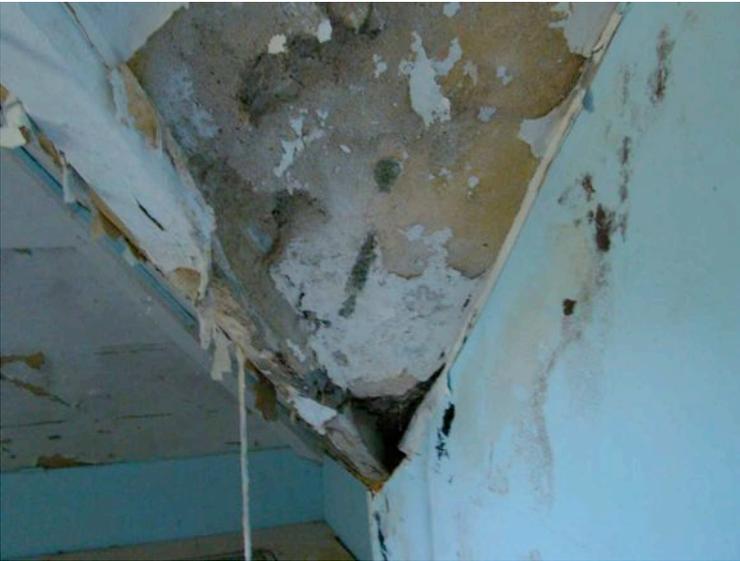
DSC00305

Over Archway:

Water damage.

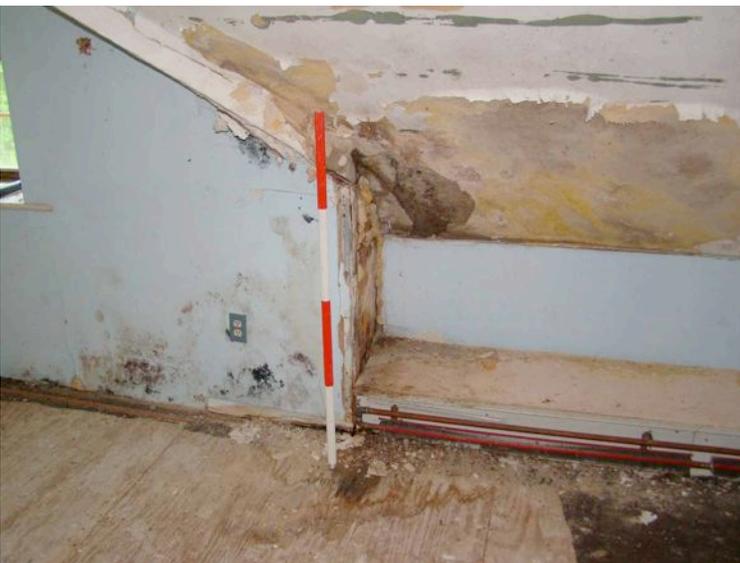
DSC00306

Over Archway:

Water damage.

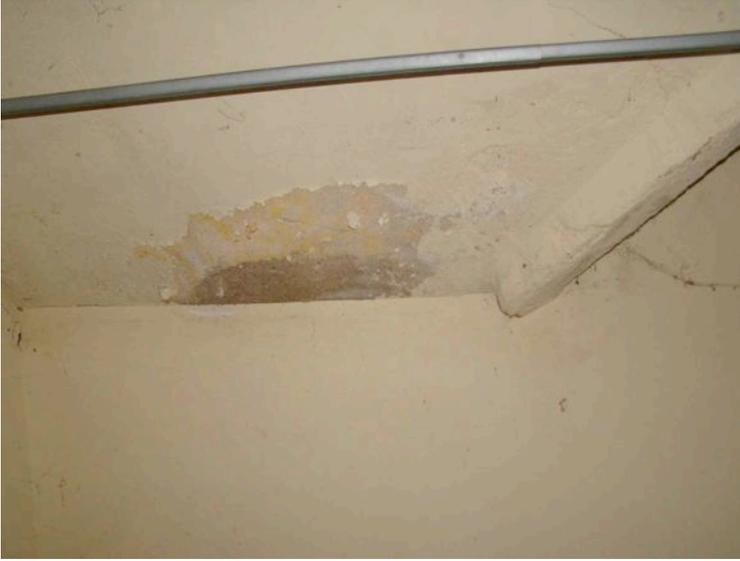
DSC00307

Over Archway:
Water damage.

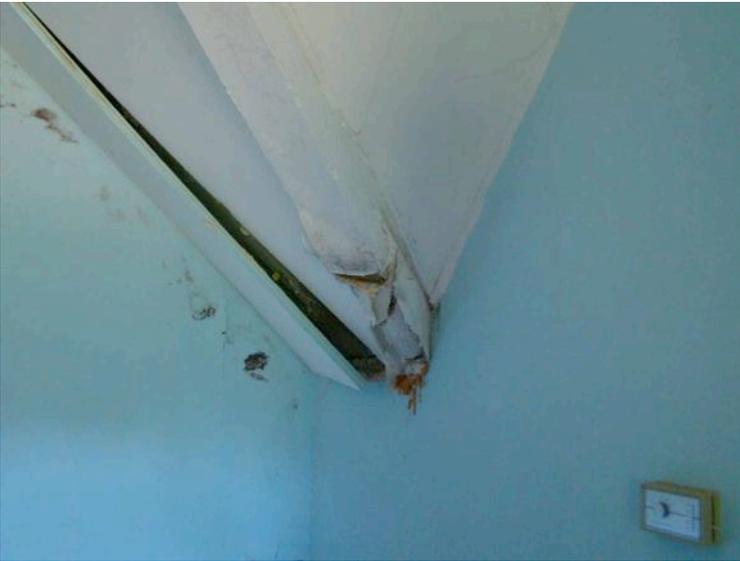
DSC00308

Over Archway:
Water damage.

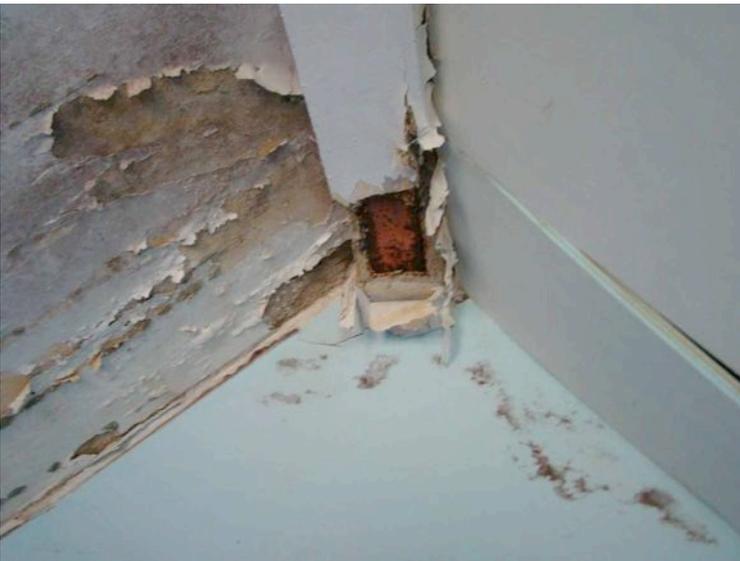
DSC00309

Over Archway:
Water damage.

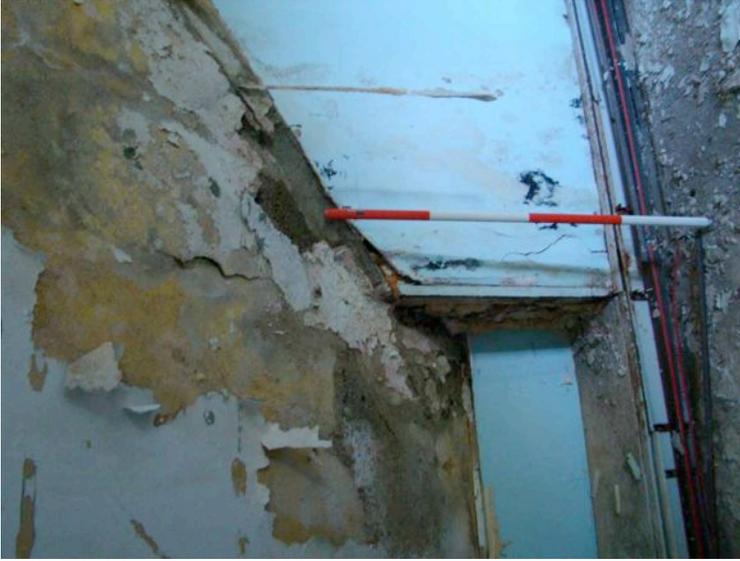
DSC00310

Over Archway:
Water damage.

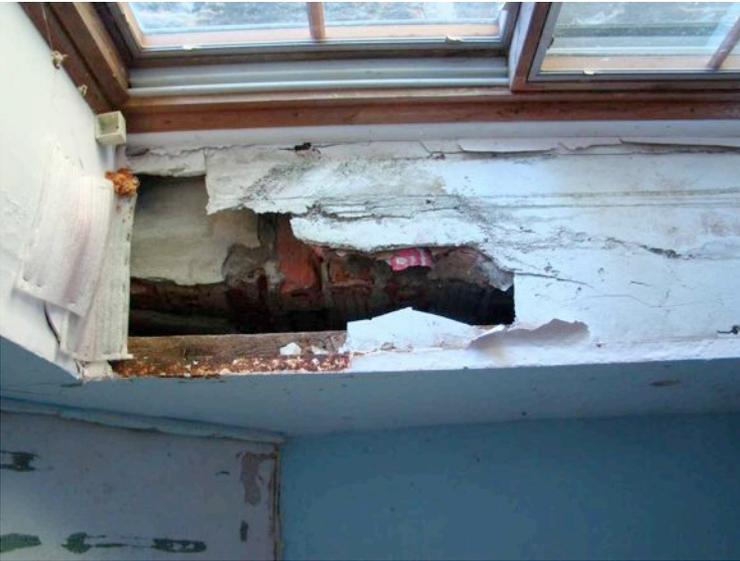
DSC00311

Over Archway:
Water damage.

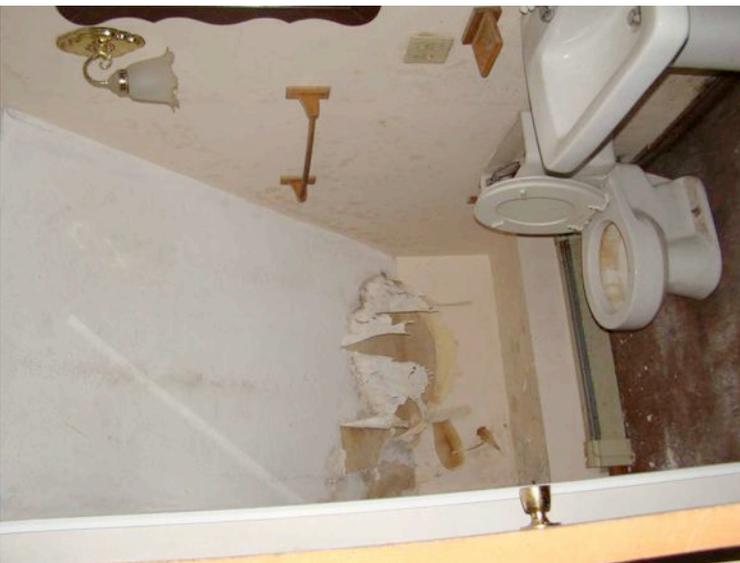
DSC00312

Over Archway:
Water damage.

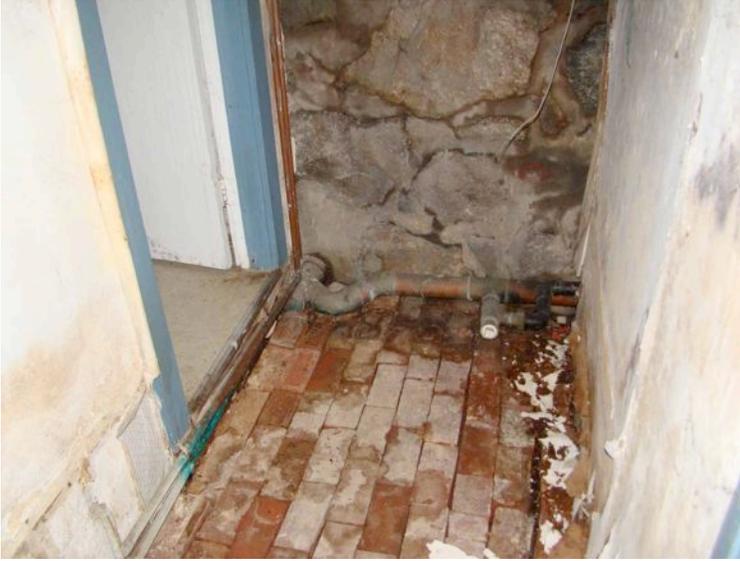
DSC00318

Basement:

Rising damp moisture damage.

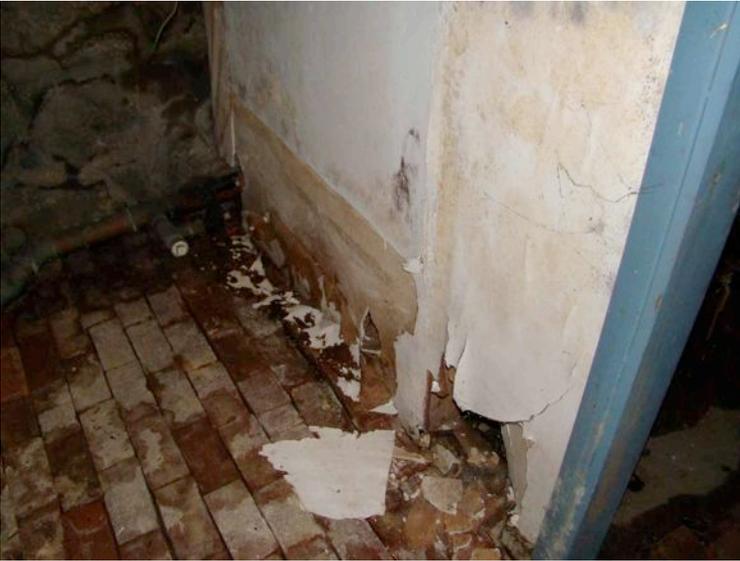
DSC00319

Basement:

Rising damp moisture damage.

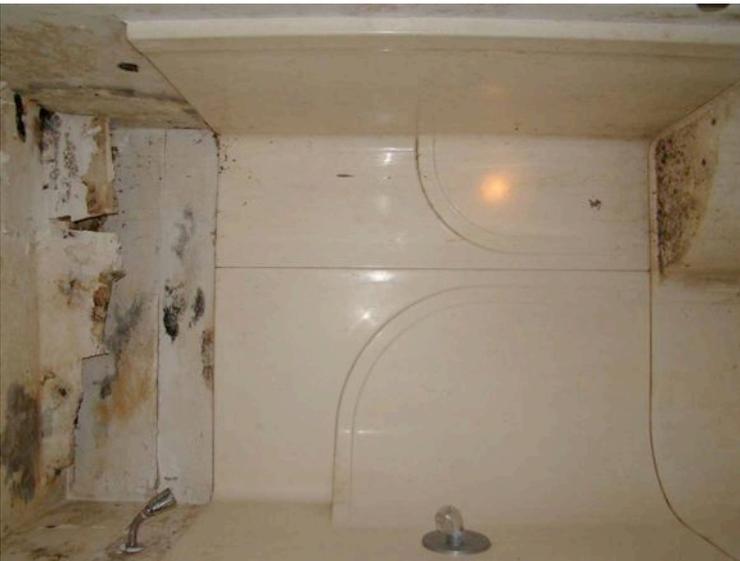
DSC00320

Basement:

Ceiling moisture damage.

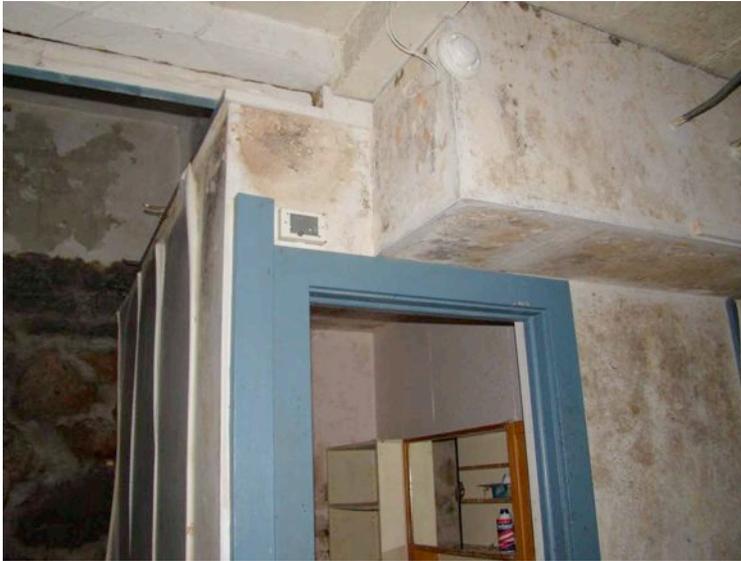
DSC00325

Basement:

Upper surfaces moisture damage.

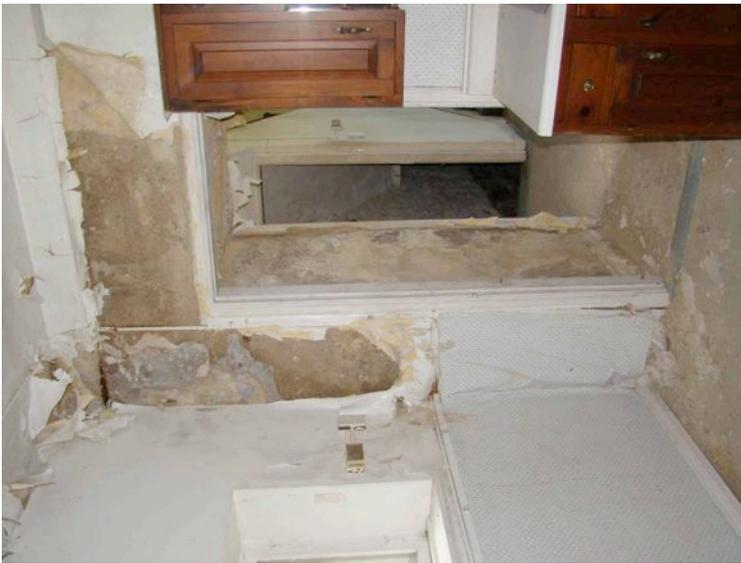
DSC00326

Basement:

Moisture damage at partitions.

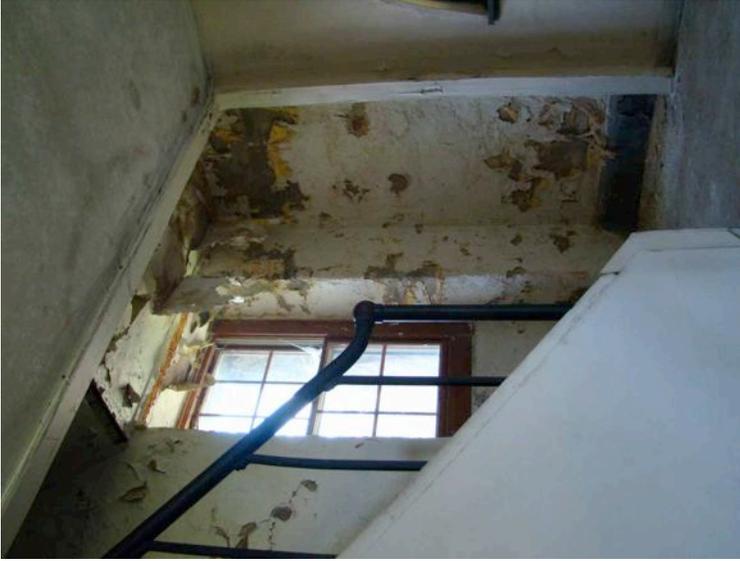
DSC00331

First Floor:

Moisture damage.

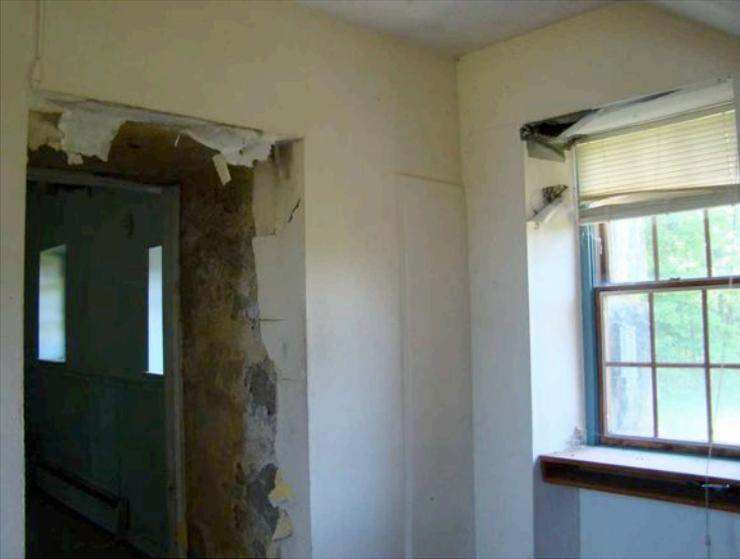
DSC00333

First Floor:

Moisture damage.

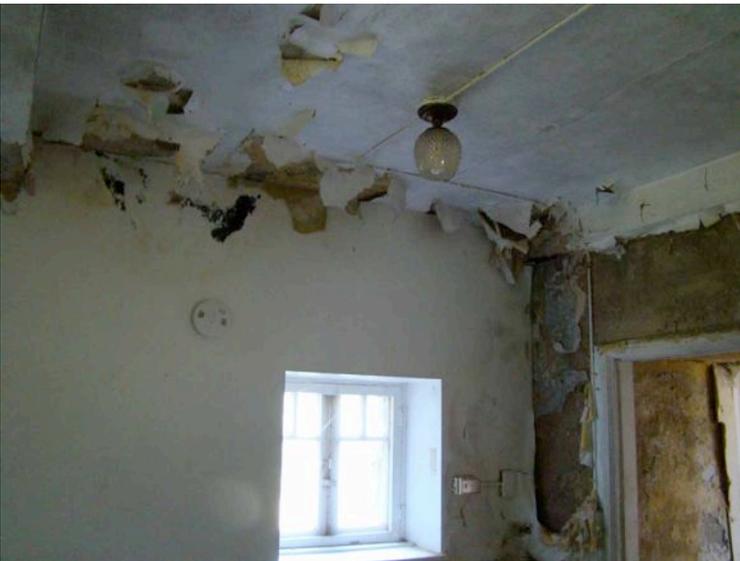
DSC00334

First Floor:

Moisture damage.
