***Town of New Paltz Historic Preservation Commission
Local Historic Landmark Designation***

***Mohonk Testimonial Gateway
1 Gatehouse Road, New Paltz, NY
(Gatehouse Structure and Adjoining Lands)***

15 October 2013

20 June 2013 Condition Assessment (04 September 2013)

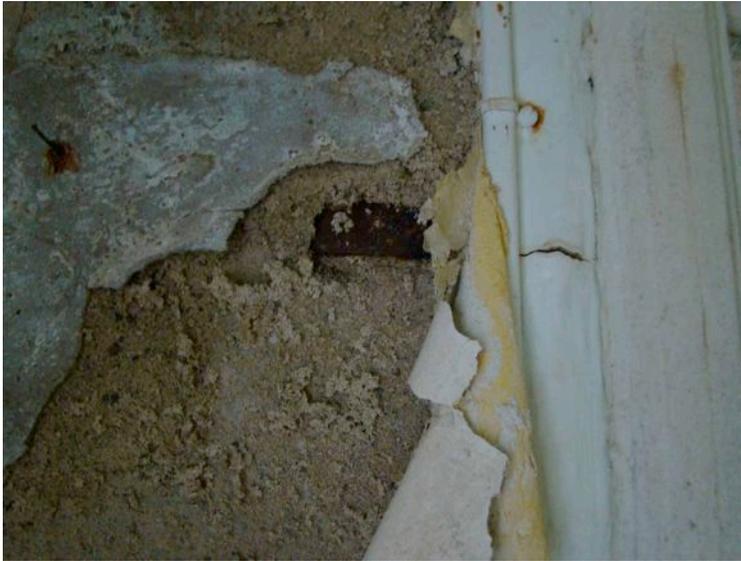
DSC00337

Details:

Moisture damage at partition.

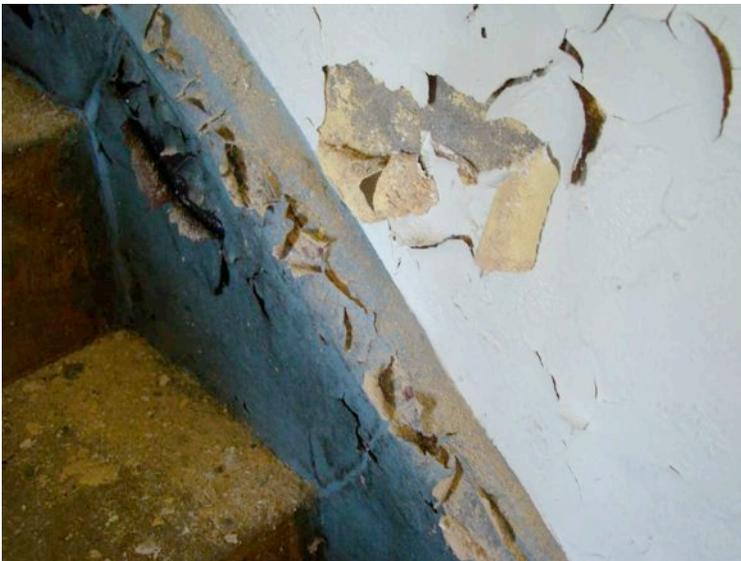
DSC00338

Details:

Moisture at staircase.

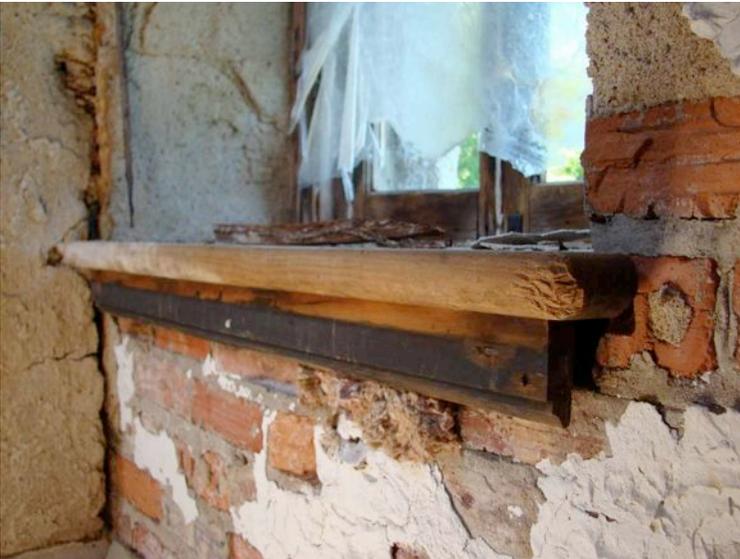
DSC00251

Original Window Stool with Apron and Bedmolding missing:
