MOHONK TESTIMONIAL GATEWAY

New Paltz, New York

CONDITION STUDY

20 June 2013 Condition Assessment (04 September 2013)

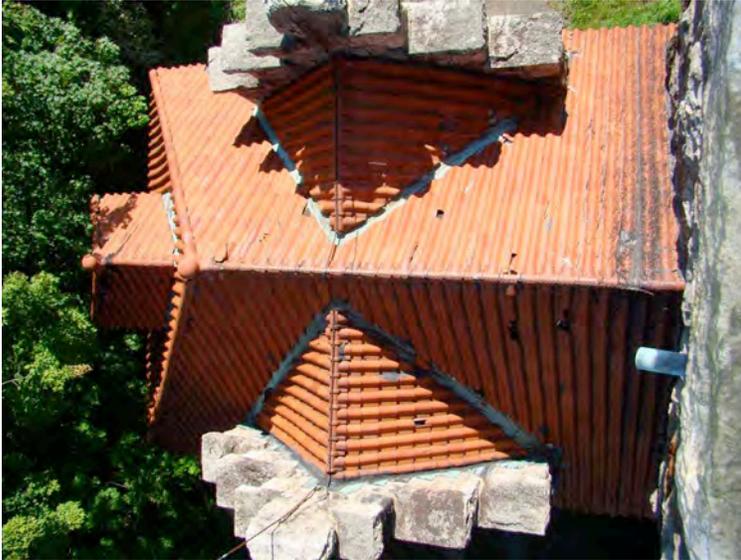
DSC00228

Roof over Archway:

From the observation deck; Note broken tiles at ridges and valleys as well as roof planes.

1. Record and remove all tiles, accessories, flashings, sheet materials and nails.
2. Repair all roof decks using matching lumber.
3. Install an impervious "underlayment" or membrane beneath all the fields (roof planes) of tile, and the sheet copper must be replaced at all valleys, parapet and wall intersections and at the horizontal drip eaves.
4. Reinstall sound tiles, using the existing tiles in coherent roof planes such that they are not mixed with new tiles. Install new tiles on tower roofs and in areas where impact from the tower roofs lands on the lower gables and hips.
5. Finish with the historic ridge and hip tiles.
6. Restore observation deck/waterproof membrane, flash into stone parapets with sheet copper, reactivate south drain scupper and build new hatch cover and install.

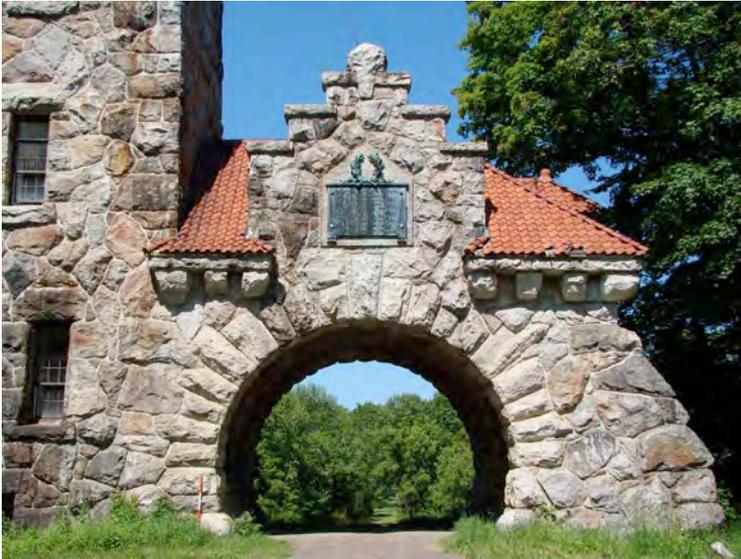
DSC00259

Roof over Archway:

From the east; Note broken tiles at eaves

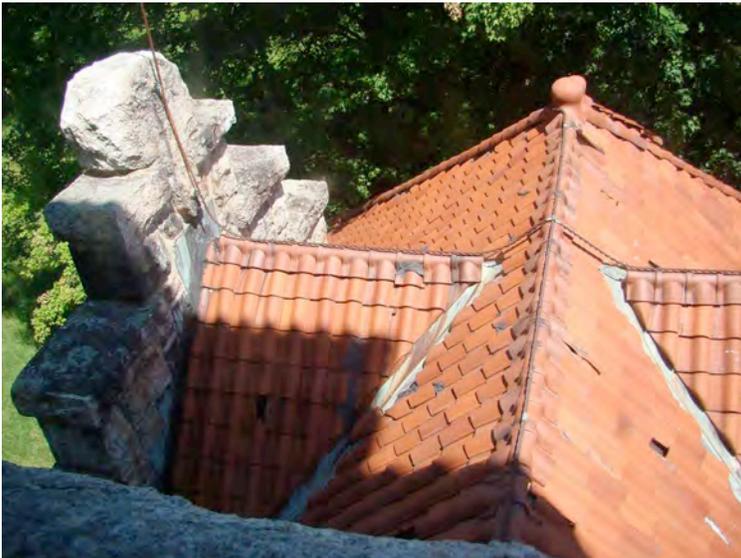
DSC00292

Roof over Archway:

From the third level; Note broken tiles and lightning arresting system, west gable and stepped stone parapet.

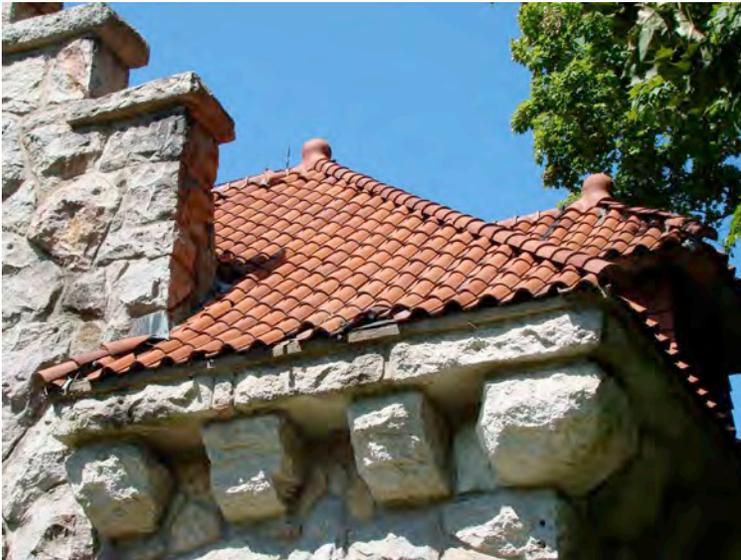
DSC00260

Details:

Broken tiles at East eaves,
north of plaque.

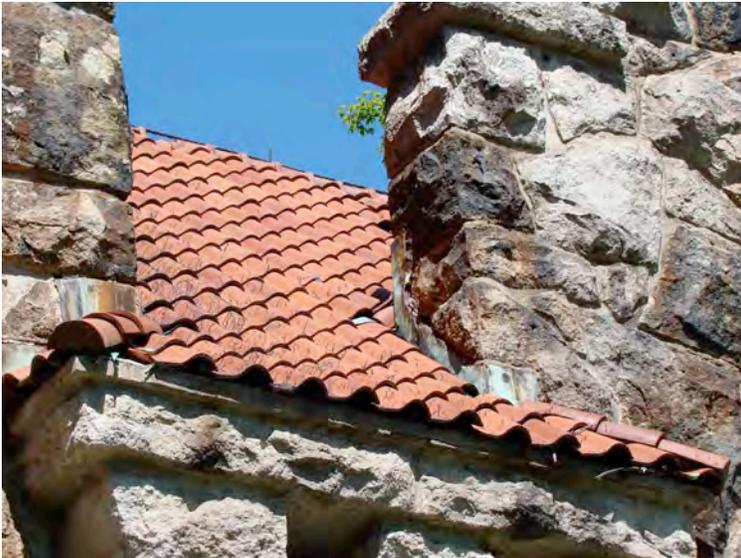
DSC00261

Details:

Broken tiles at East eaves,
South of plaque.

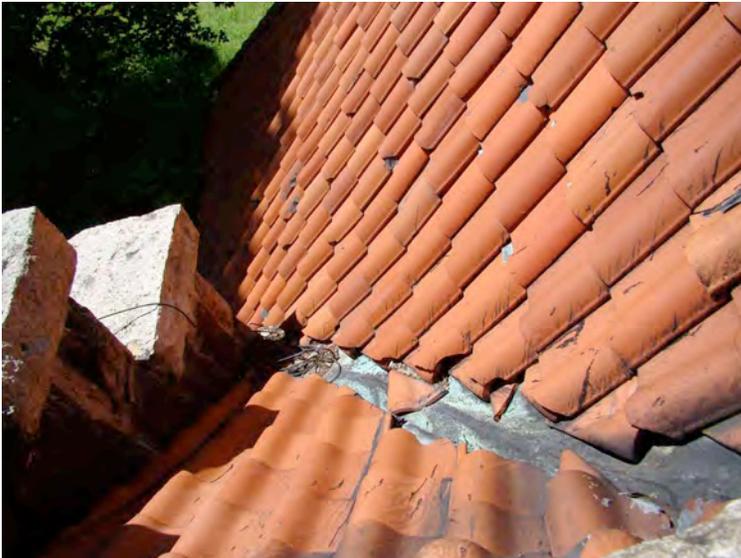
DSC00285

Kitchen Wing Roof:

Detail of valley with broken tiles.

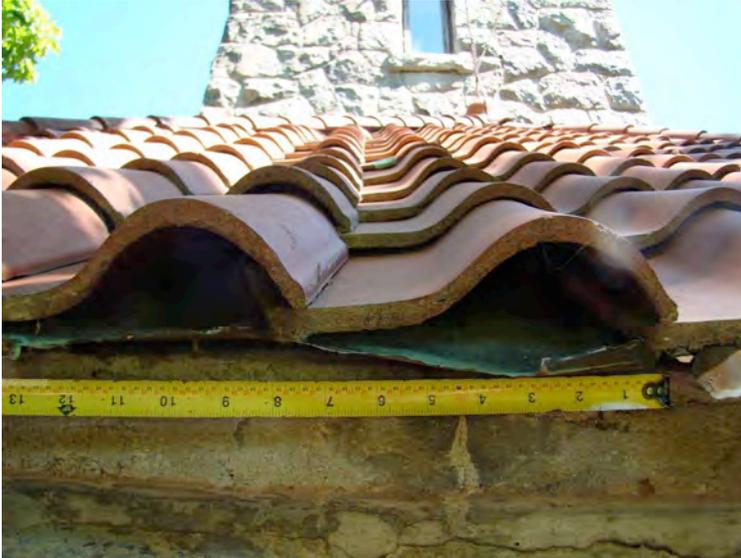
DSC00278

Details:

Worn out copper drip edge of eaves over kitchen door.

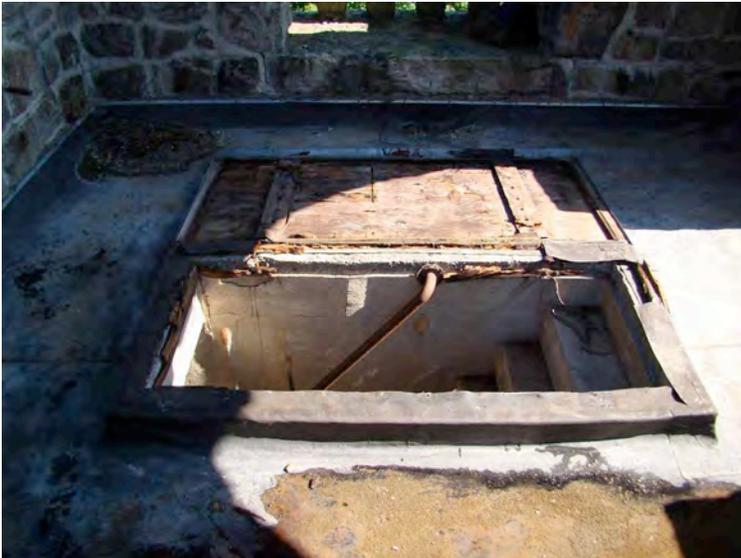
DSC00230

Rotted Hatch:

The wooden and sheet metal hatch cover is deteriorated beyond its useful life.

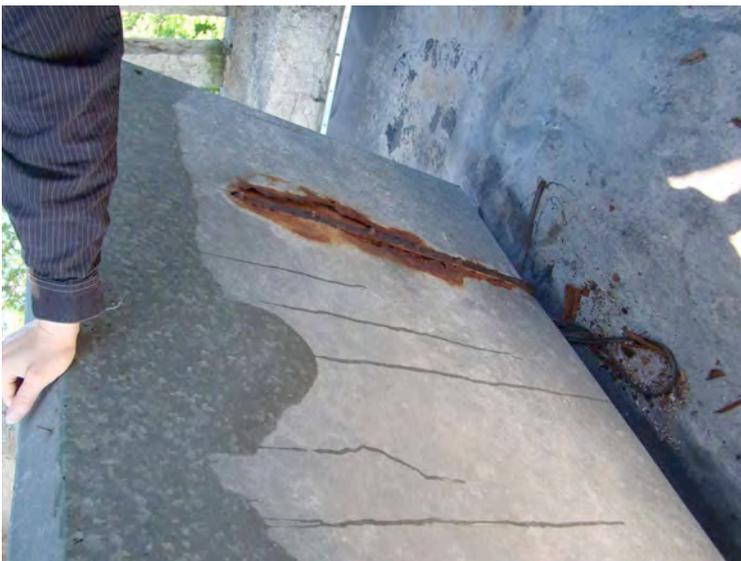
DSC00234

Rotted Hatch:

The sheet metal has rusted through.

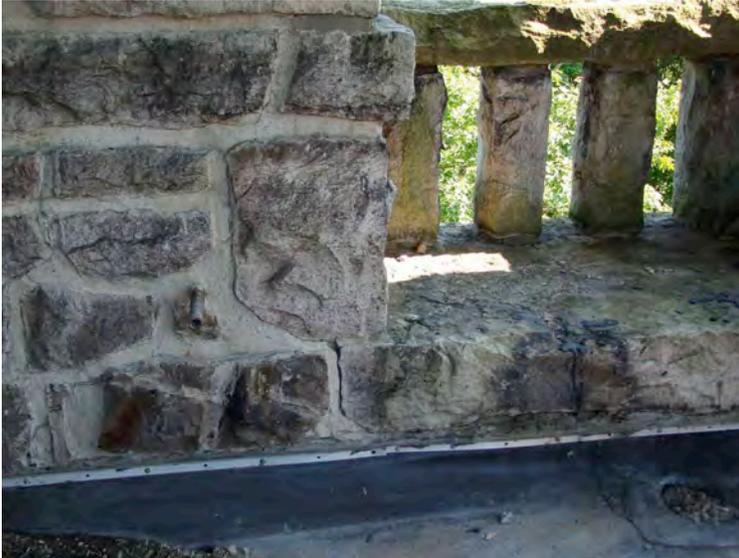
DSC00232

Condition Observation:

Crack in corner pier indicates need for compatible repointing

1. Test the existing mortars for composition and physical properties. Ascertain type(s) and proportions if present of hydraulic cement, lime and sand used in the bedding and pointing mortars. Determine why there are different colors and textures present in the existing mortars.
2. Select bedding, repointing and parapet mortars for use in distinct locations.
3. Carefully and selectively remove cracked and unbonded mortar.
4. Repair voids and repoint mortar joints.
5. Clean surfaces affected by repointing operations.

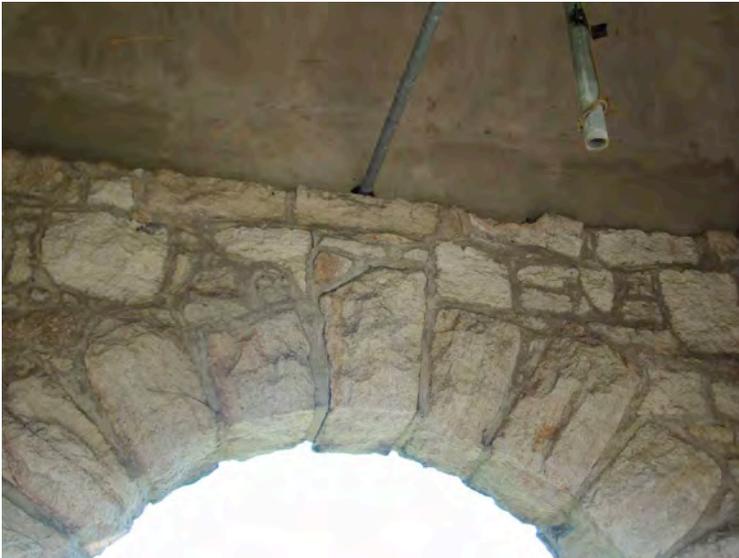
DSC00236

Condition Observation:

Crack in keystone mortar at North observation arch is start of deterioration

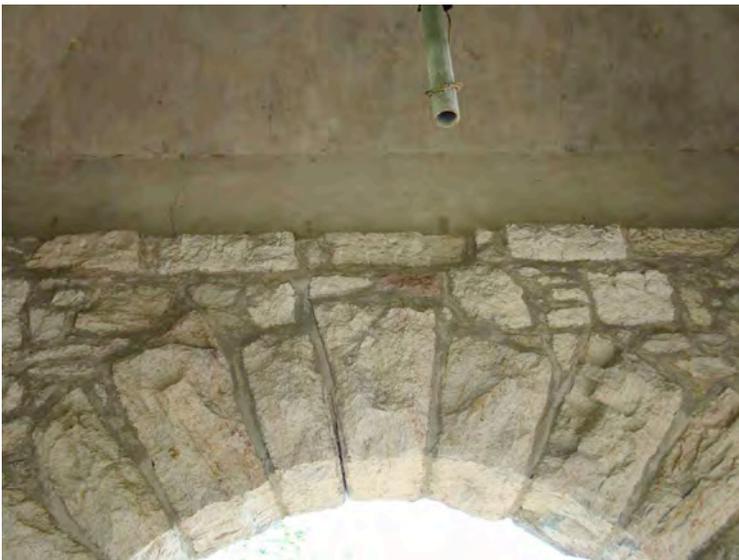
DSC00237

Condition Observation:

Crack in keystone mortar at East arch.

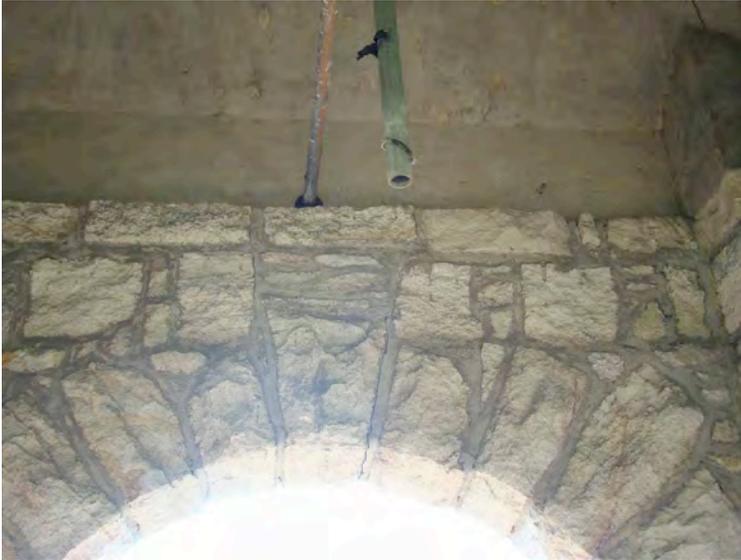
DSC00238

Condition Observation:

Crack in keystone mortar at South arch.

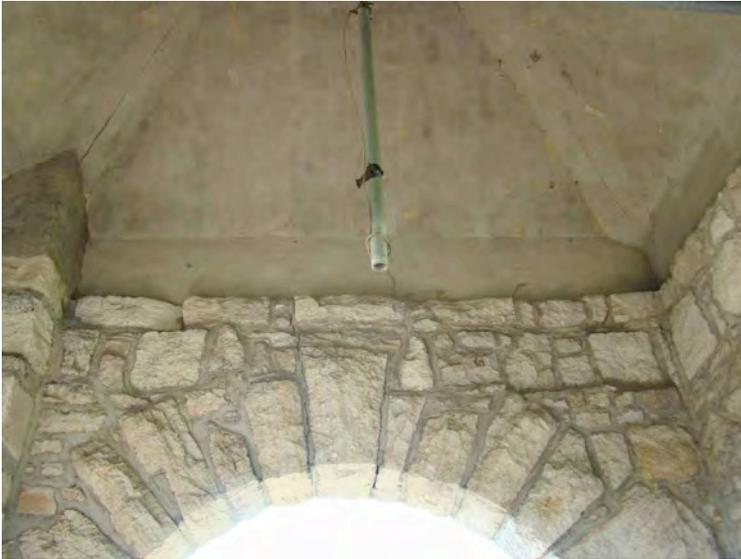
DSC00239

Condition Observation:

Crack in keystone mortar at West arch.

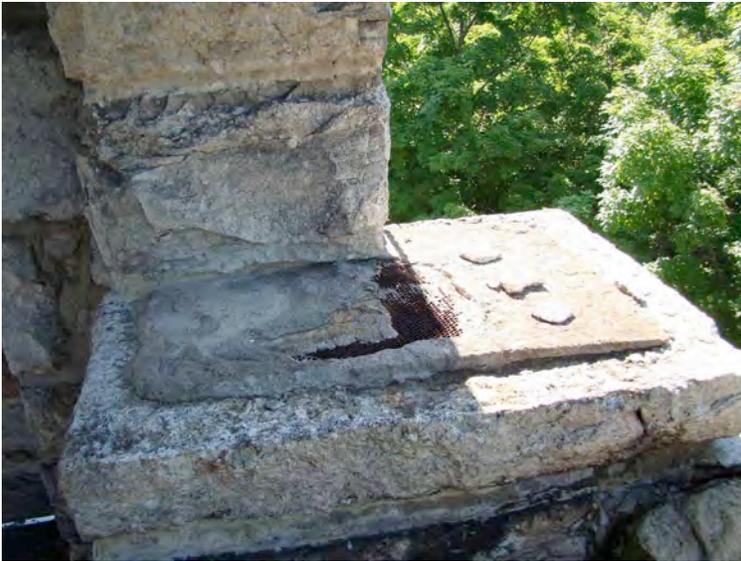
DSC00231

Details: Covered Planter

What appears to have been planters originally have been covered over with wire mesh and mortar, now deteriorated.

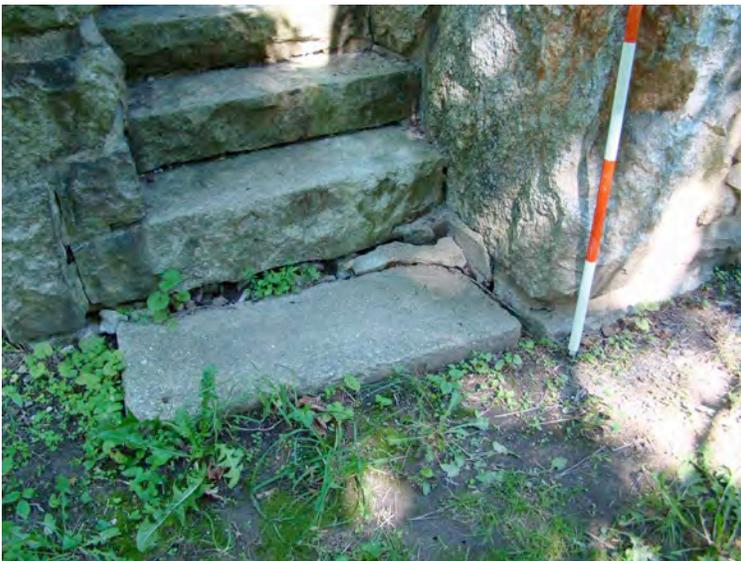
DSC00244

Details: Kitchen Stair

Illustrating need for repair and repointing.

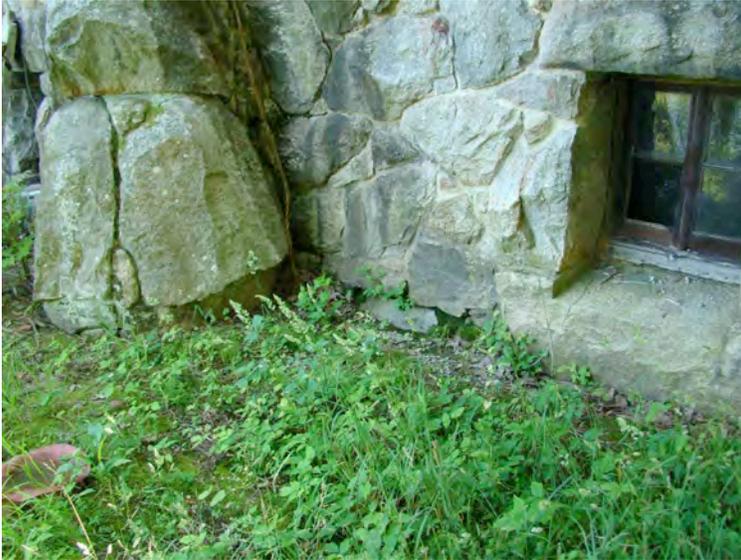
DSC00271

West:

Deterioration of mortar at arch buttress and facade at ground level.

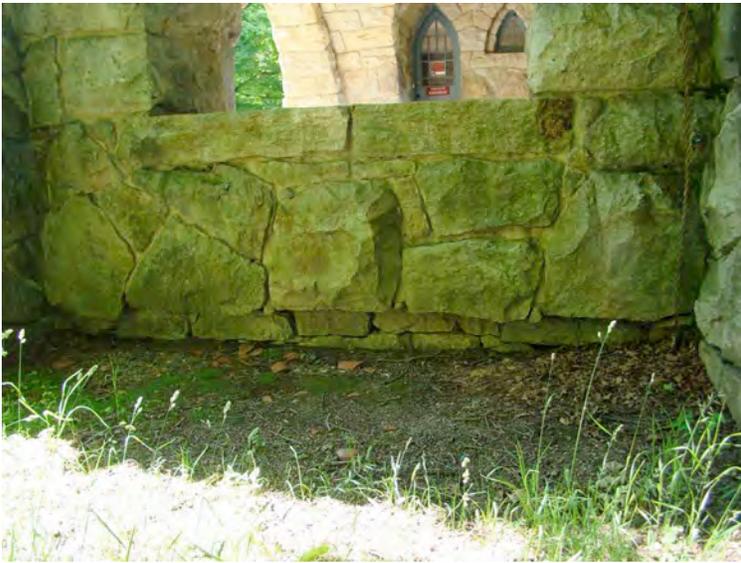
DSC00274

North:

Need for repointing, emphasized at ground level.

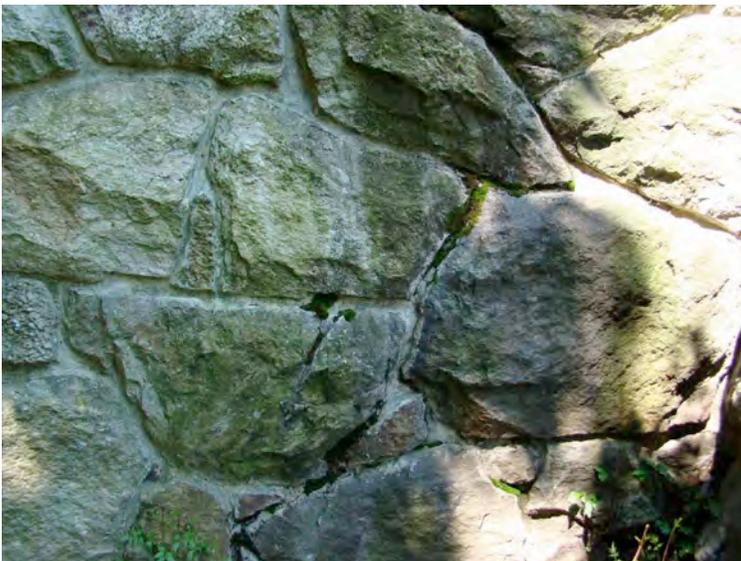
DSC00275

East:

Cracking of mortar joints.

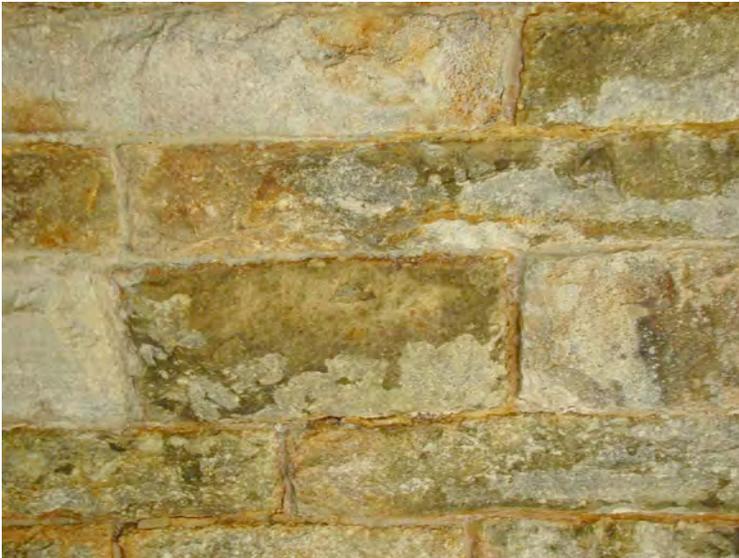
DSC00354

At Archway:

Cracking of mortar in stone barrel vault.

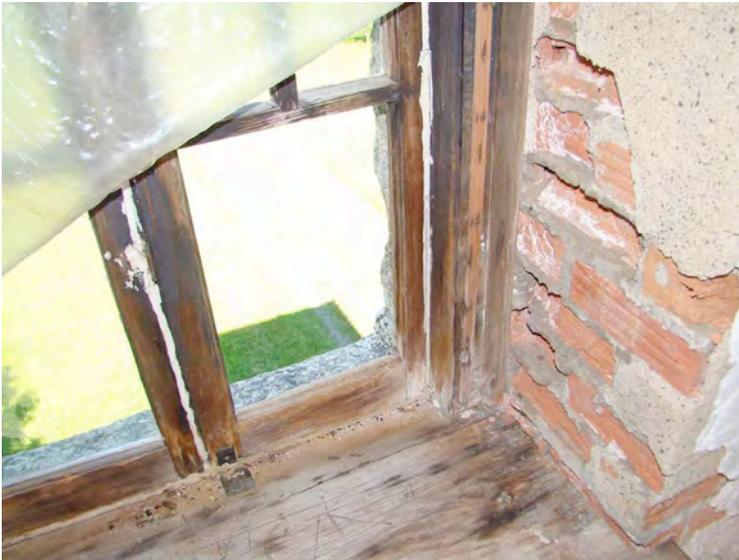
DSC00245

Original, Modified:

Illustrated here is a stair hall window in the west facade. The frame and sash are original and restorable even though the sash has been modified.

1. Photograph existing window conditions in detail and remove original sash and transoms where they exist for restoration.
2. Restore frames in place, using Dutchmen, epoxy repair and replacement in kind where needed.
3. Restore the removed sash, again using Dutchmen, epoxy repairs and replacement of wooden components as needed.
4. Prime the glazing reveals of the frames and reglaze using leaded comes and drawn (period) glass in the historic design. The configuration of transoms is as seen in the third-level north-facing tower room window and the casement subdivision is as seen in the one original west-facing window. This is the small window which cannot be accessed from the interior.
5. Paint and finish sash and frames, restore casement hardware and reinstall.

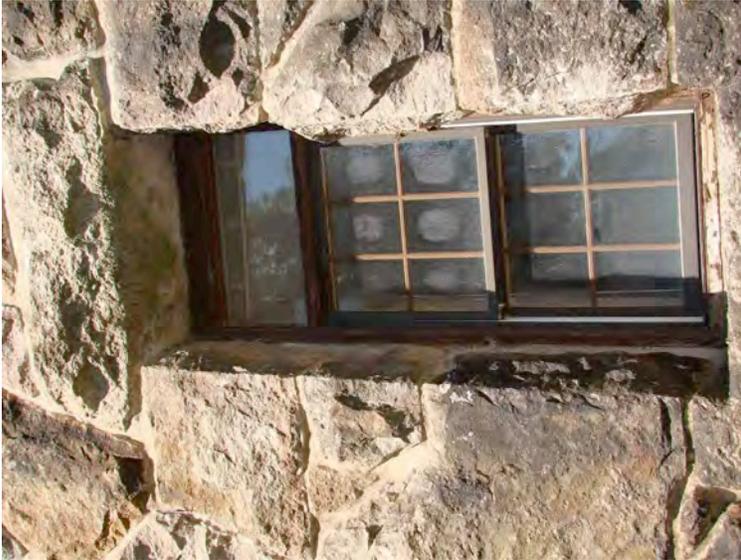
DSC00262

Replace with original transom frames:

Six-over-six pane incompatible sash.

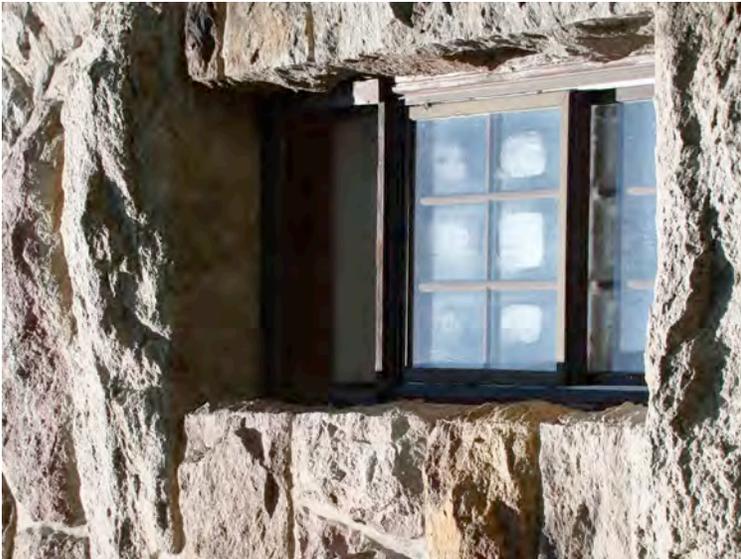
DSC00263

Replace with original transom frames:

Six-over-six

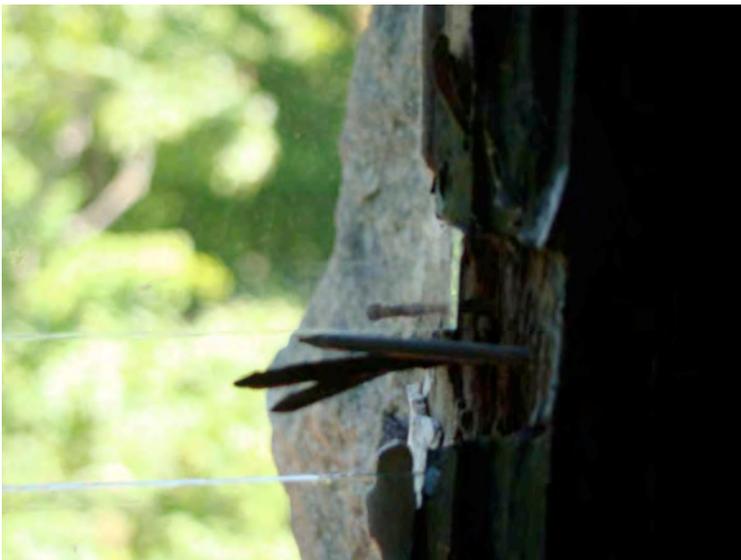
DSC00290

Detail of crude modification:

Apparently, when the original, leaded-glass was replaced, wooden horizontal muntins were set into the original sash stiles, secured rather crudely with nails.

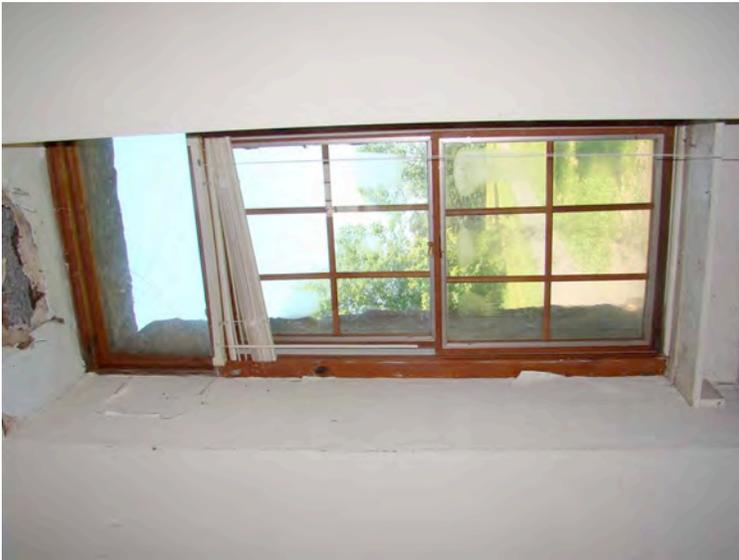
DSC00315

Original:

Six-over-six pane sash from interior.

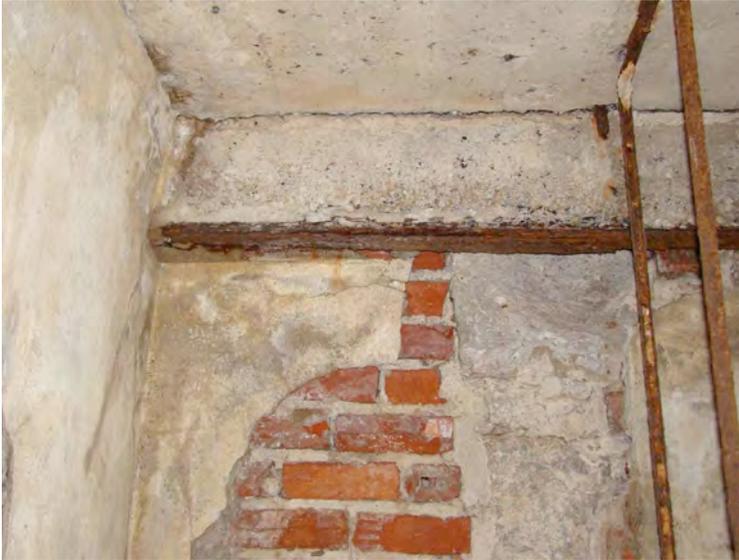
DSC00249

Condition:

Steel is oxidized where exposed to interior moisture. The extensive use of steel in this building is documented in the original drawings.

1. Photograph each room and remove all renovations that are less than 50 years of age. Remove gypsum board partitions and all false ceilings.
2. Photograph in detail and remove deteriorated portions of historic materials and finishes so that steel beams and metal lath can be further evaluated for condition.
3. If condition of steel beams warrants it, have a professional engineer inspect the concrete and steel structural components.
4. Repair and stabilize rust on steel components.
5. Restore concrete covers and coatings over steel beams.

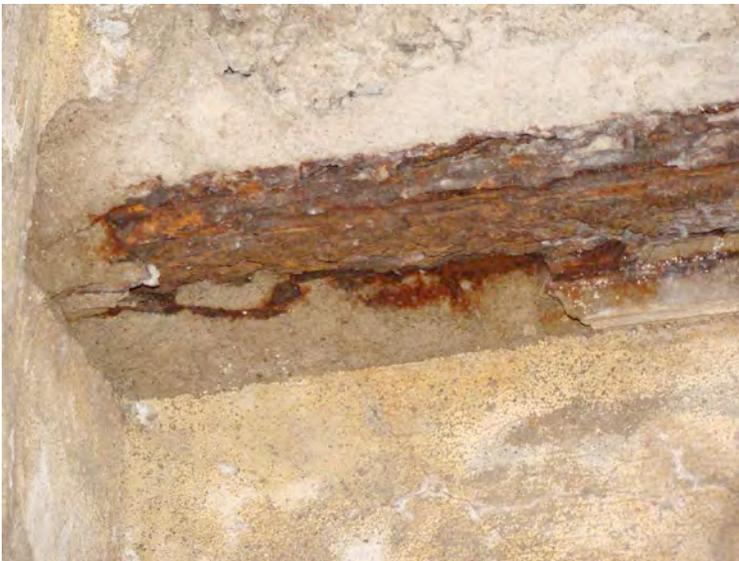
DSC00250

Condition:

Detail of oxidation of steel. "Oxide jacking", that is, the expansion of material which accompanies the formation of rust, has expelled the concrete covering beneath this beam.

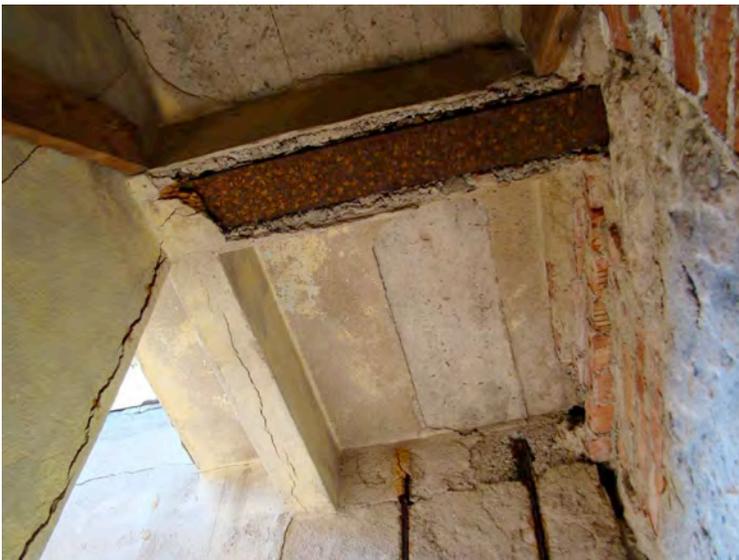
DSC00253

Condition:

Even more dramatic example of "oxide jacking" at beam over upper stairway to observation deck. It appears that moisture collects at steel components and migrates to their hollow surfaces, even though they are concealed within concrete and or plaster.

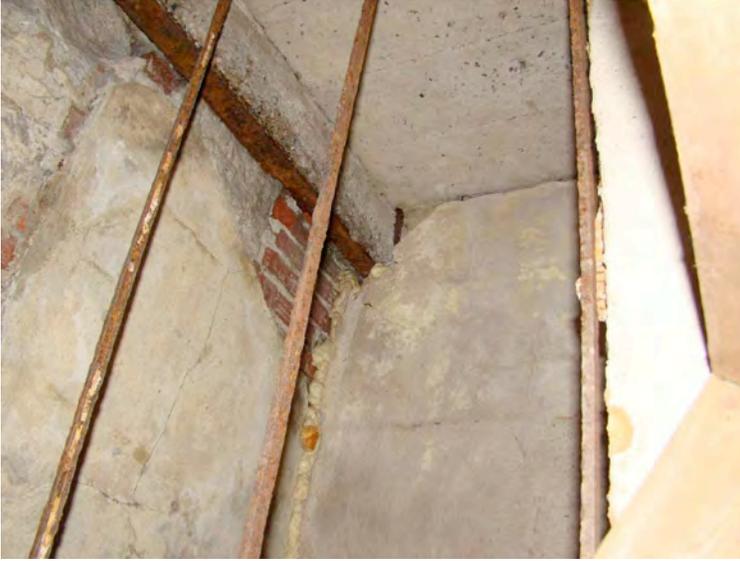
DSC00256

Condition:

The vertical ferrous ribs shown are all that survives of several thin cementitious partitions. The metal mesh is gone as well as the plaster finish.

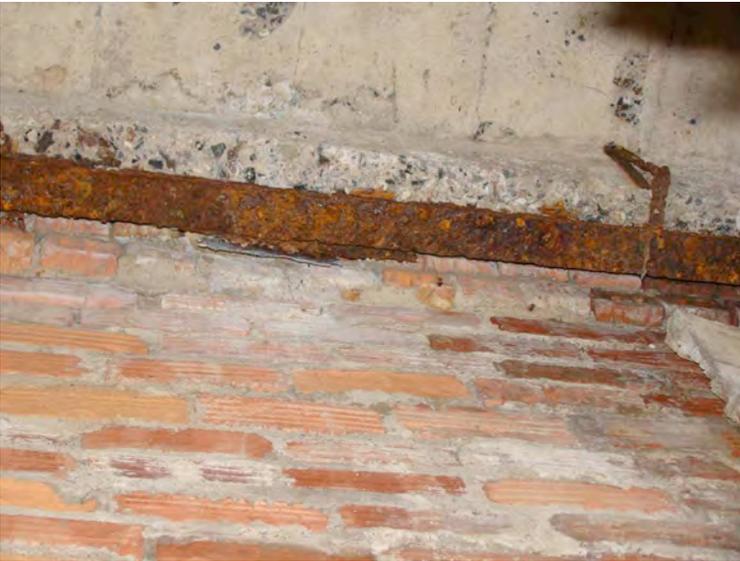
DSC00295

Condition:

More iron oxide (rust).

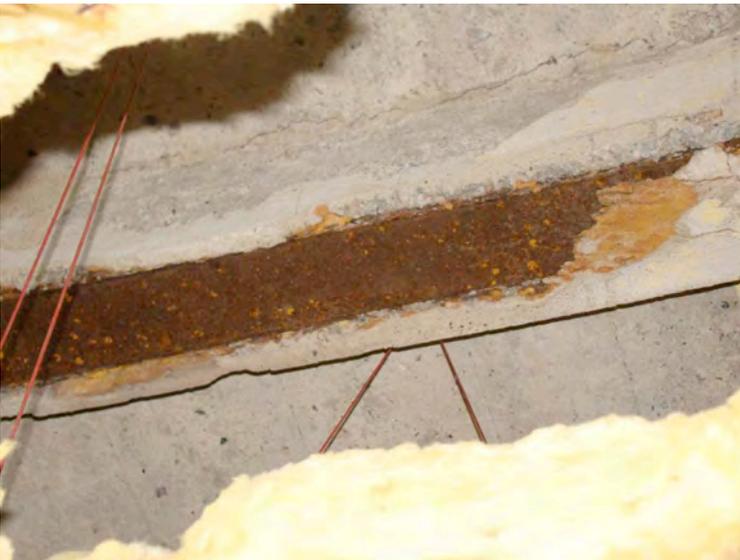
DSC00300

Condition:

Detail of rust.

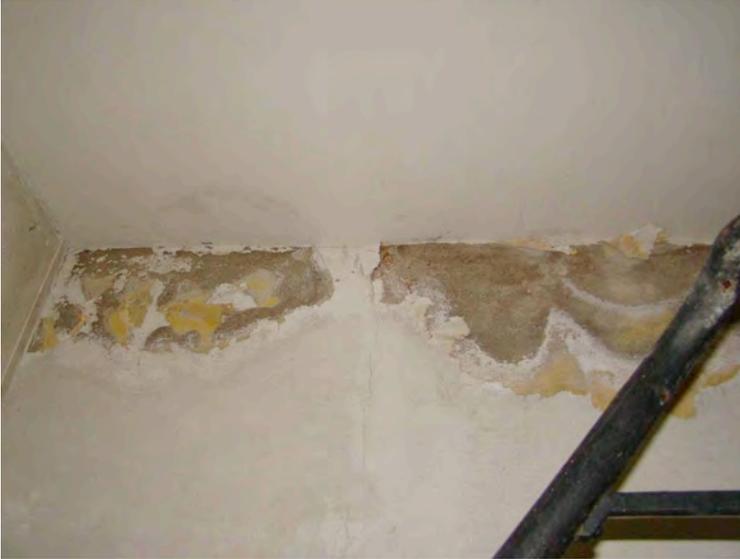
DSC00344

Condition:

Evidence of water intrusion at upper levels.

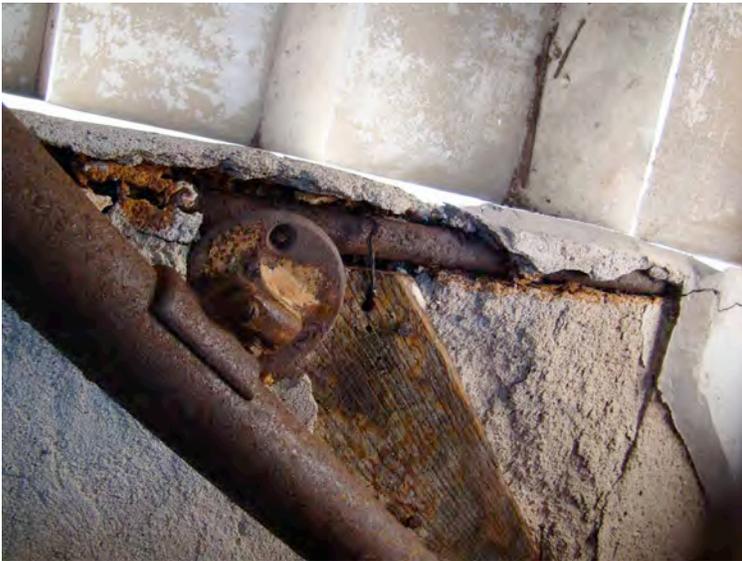
DSC00254

Details at thin walls:

More oxide jacking across staircase from image above. No doubt, roof hatch left open has exasperated this condition.

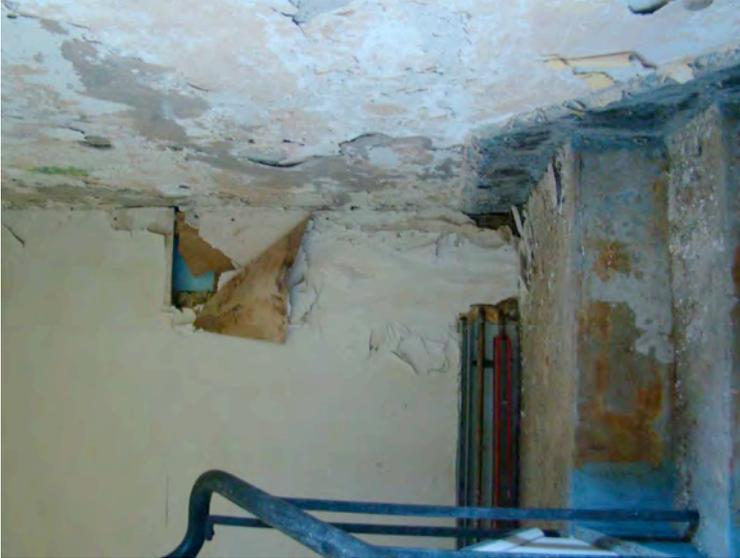
DSC00258

Stair Hall:

Moisture damage to plaster and gypsum board finishes.

1. As in the case of concrete and steel components, remove deteriorated plaster and investigate conditions within/behind it.
2. Clean the concrete floors and repair cracks as in the case of the floor in the third-level tower room.
3. Restore the plaster finishes in conjunction with partitions to be restored and added for an agreed upon new use for the building.

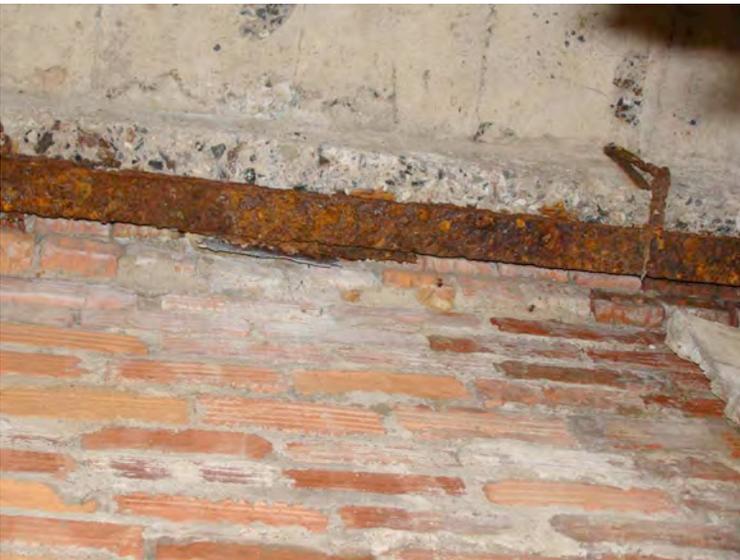
DSC00295

Loss of concrete beam encasement.

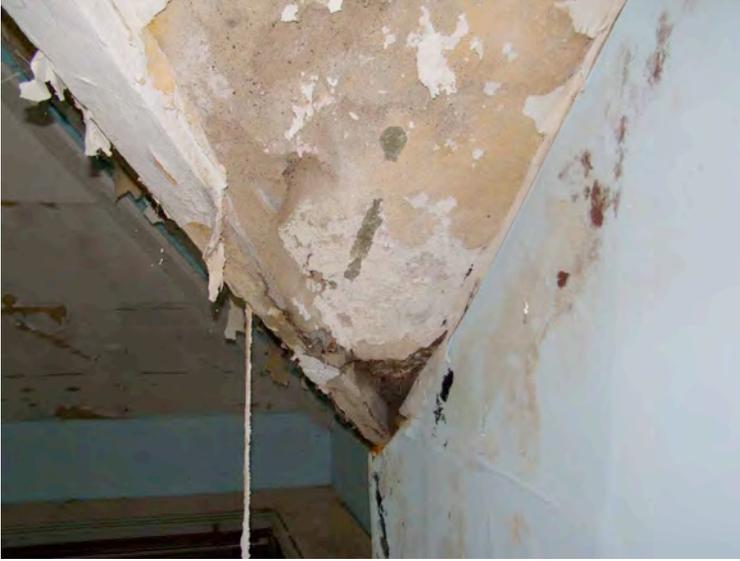
DSC00304

Over Archway:

Water damage. See tile roof images.

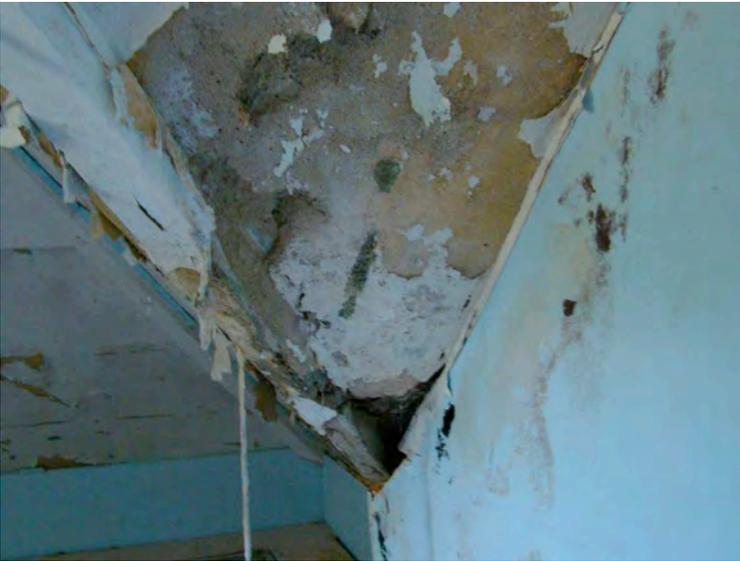
DSC00305

Over Archway:

Water damage.

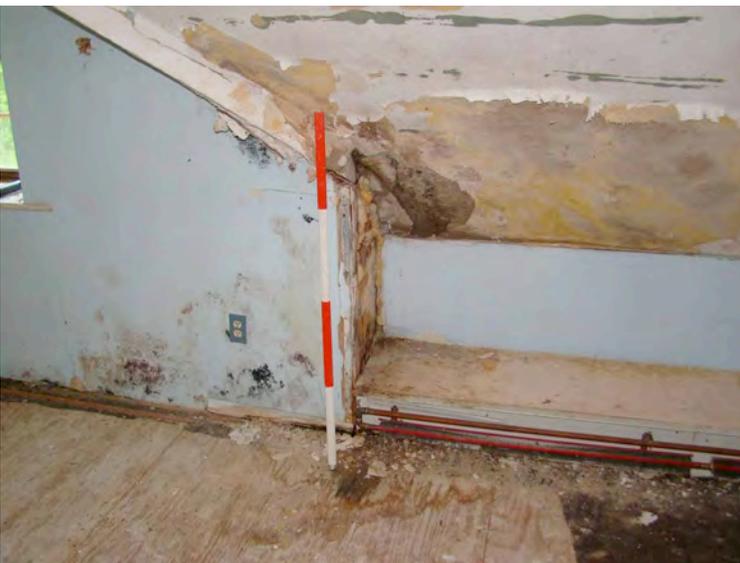
DSC00306

Over Archway:

Water damage.

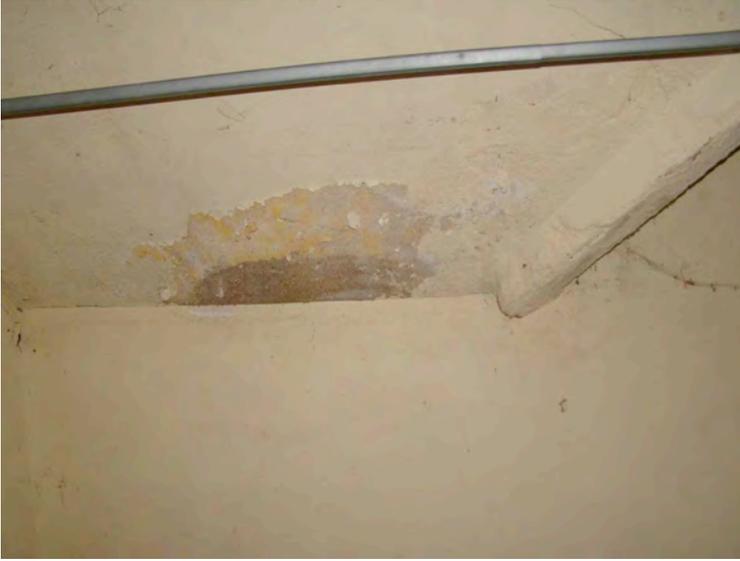
DSC00307

Over Archway:
Water damage.

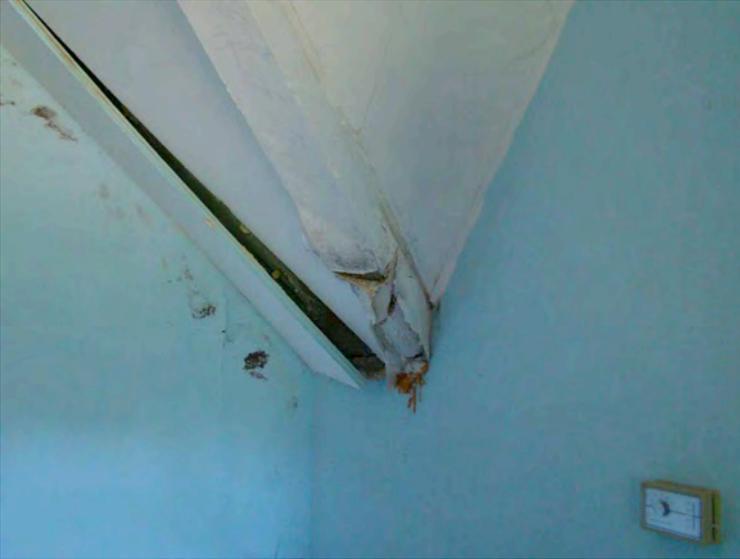
DSC00308

Over Archway:
Water damage.

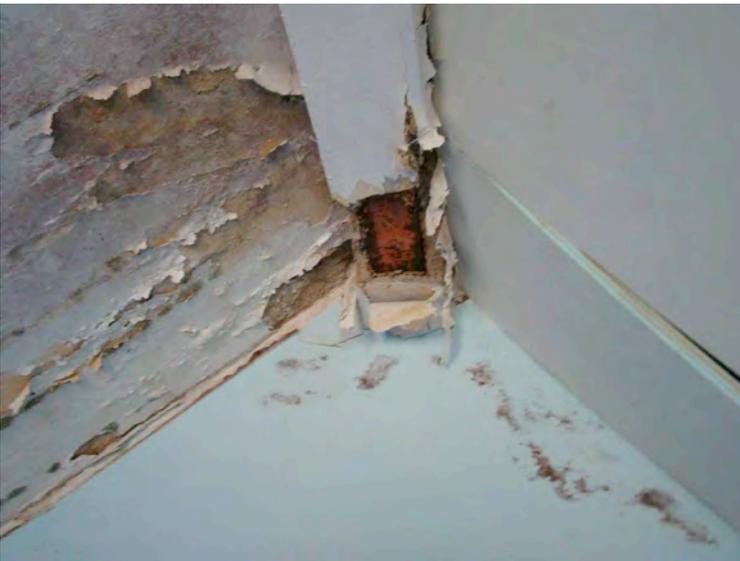
DSC00309

Over Archway:
Water damage.

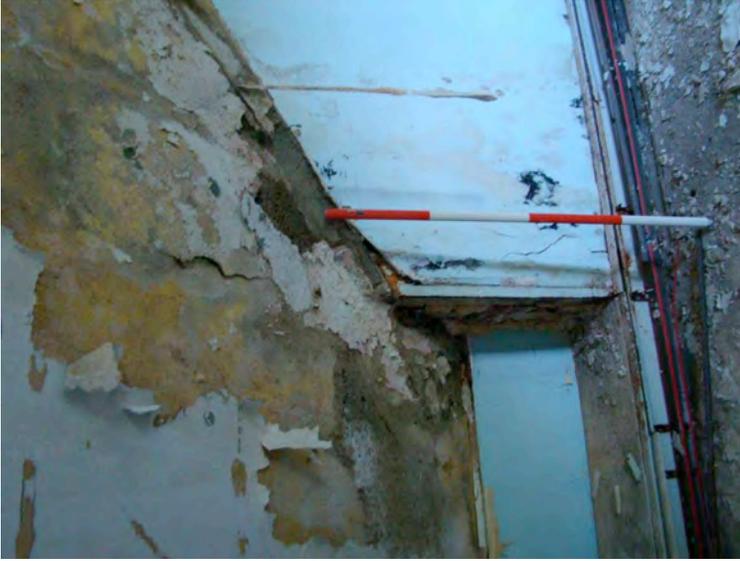
DSC00310

Over Archway:
Water damage.

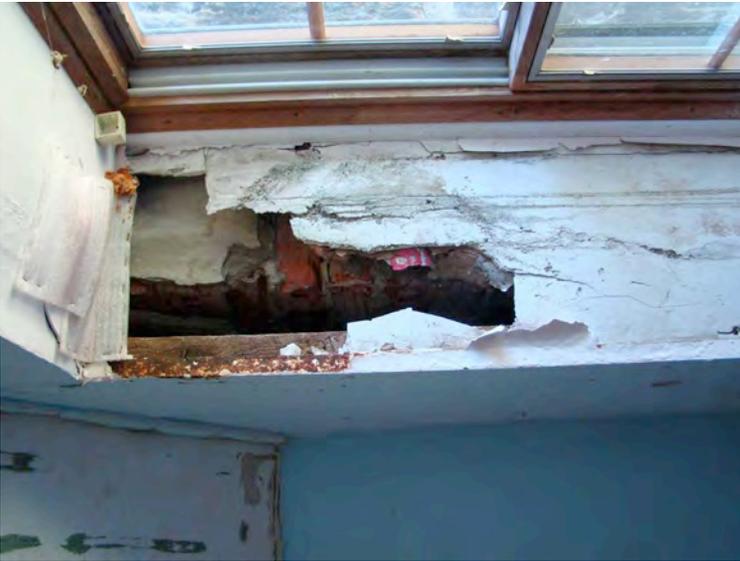
DSC00311

Over Archway:
Water damage.

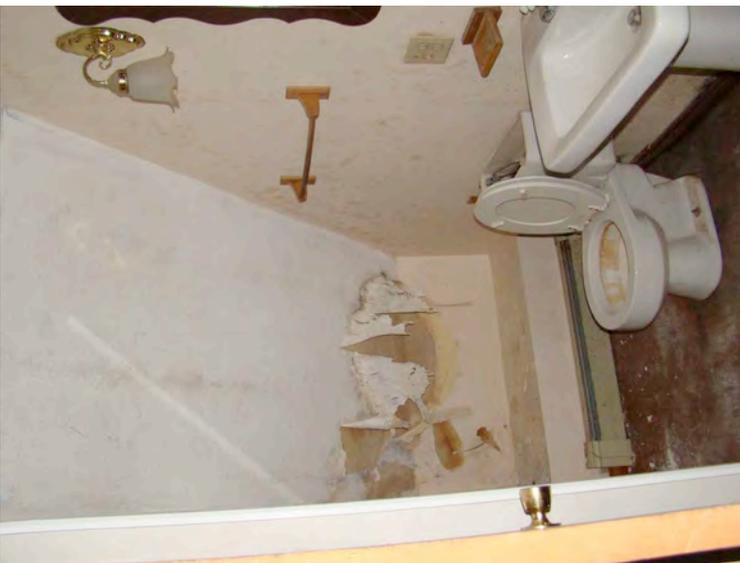
DSC00312

Over Archway:
Water damage.

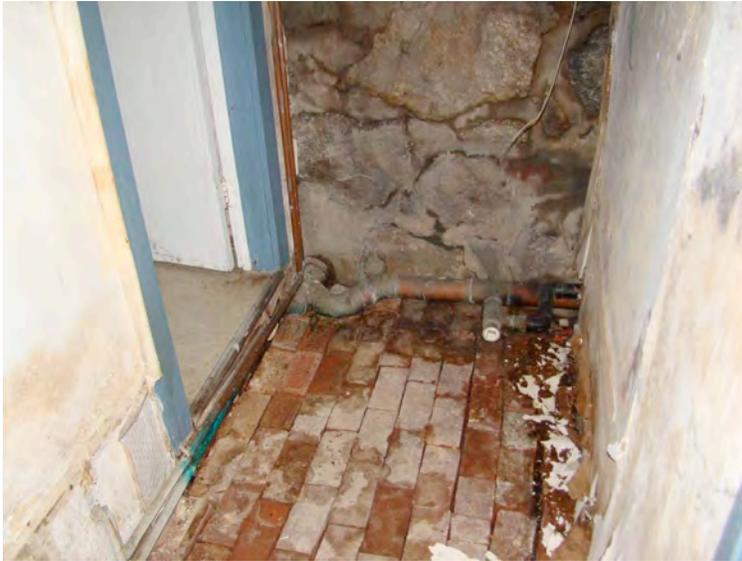
DSC00318

Basement:

Rising damp moisture damage.

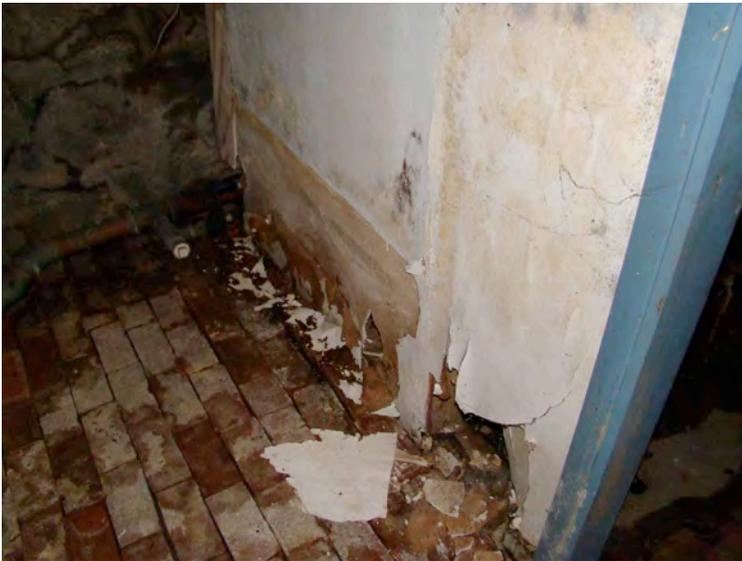
DSC00319

Basement:

Rising damp moisture damage.

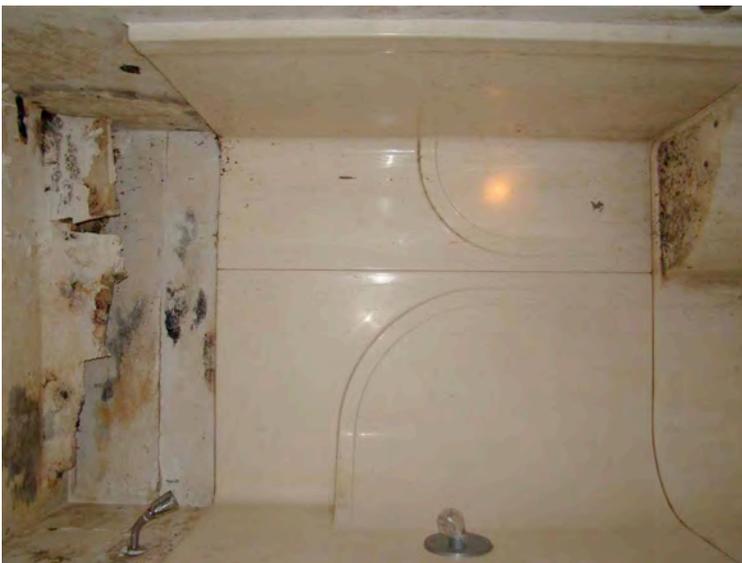
DSC00320

Basement:

Ceiling moisture damage.

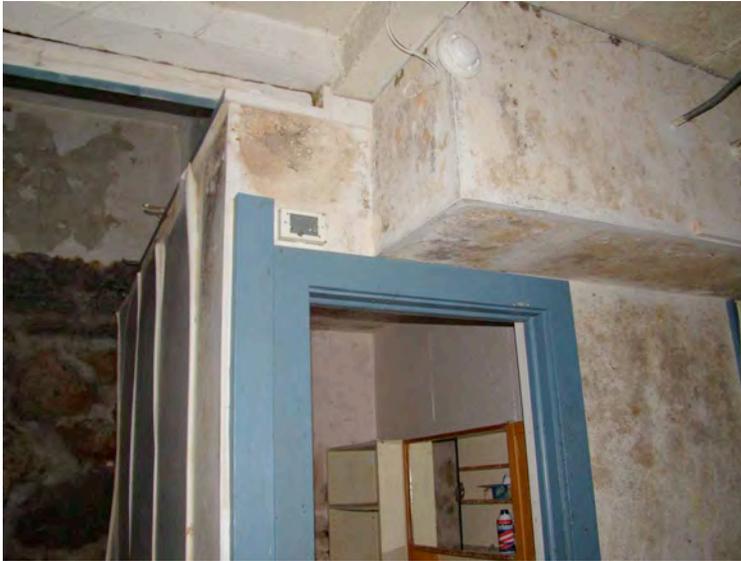
DSC00325

Basement:

Upper surfaces moisture damage.

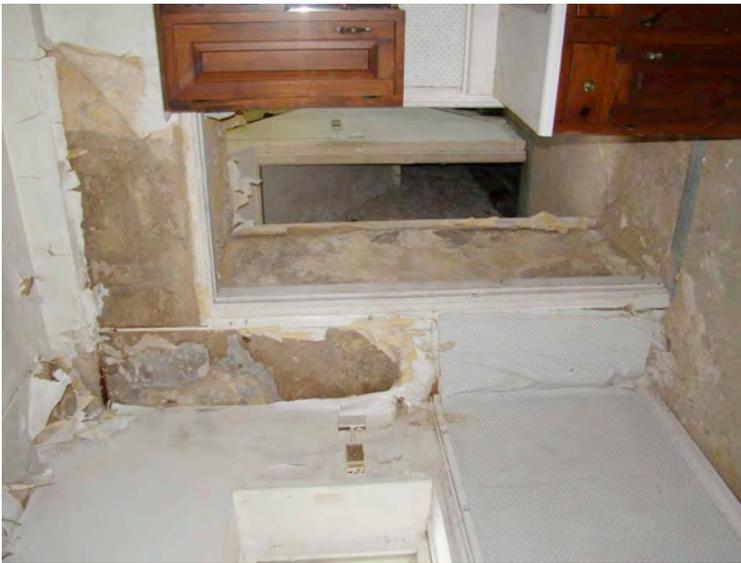
DSC00326

Basement:

Moisture damage at partitions.

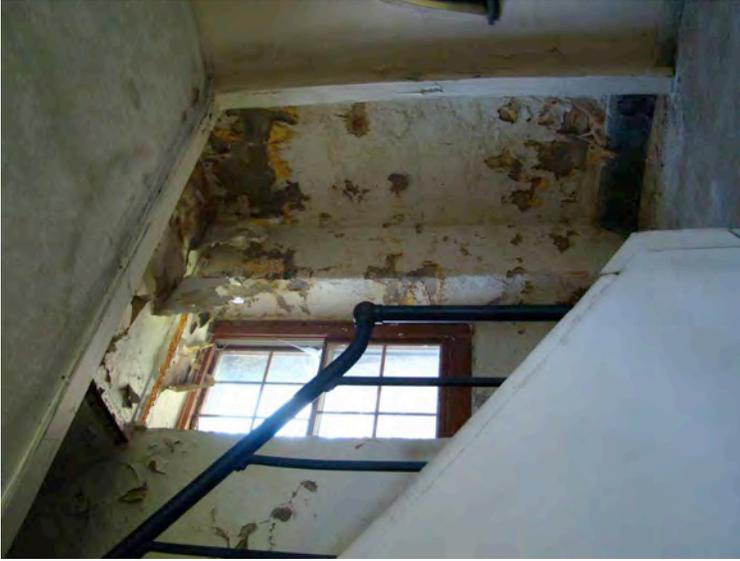
DSC00331

First Floor:

Moisture damage.

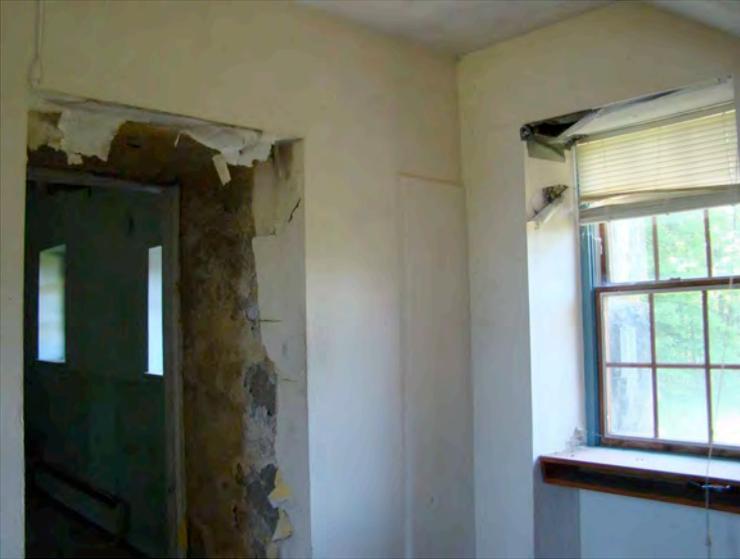
DSC00333

First Floor:

Moisture damage.
