MOHONK TESTIMONIAL GATEWAY

New Paltz, New York

CONDITION STUDY

20 June 2013 Condition Assessment (04 September 2013)

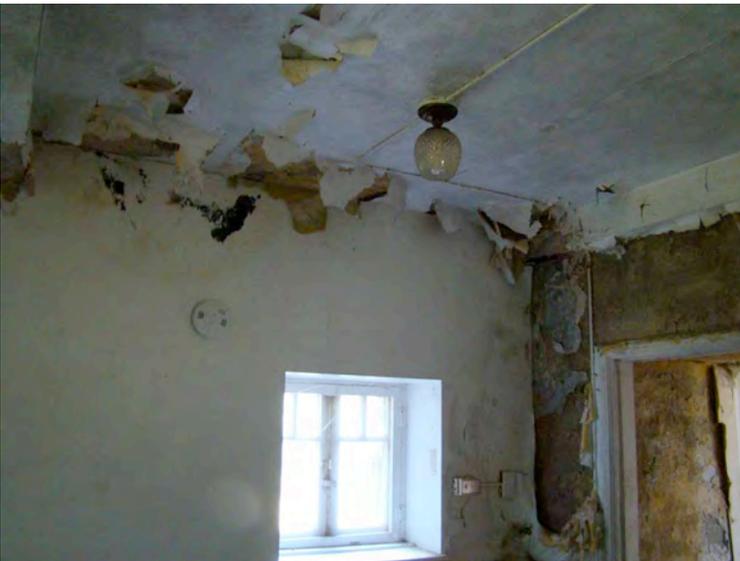
DSC00334

First Floor:

Moisture damage.

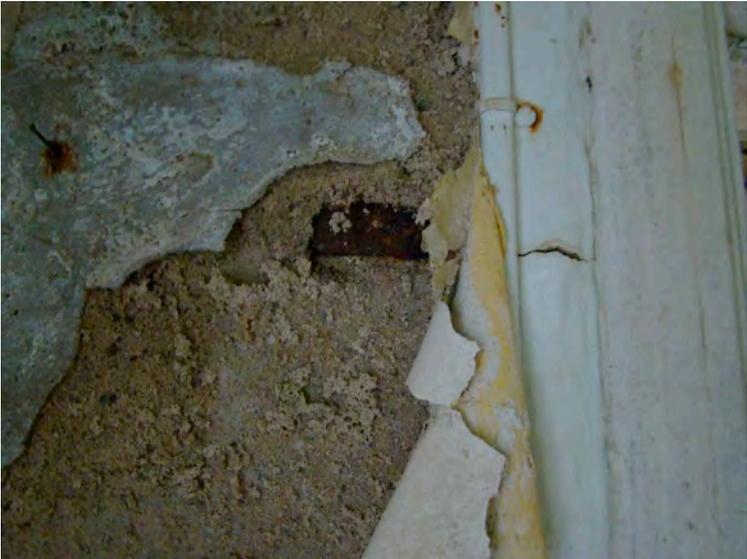
DSC00337

Details:
Moisture damage at partition.

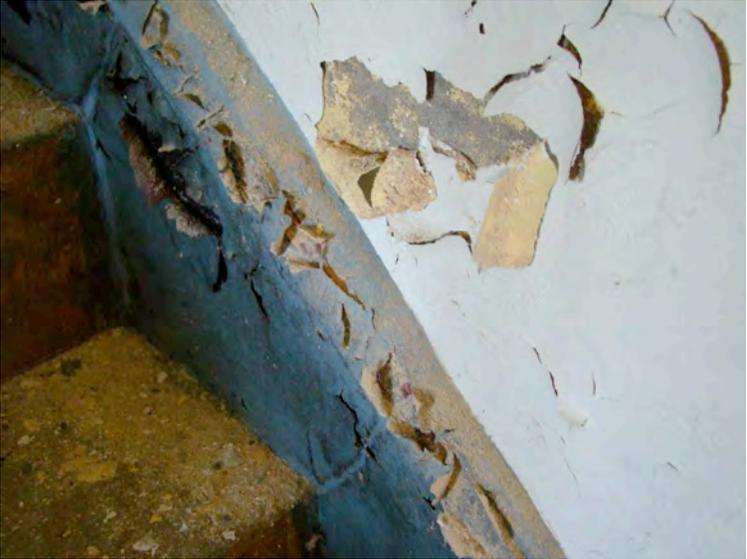
DSC00338

Details:
Moisture at staircase.

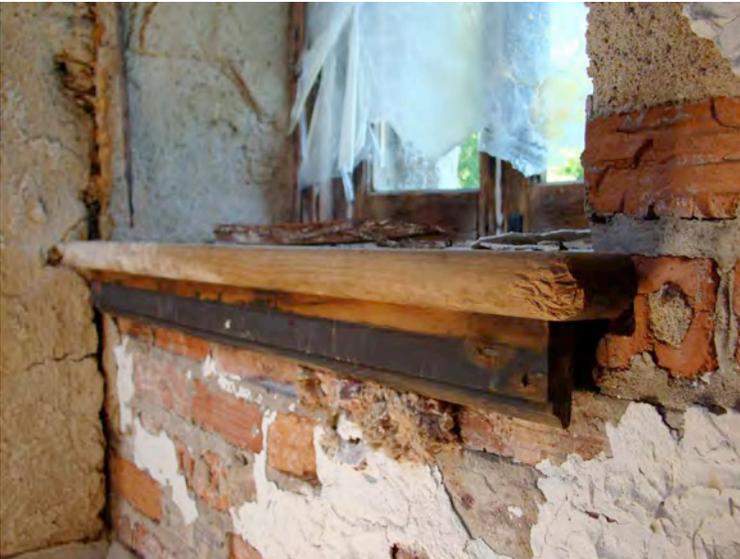
DSC00251

Original Window Stool with Apron and Bedmolding missing:

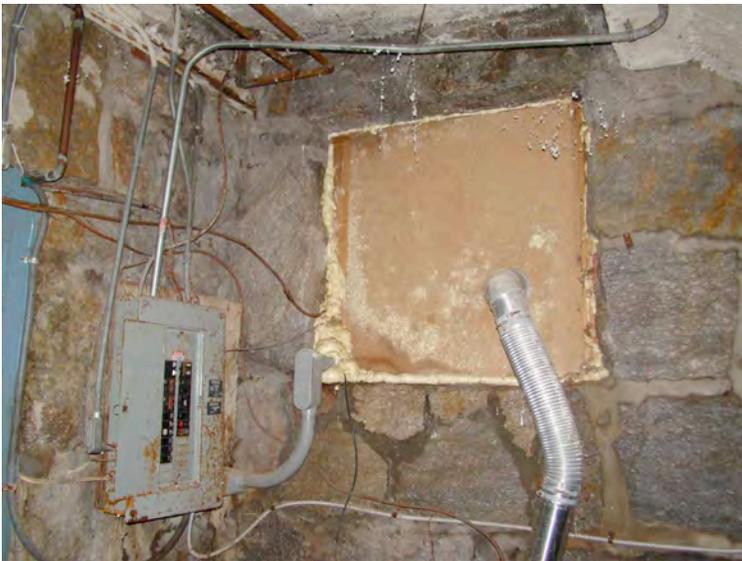
DSC00316

Electrical Panel in basement.
Note corrosion and closure of
window opening.

The electric wiring, despite some updating, is also a candidate for replacement of most of the branch circuits.

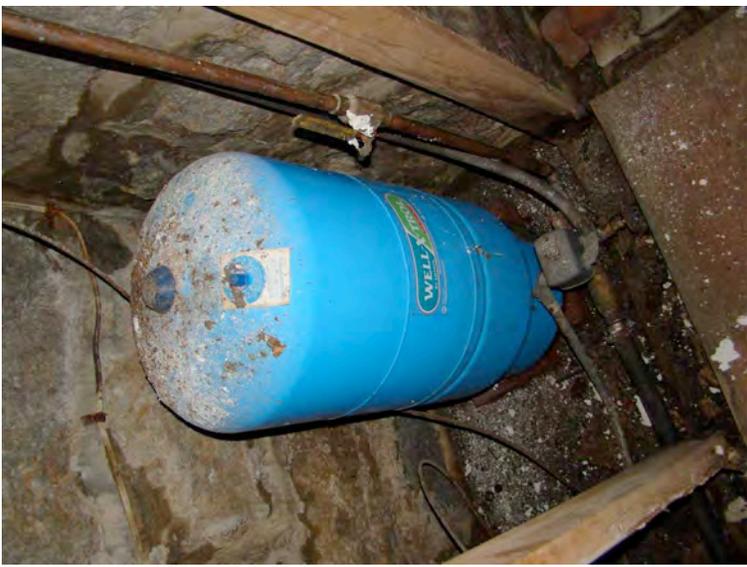
DSC00323

Pressure Tank in basement. Note dirt and rust.
