***Town of New Paltz Historic Preservation Commission  
Local Historic Landmark Designation***

***Mohonk Testimonial Gateway  
1 Gatehouse Road, New Paltz, NY  
(Gatehouse Structure and Adjoining Lands)***

***15 October 2013***

20 June 2013 Condition Assessment (04 September 2013)

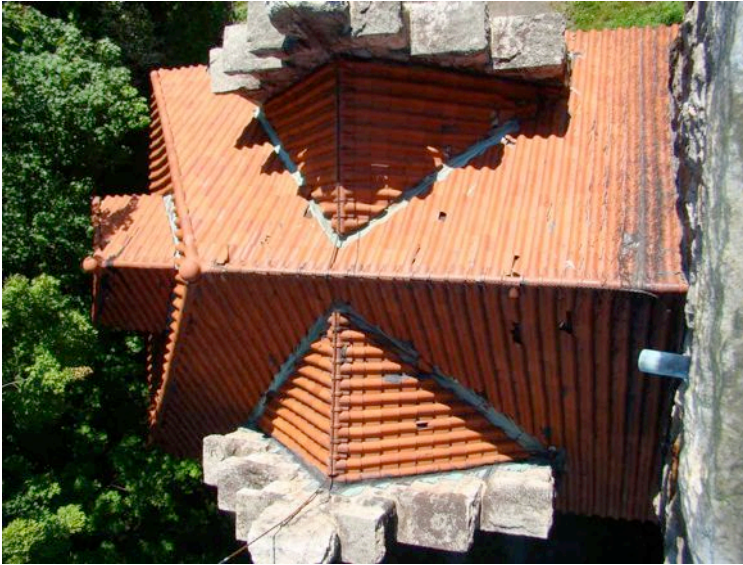
DSC00228

Roof over Archway:

From the observation deck;  
Note broken tiles at ridges  
and valleys as well as roof  
planes.

- Record and remove all tiles, accessories, flashings, sheet materials and nails.
- Repair all roof decks using matching lumber.
- Install an impervious “underlayment” or membrane beneath all the fields (roof planes) of tile, and the sheet copper must be replaced at all valleys, parapet and wall intersections and at the horizontal drip eaves.
- Reinstall sound tiles, using the existing tiles in coherent roof planes such that they are not mixed with new tiles. Install new tiles on tower roofs and in areas where impact from the tower roofs lands on the lower gables and hips.
- Finish with the historic ridge and hip tiles.
- Restore observation deck/waterproof membrane, reactivate south drain scupper and build new hatch cover and install.

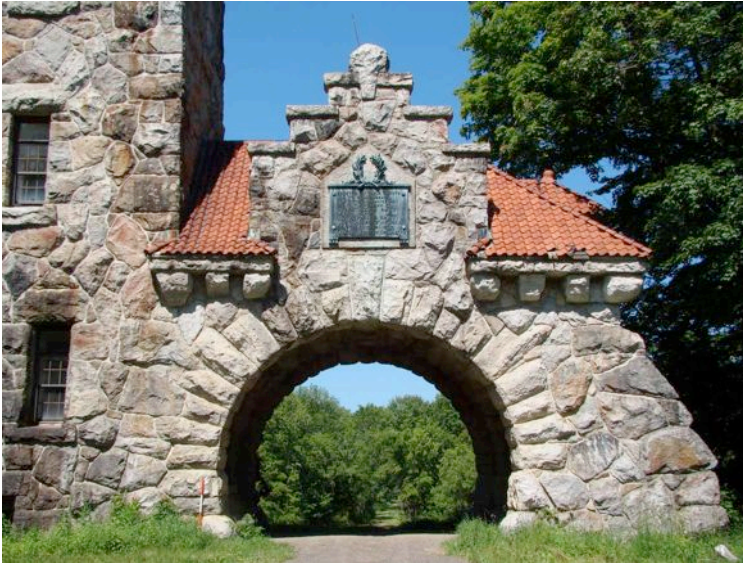
DSC00259

Roof over Archway:

From the east; Note broken  
tiles at eaves

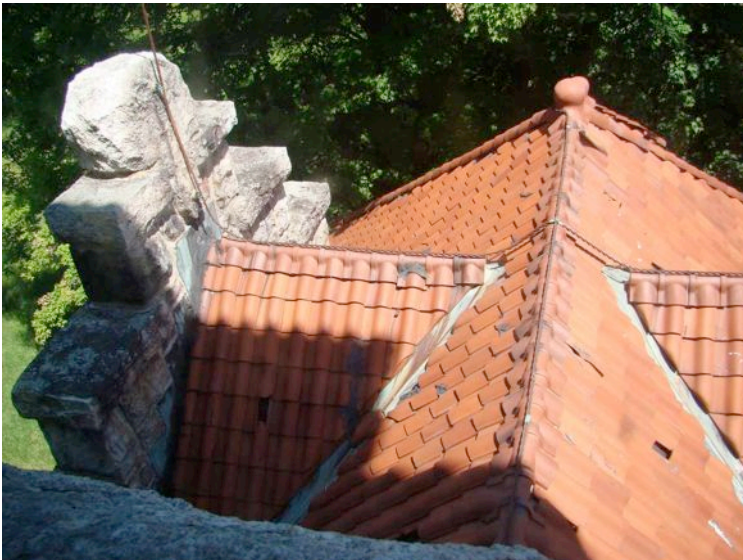
DSC00292

Roof over Archway:

From the third level; Note  
broken tiles and lightning  
arresting system, west gable  
and stepped stone parapet.

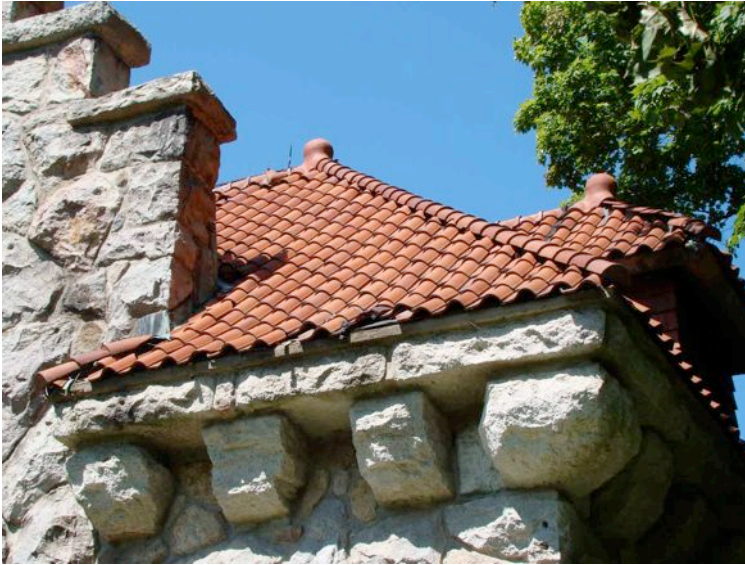
DSC00260

Details:

Broken tiles at East eaves,  
north of plaque.

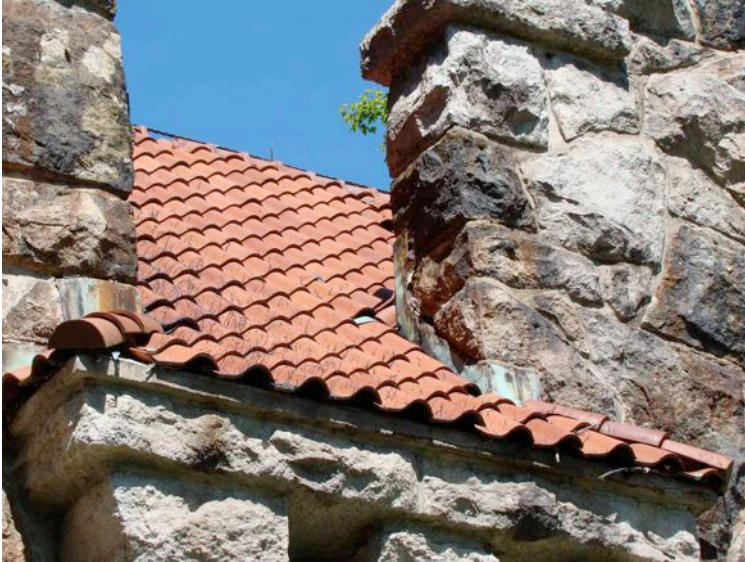
DSC00261

Details:

Broken tiles at East eaves,  
South of plaque.

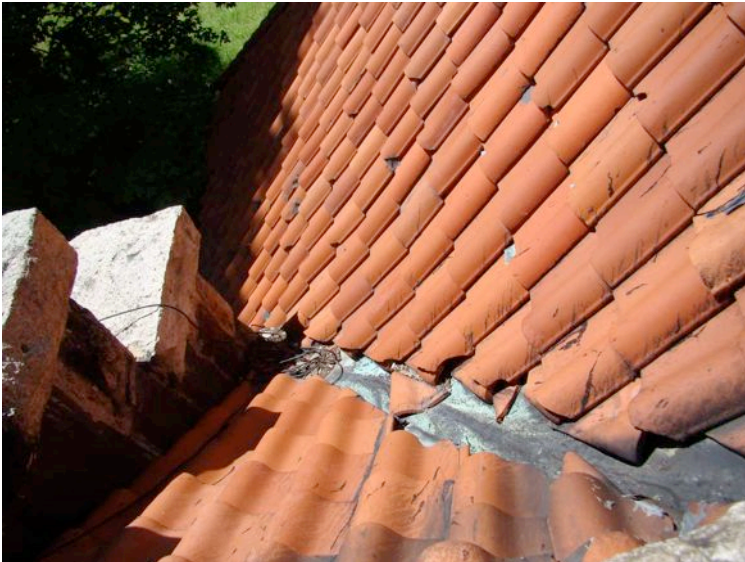
DSC00285

Kitchen Wing Roof:

Detail of valley with broken tiles.

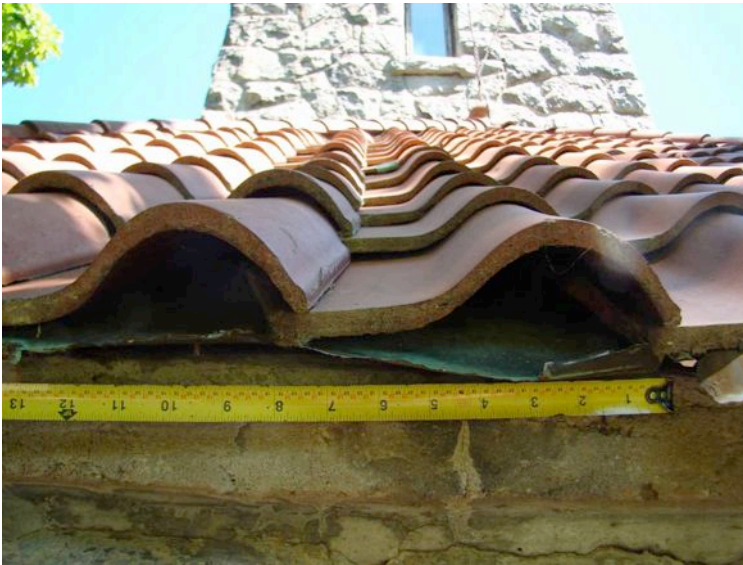
DSC00278

Details:

Worn out copper drip edge of eaves over kitchen door.

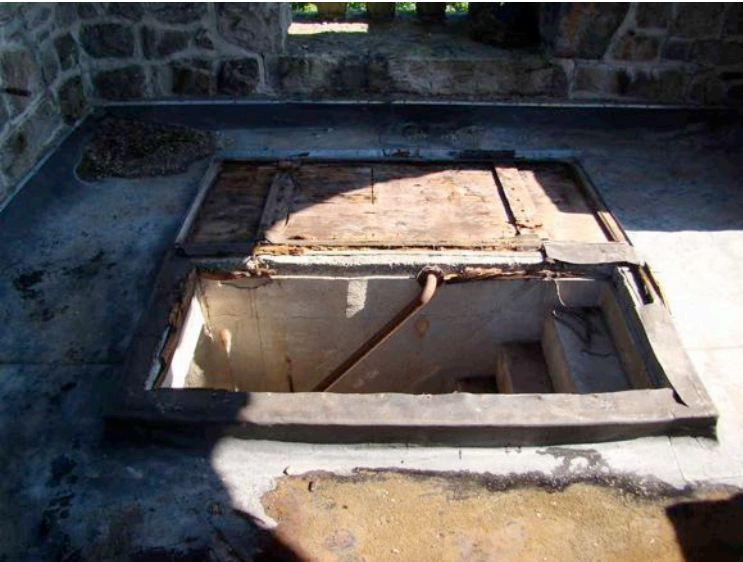
DSC00230

Rotted Hatch:

The wooden and sheet metal hatch cover is deteriorated beyond its useful life.

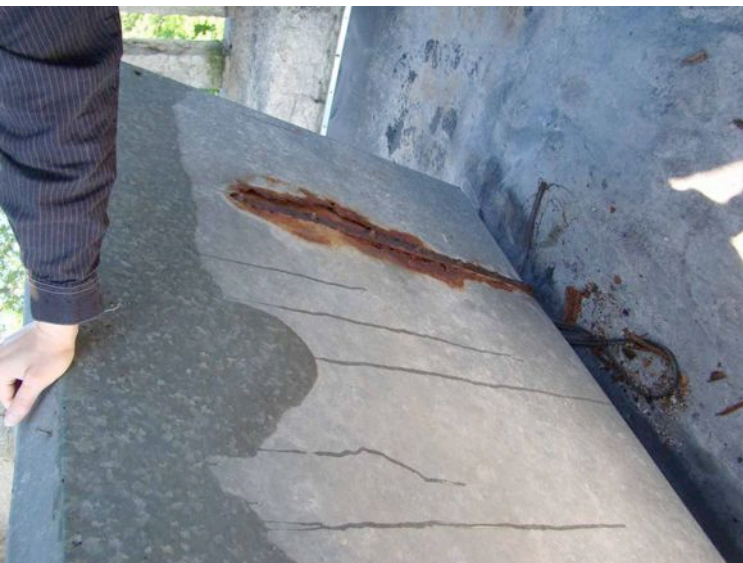
Rotted Hatch:

The sheet metal has rusted through.

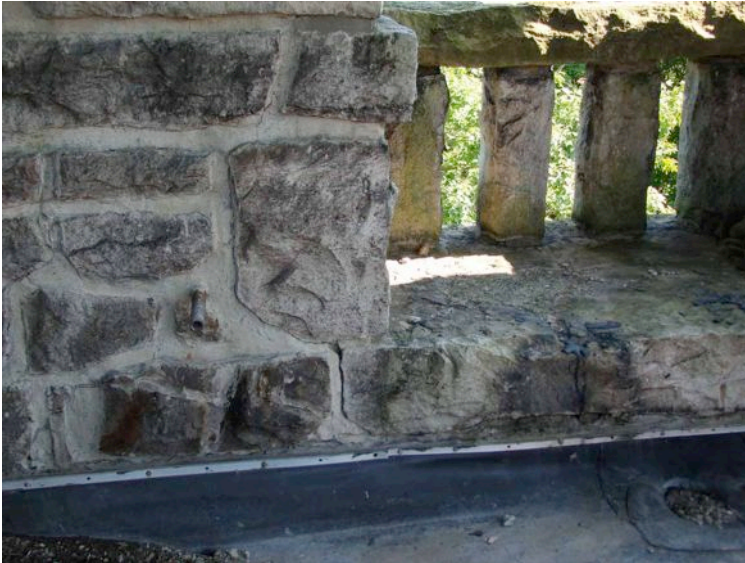
DSC00232

Condition Observation:

Crack in corner pier indicates need for compatible repointing

- Select bedding, repointing and parapet mortars for use in distinct locations.
- Carefully and selectively remove cracked and unbonded mortar.
- Repair voids and repoint mortar joints.
- Clean surfaces affected by repointing operations.

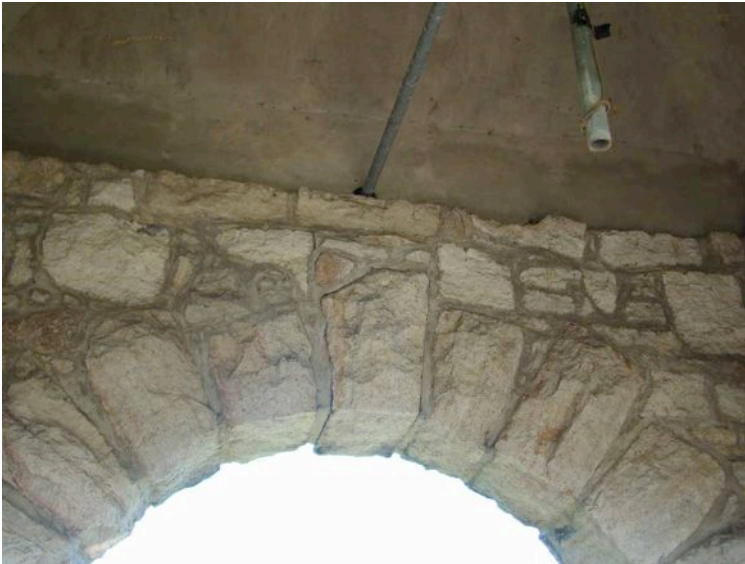
DSC00236

Condition Observation:

Crack in keystone mortar at North observation arch is start of deterioration

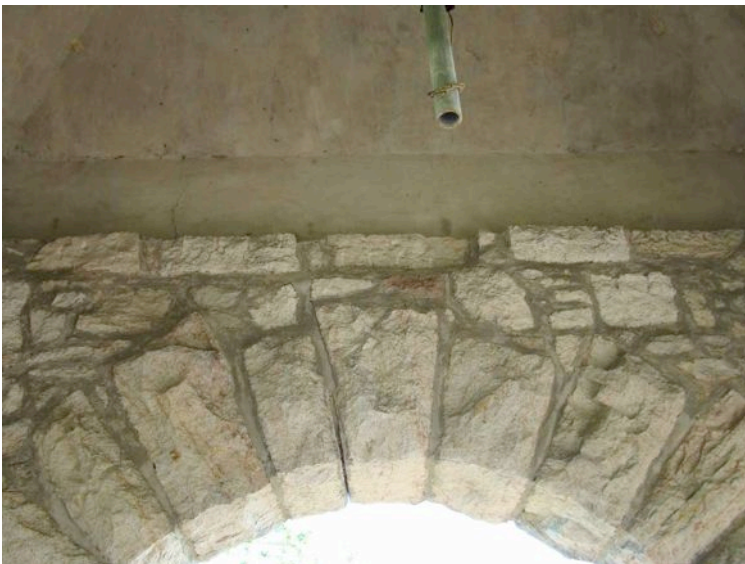
DSC00237

Condition Observation:

Crack in keystone mortar at East arch.

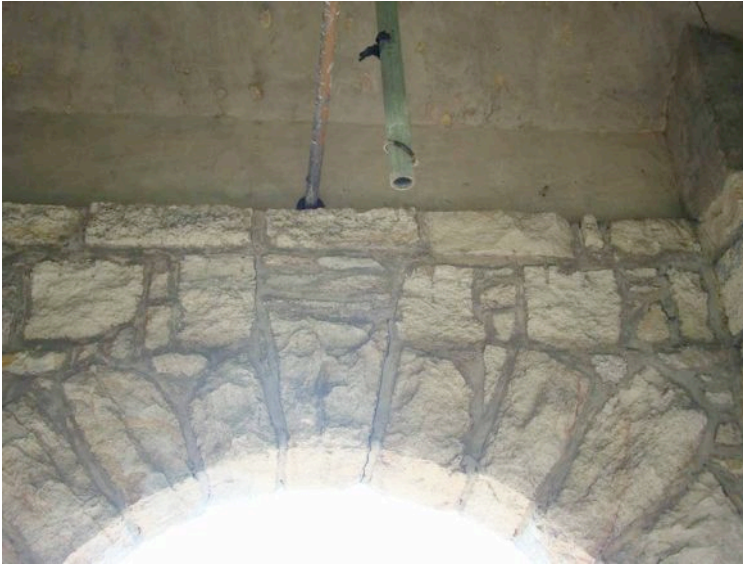
DSC00238

Condition Observation:

Crack in keystone mortar at South arch.

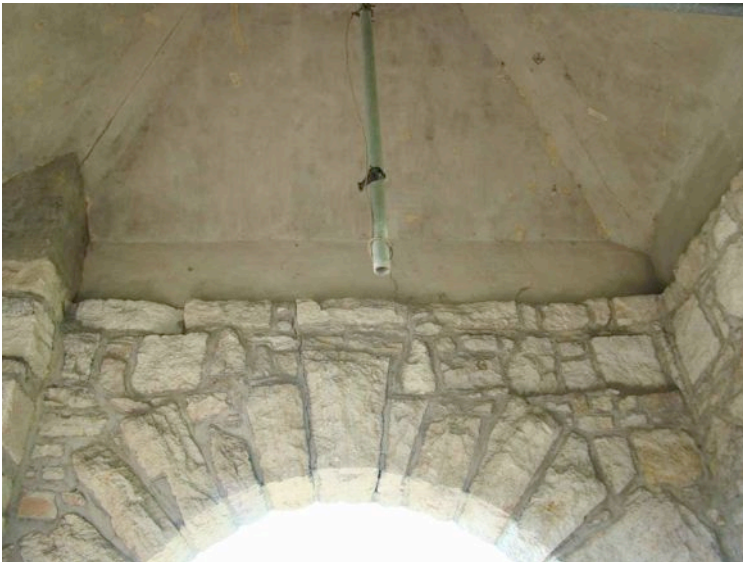
Condition Observation:

Crack in keystone mortar at West arch.

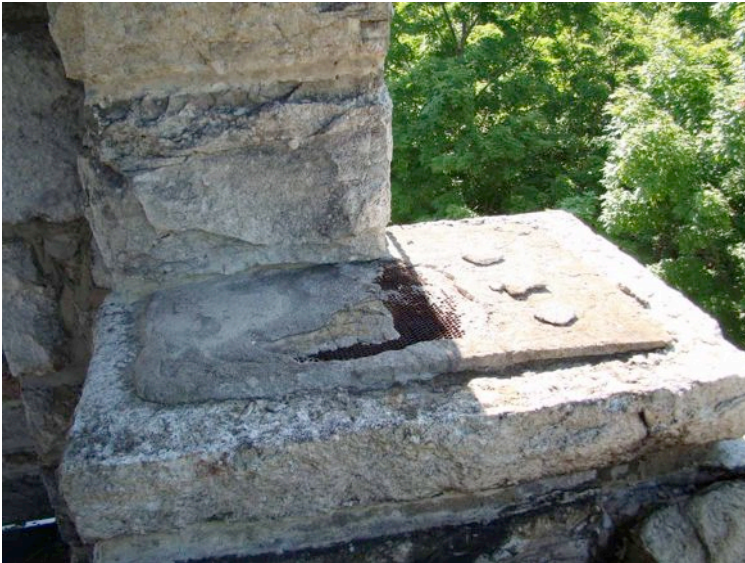
DSC00231

Details: Covered Planter

What appears to have been planters originally have been covered over with wire mesh and mortar, now deteriorated.

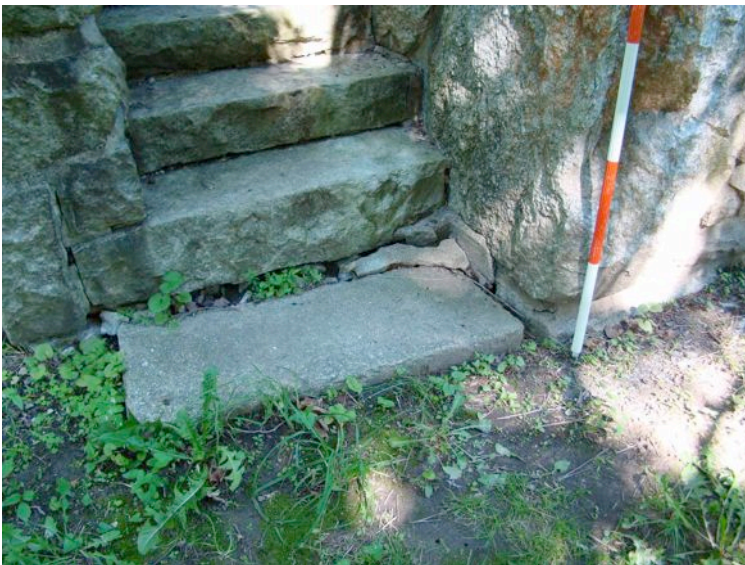
DSC00244

Details: Kitchen Stair

Illustrating need for repair and repointing.

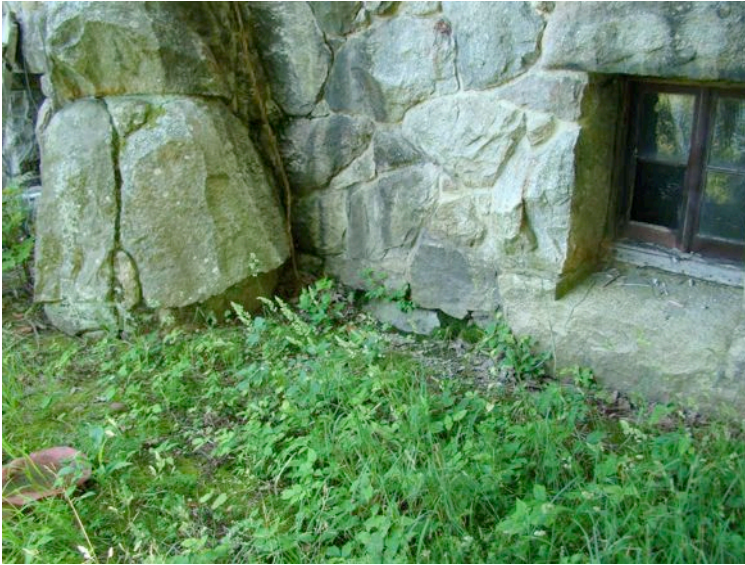
DSC00271

West:

Deterioration of mortar at arch buttress and facade at ground level.

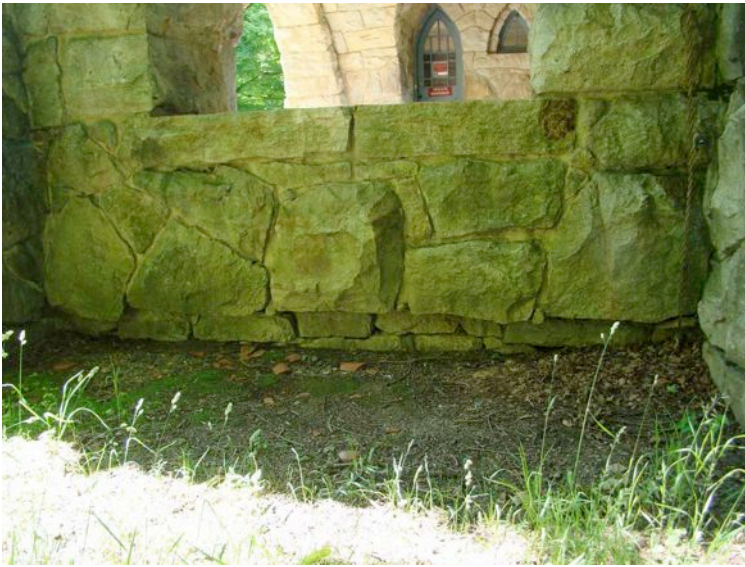
DSC00274

North:

Need for repointing, emphasized at ground level.

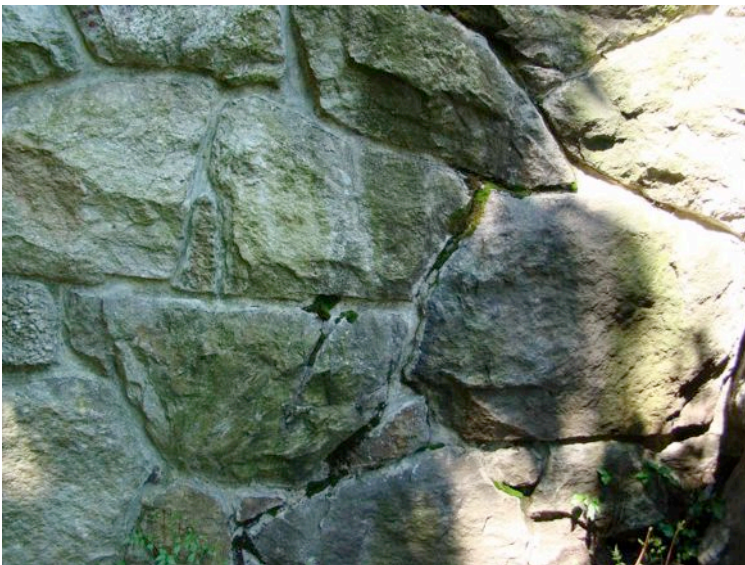
East:

Cracking of mortar joints.

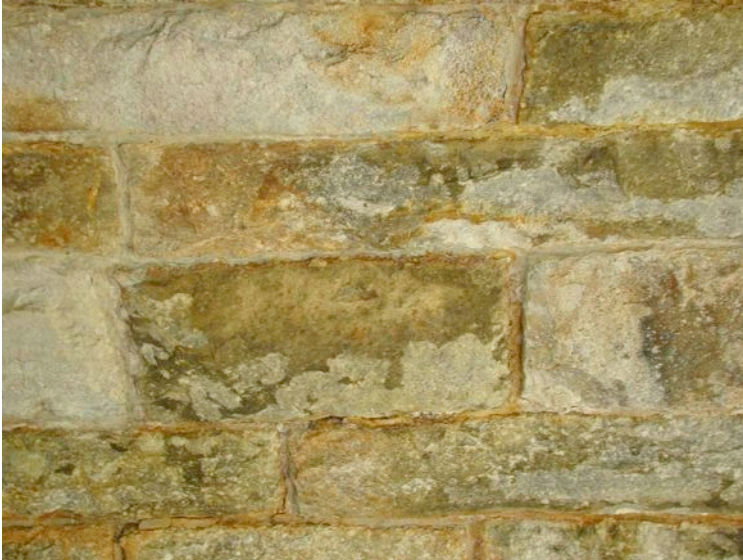
DSC00354

At Archway:

Cracking of mortar in stone barrel vault.

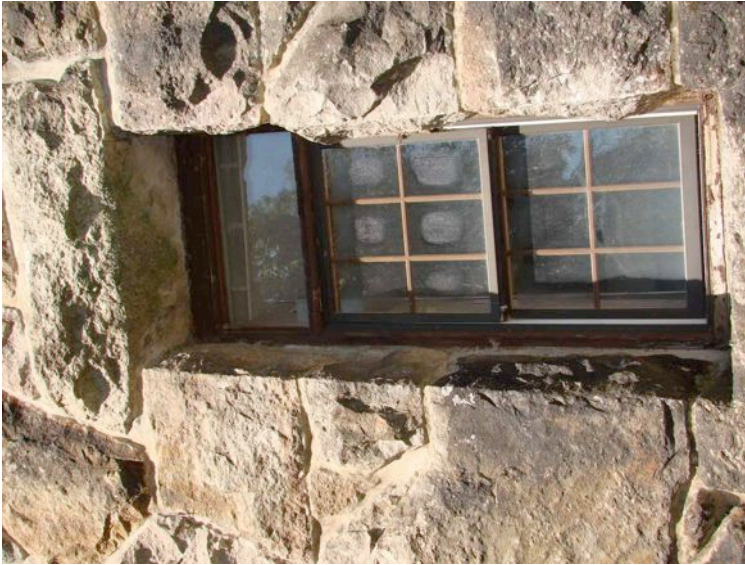
DSC00262

### The Wooden Windows

Replace with original transom frames:

Six-over-six pane incompatible sash.

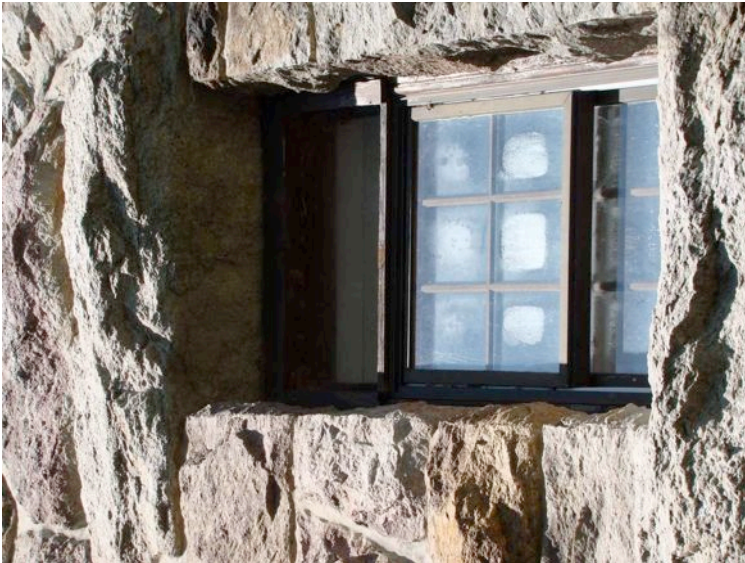
DSC00263

Replace with original transom frames:

Six-over-six

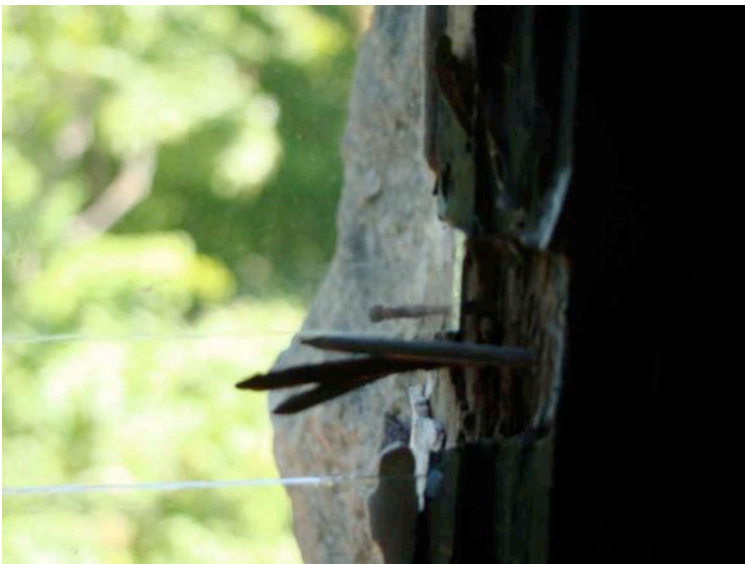
DSC00290

Detail of crude modification:

Apparently, when the original, leaded-glass was replaced, wooden horizontal muntins were set into the original sash stiles, secured rather crudely with nails.

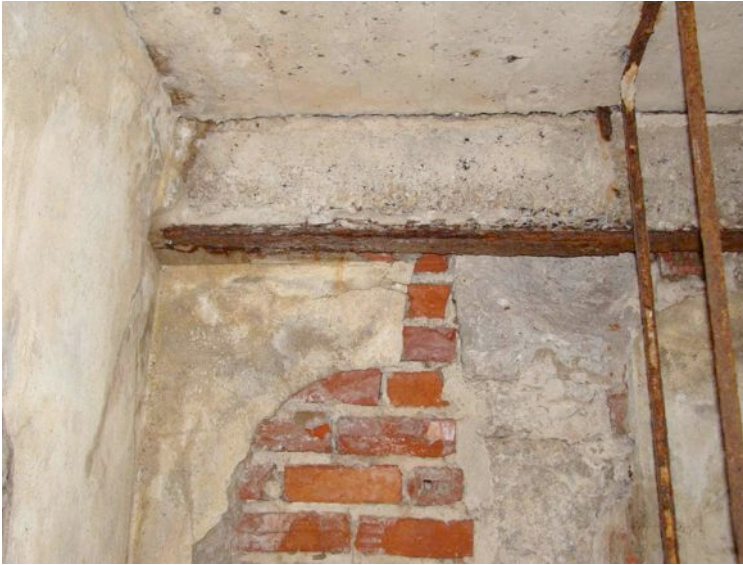
DSC00249

Condition:

Steel is oxidized where exposed to interior moisture. The extensive use of steel in this building is documented in the original drawings.

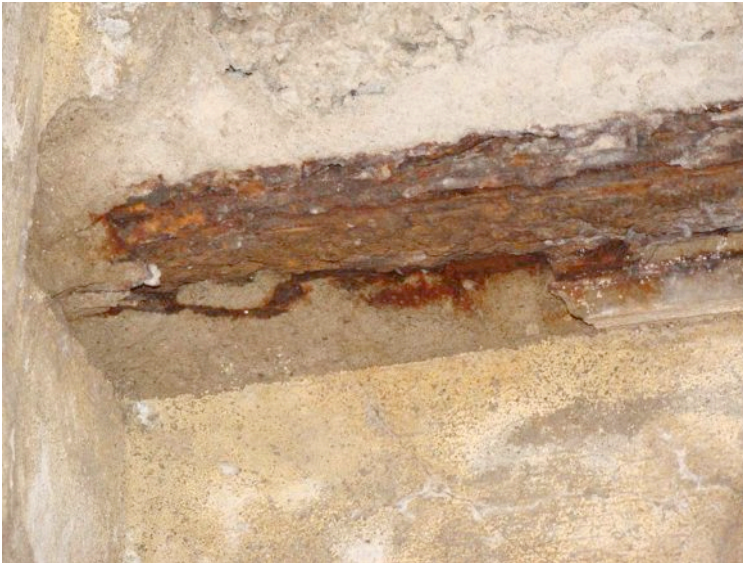
DSC00250

Condition:

Detail of oxidation of steel. "Oxide jacking", that is, the expansion of material which accompanies the formation of rust, has expelled the concrete covering beneath this beam.

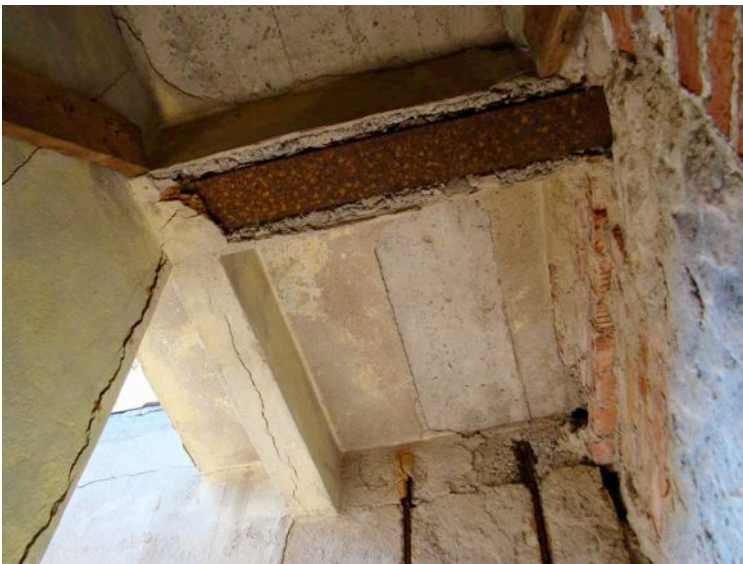
DSC00253

Condition:

Even more dramatic example of "oxide jacking" at beam over upper stairway to observation check. It appears that moisture collects at steel components and migrates to their hollow surfaces, even though they are concealed within concrete and or plaster.

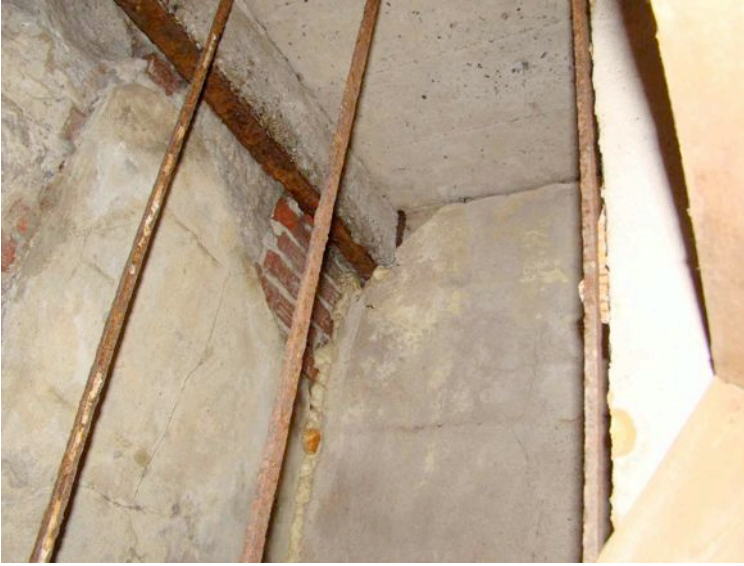
DSC00256

Condition:

The vertical ferrous ribs shown are all that survives of several thin cementitious partitions. The metal mesh is gone as well as the plaster finish.

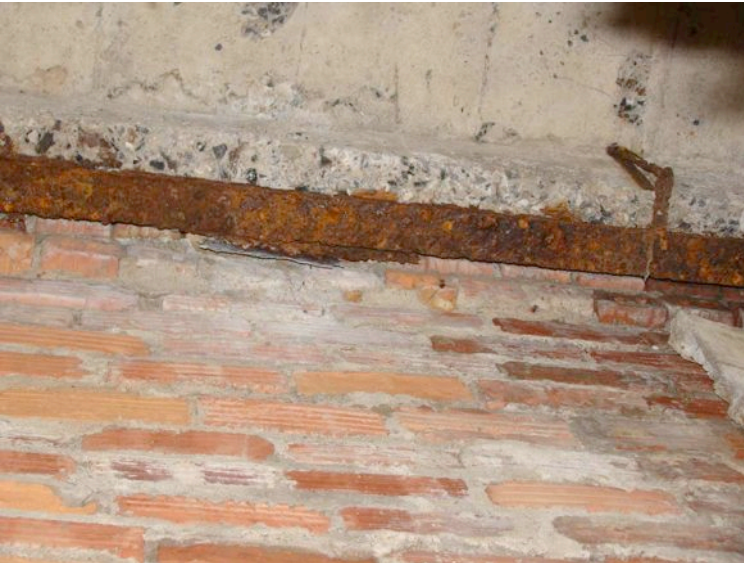
DSC00295

Condition:

More iron oxide (rust).

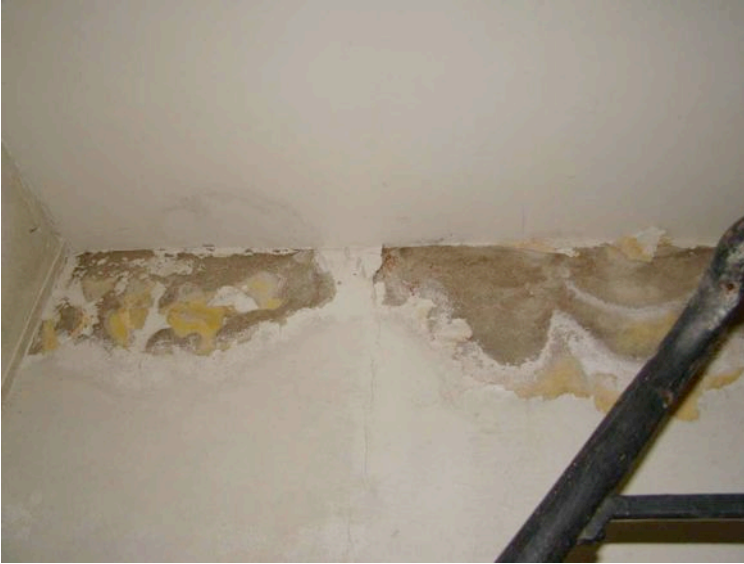
DSC00344

Condition:

Evidence of water intrusion at upper levels.

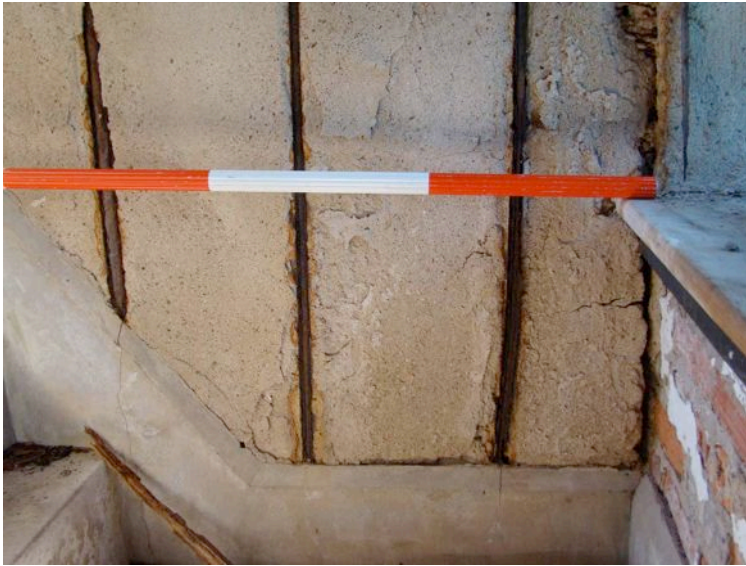
DSC00252

Details at thin walls:

Here in the upper staircase to the observation level the partition survives, but the vertical reinforcing panel ribs have rusted.

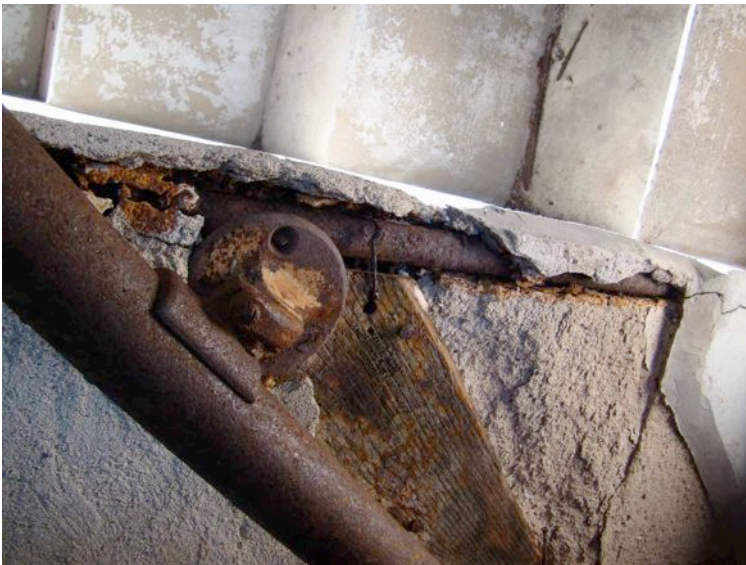
DSC00254

Details at thin walls:

More oxide jacking across staircase from image above. No doubt, roof hatch left open has exasperated this condition.

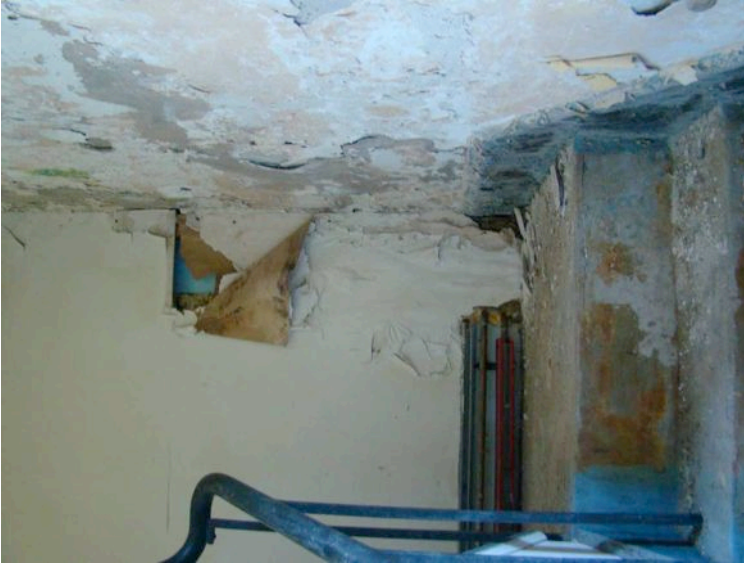
DSC00258

Stair Hall:

Moisture damage to plaster and gypsum board finishes.

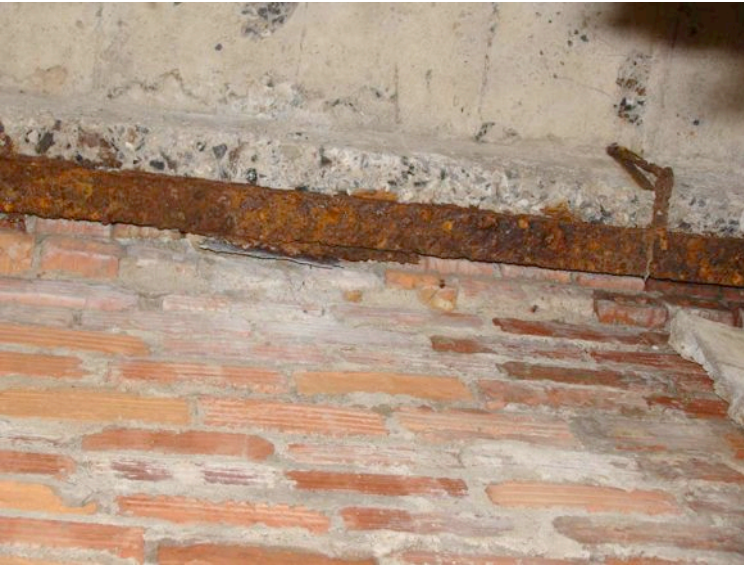
DSC00295

Loss of concrete beam encasement.

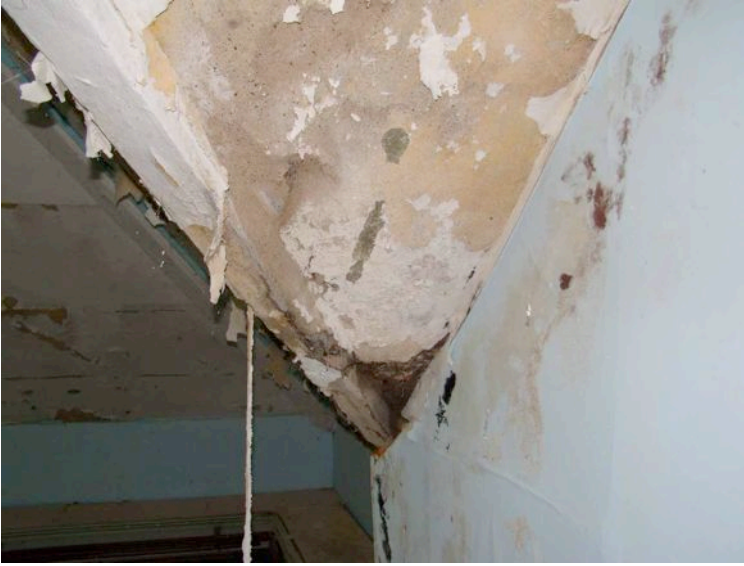
DSC00304

Over Archway:

Water damage. See tile roof images.

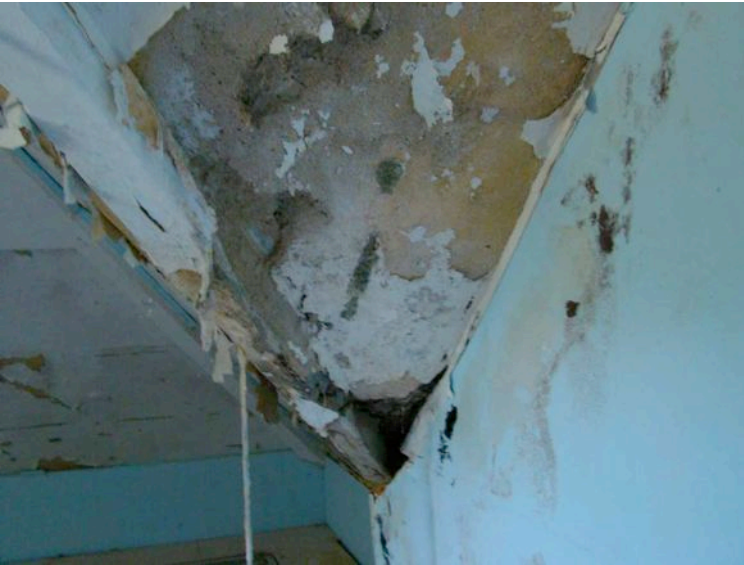
DSC00305

Over Archway:

Water damage.

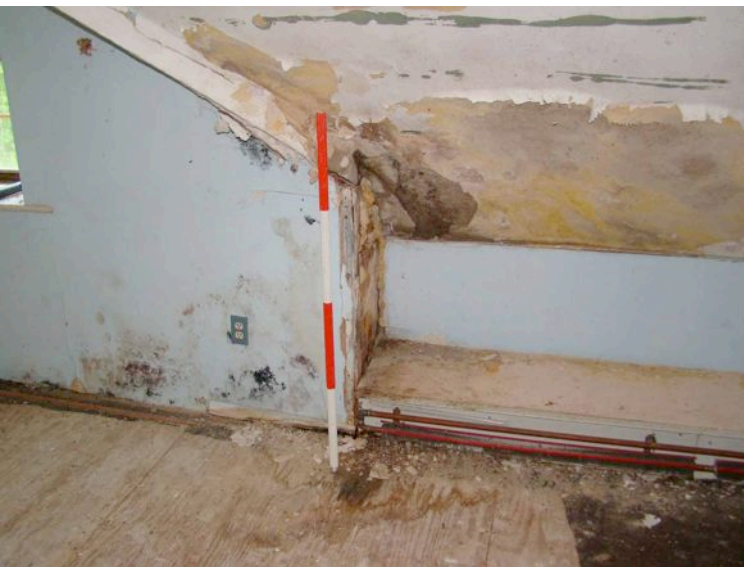
DSC00306

Over Archway:

Water damage.

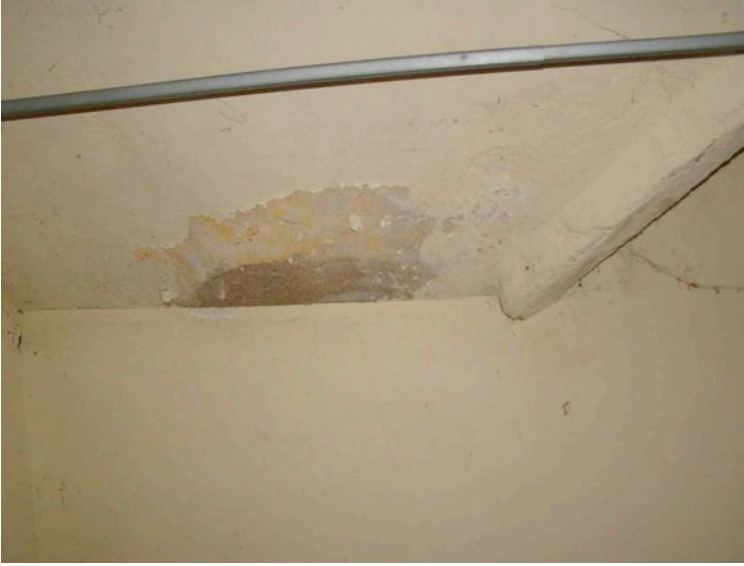
DSC00307

Over Archway:  
Water damage.

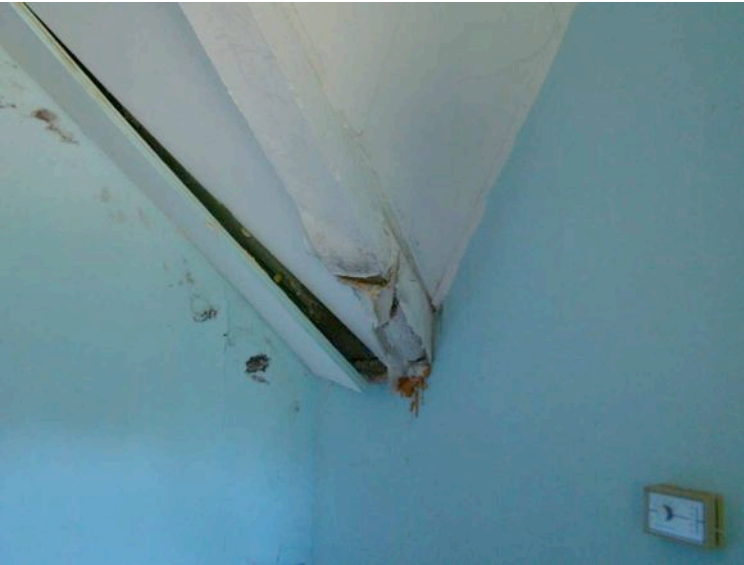
DSC00308

Over Archway:  
Water damage.

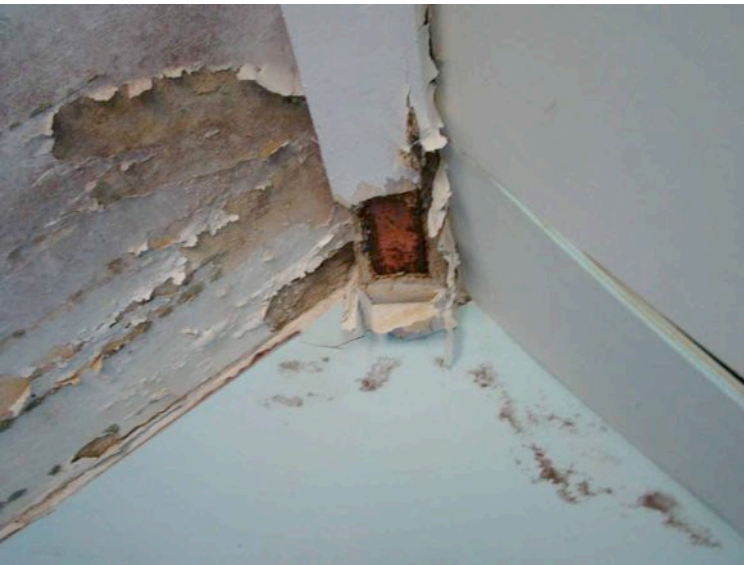
DSC00309

Over Archway:  
Water damage.

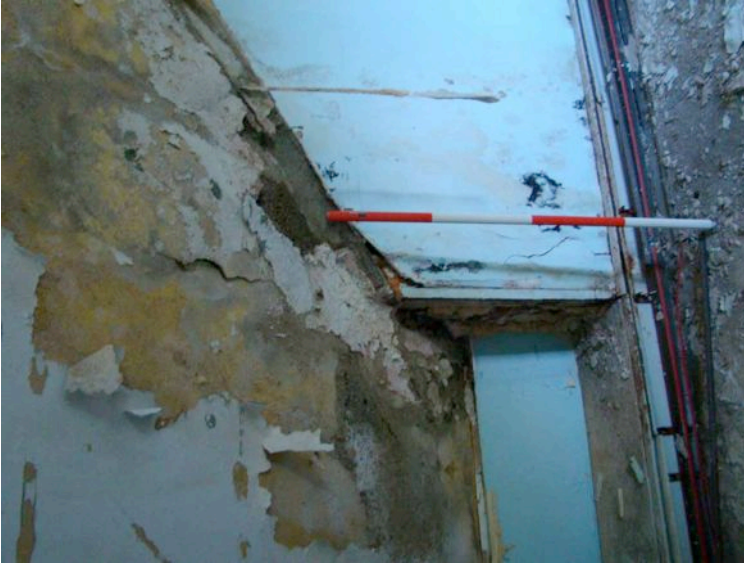
DSC00310

Over Archway:  
Water damage.

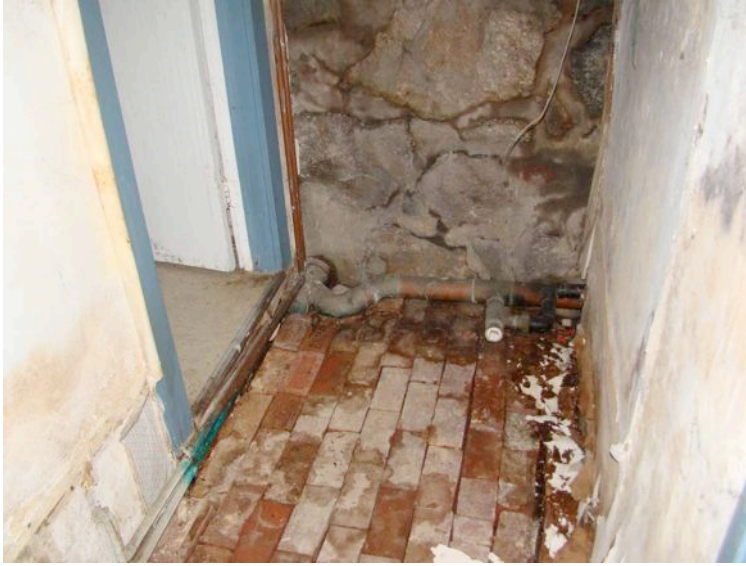
DSC00318

Basement:

Rising damp moisture damage.

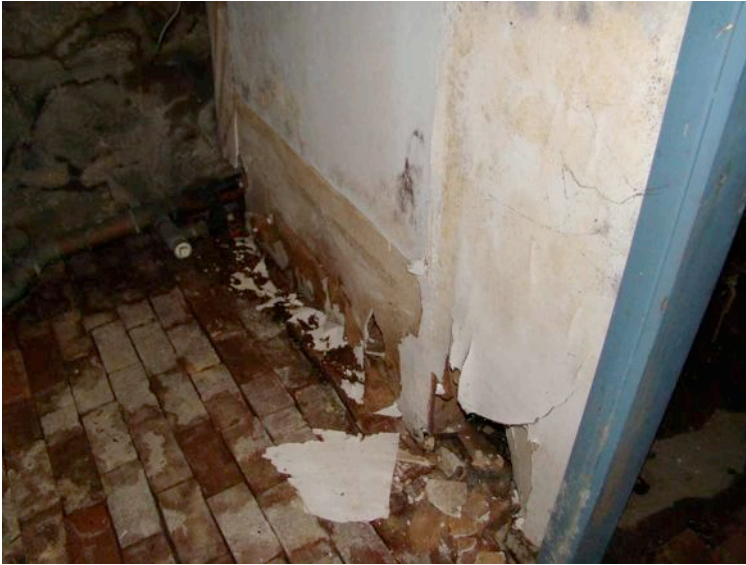
DSC00319

Basement:

Rising damp moisture damage.

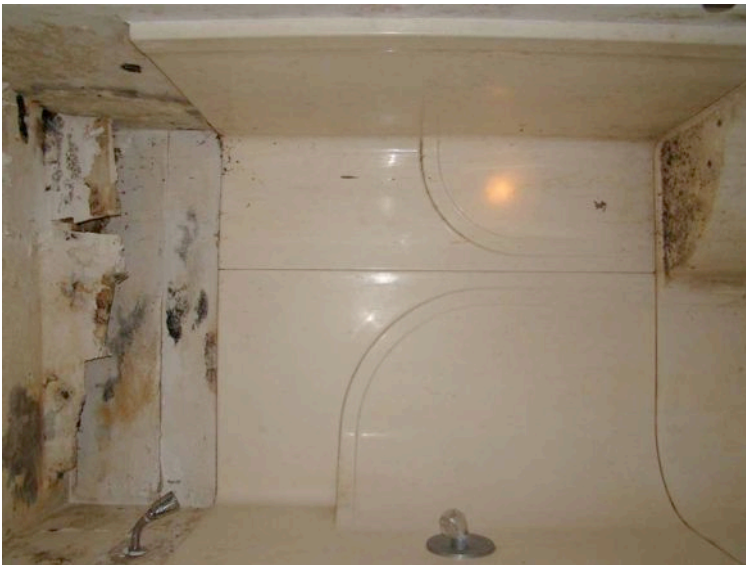
DSC00320

Basement:

Ceiling moisture damage.

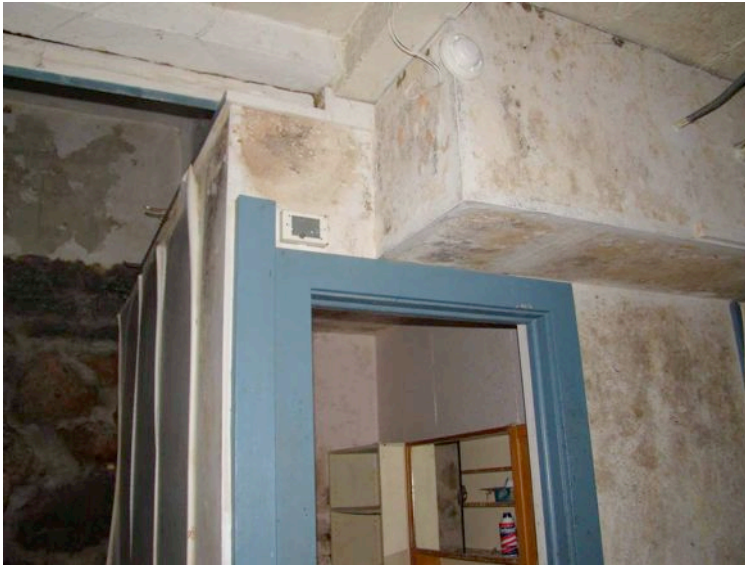
DSC00325

Basement:

Upper surfaces moisture damage.

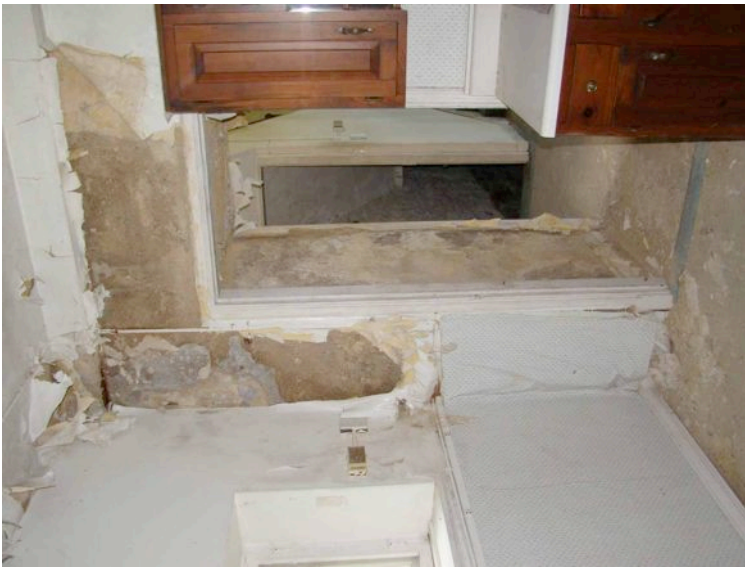
DSC00326

Basement:

Moisture damage at partitions.

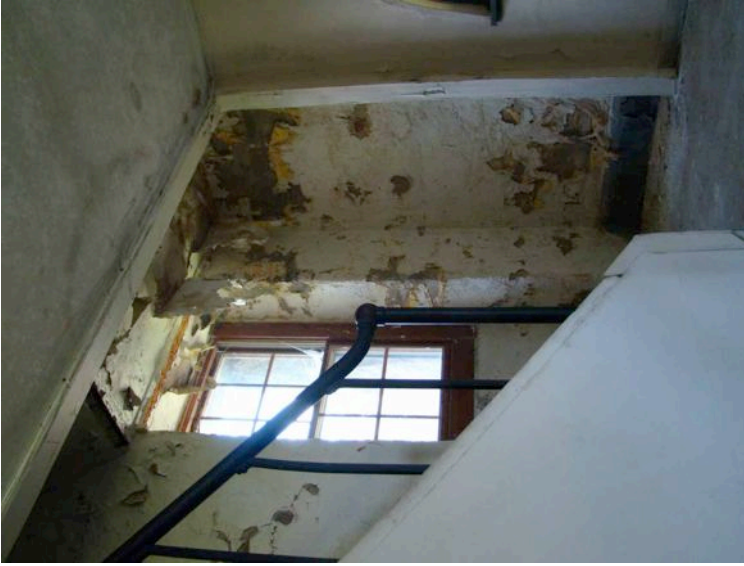
DSC00331

First Floor:

Moisture damage.

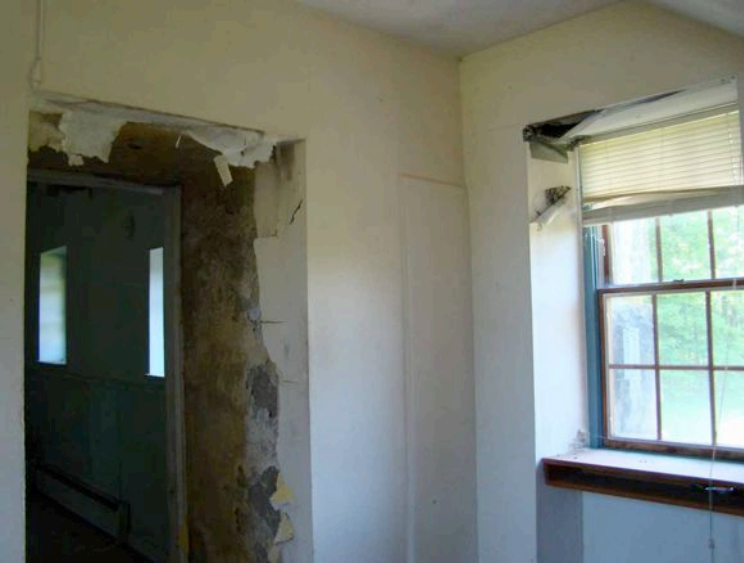
DSC00333

First Floor:

Moisture damage.

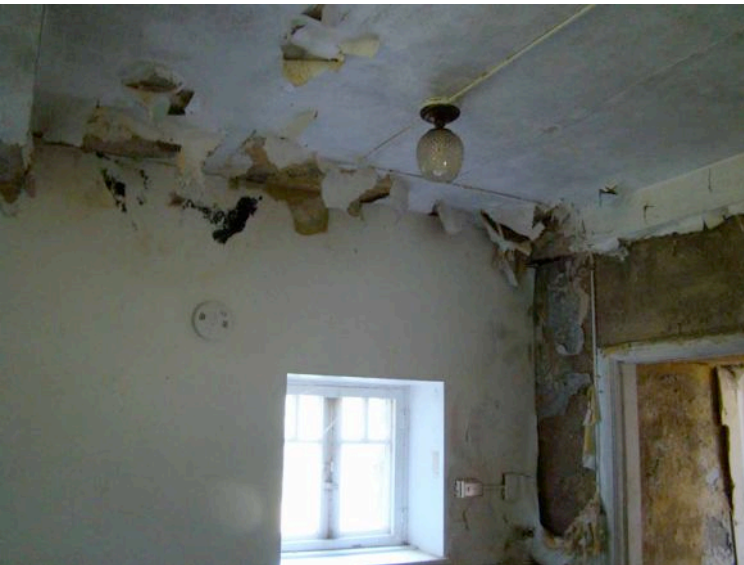
First Floor:

Moisture damage.

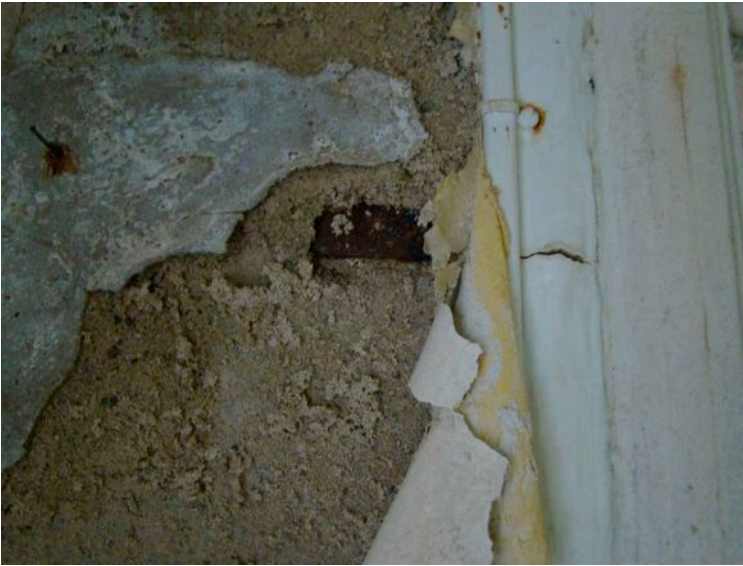
DSC00337

Details:

Moisture damage at partition.

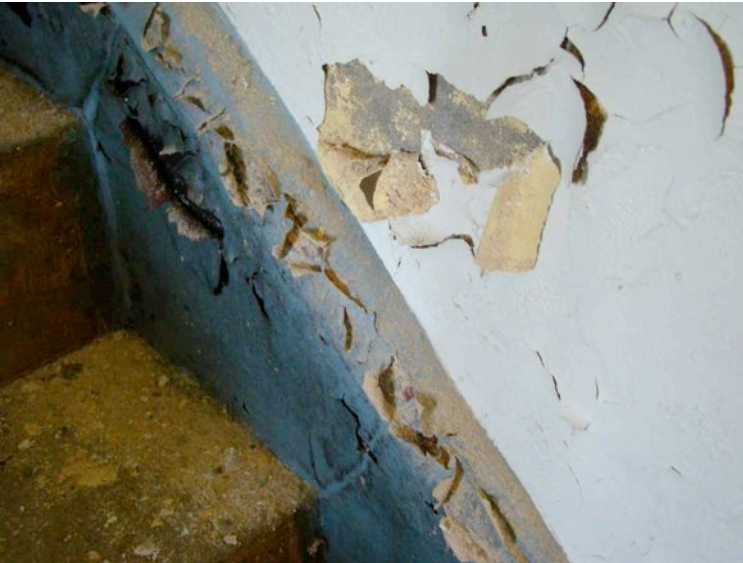
DSC00338

Details:

Moisture at staircase.

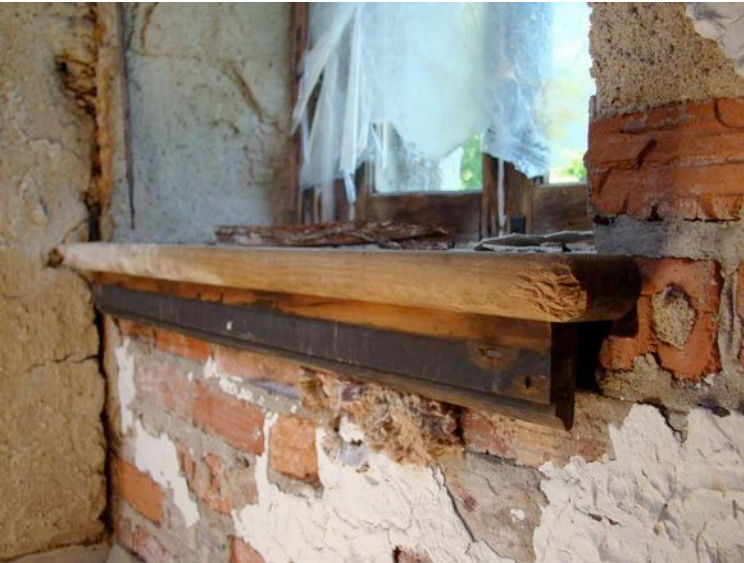
DSC00251

Original Window Stool with Apron and Bedmolding missing:
