***Town of New Paltz Historic Preservation Commission
Local Historic Landmark Designation***

***Mohonk Testimonial Gateway
1 Gatehouse Road, New Paltz, NY
(Gatehouse Structure and Adjoining Lands)***

15 October 2013

20 June 2013 Condition Assessment (04 September 2013)

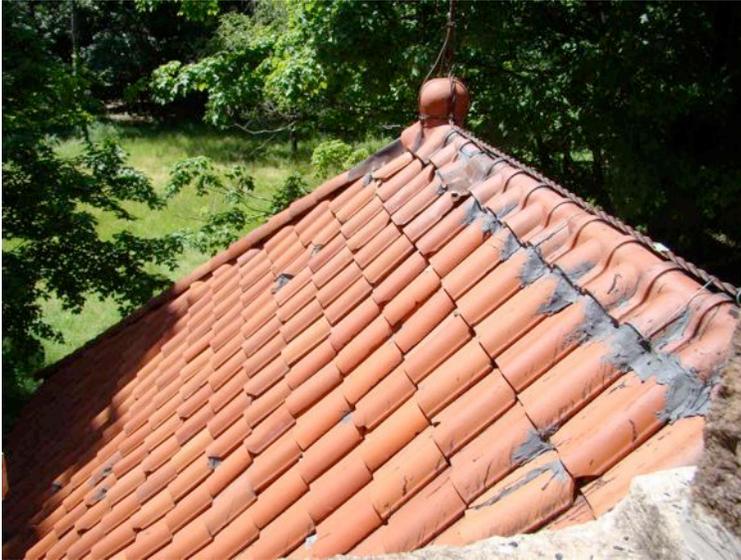
Kitchen Wing Roof:

General view of east plane with chipped tiles.

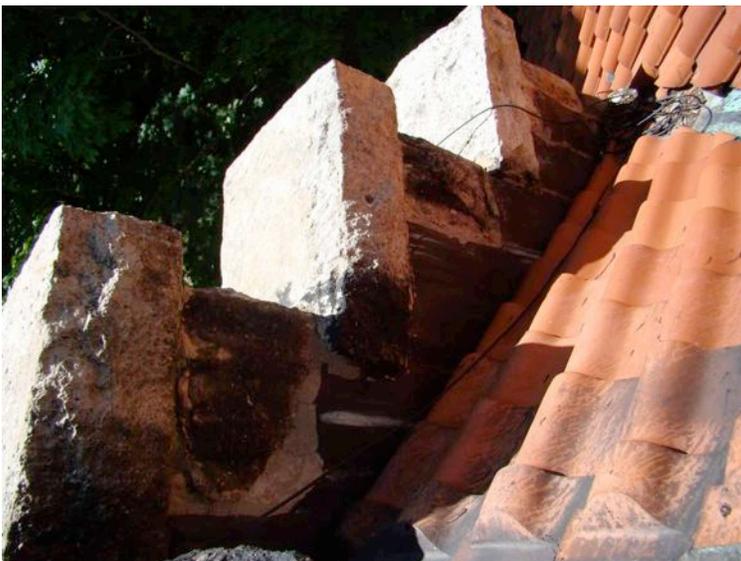
Kitchen Wing Roof:

Detail of valley exit and parapet flashing.

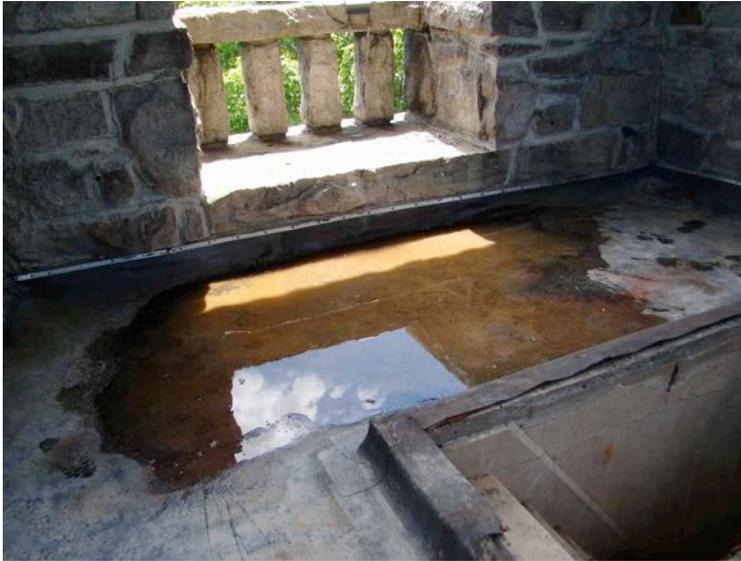
Observation Deck Roof:

Ponding; It appears that the south drain tube has been plugged and therefore eliminated functionally.

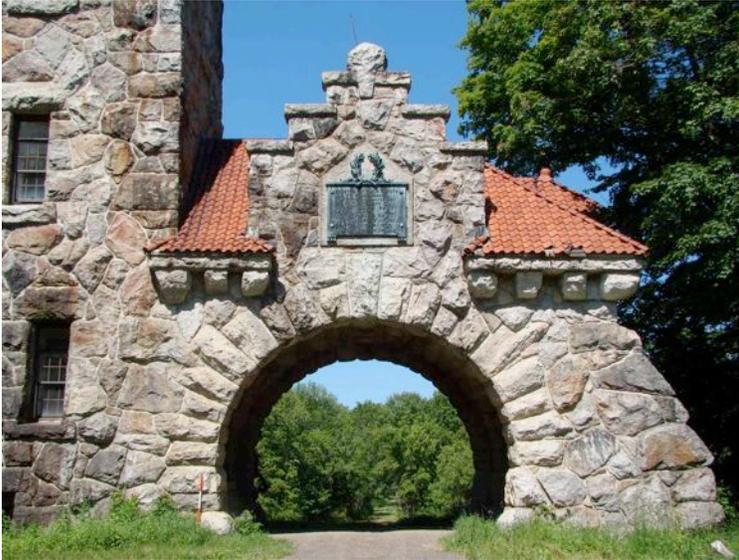
East:

Archway from East with buttress on right and tower on left.

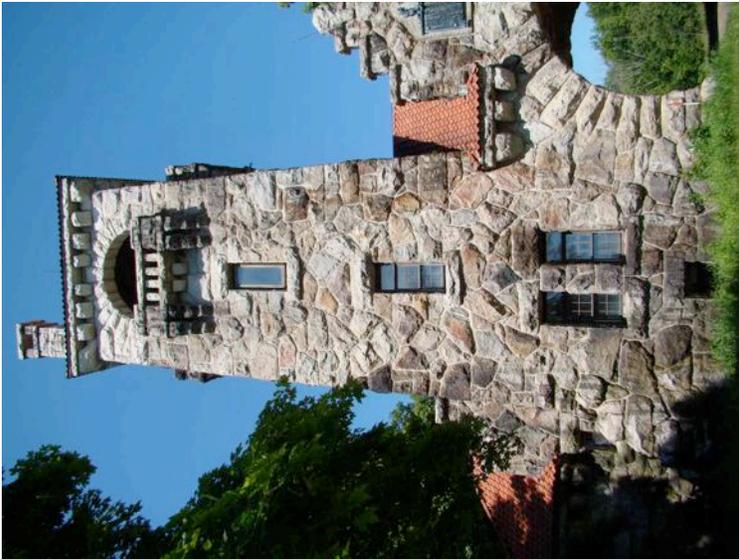
East:

Tower elevation; Note that observation deck balconies were constructed according to revised drawings.

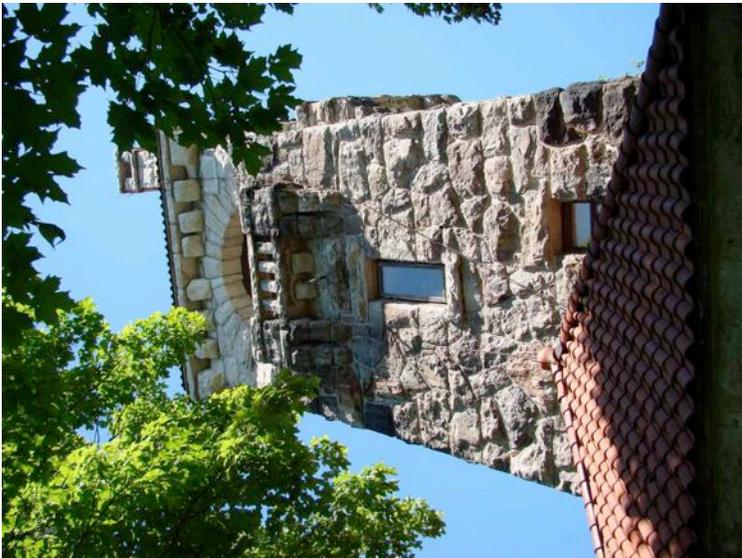
South:

Tower elevation; Note that south drawings scupper (tube) at observation deck level is extant.

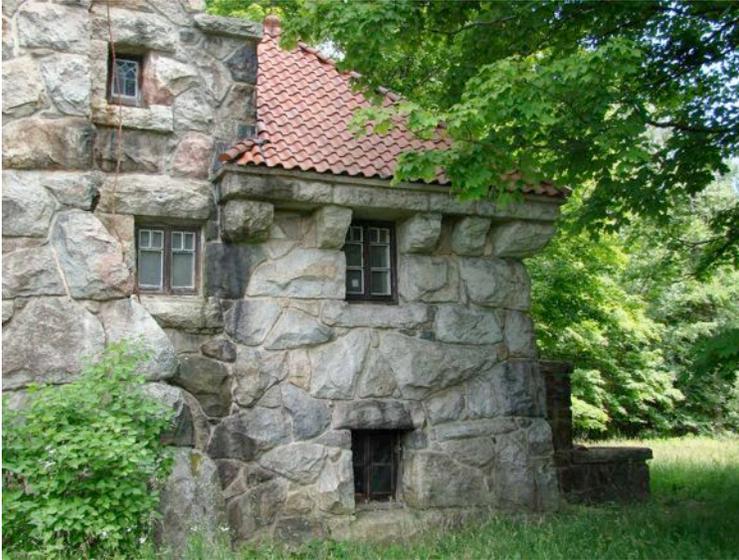
West:

Kitchen wing; window frame and sash at upper left is a complete original.

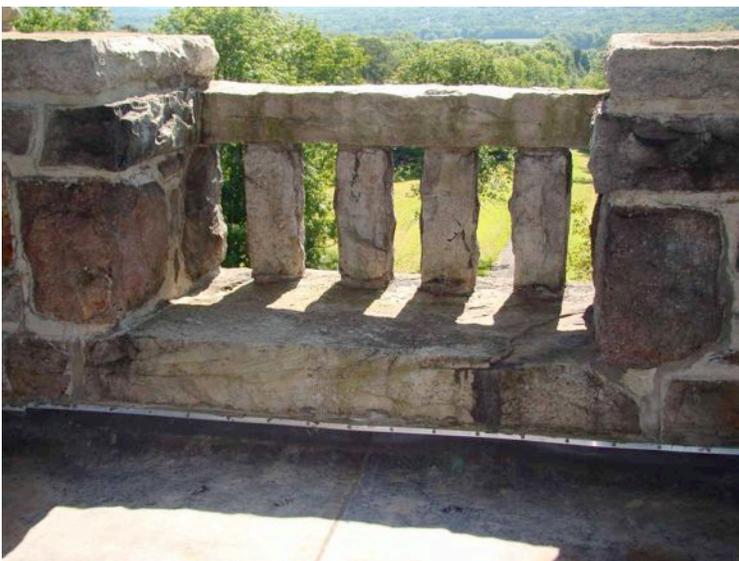
Balustrade:

This stone railing balusters are in need of repointing.

- Select bedding, repointing and parapet mortars for use in distinct locations.
- Carefully and selectively remove cracked and unbonded mortar.
- Repair voids and repoint mortar joints.
- Clean surfaces affected by repointing operations.

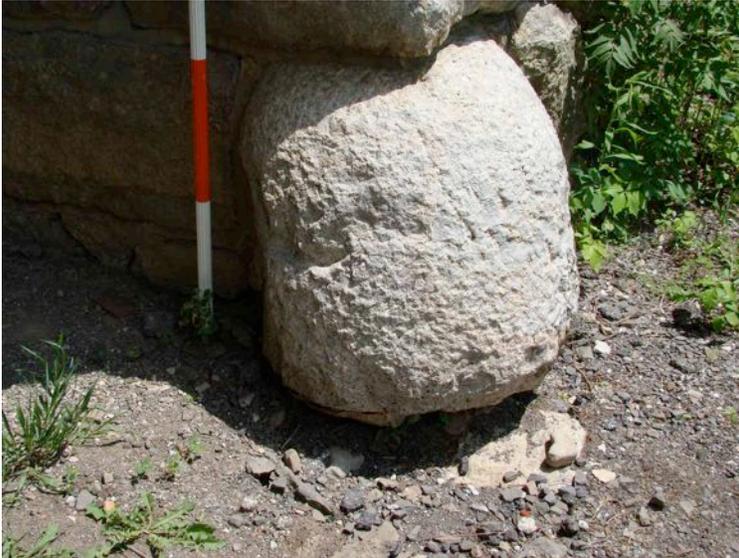
Bollard at Archway:

Base mortar has eroded away.

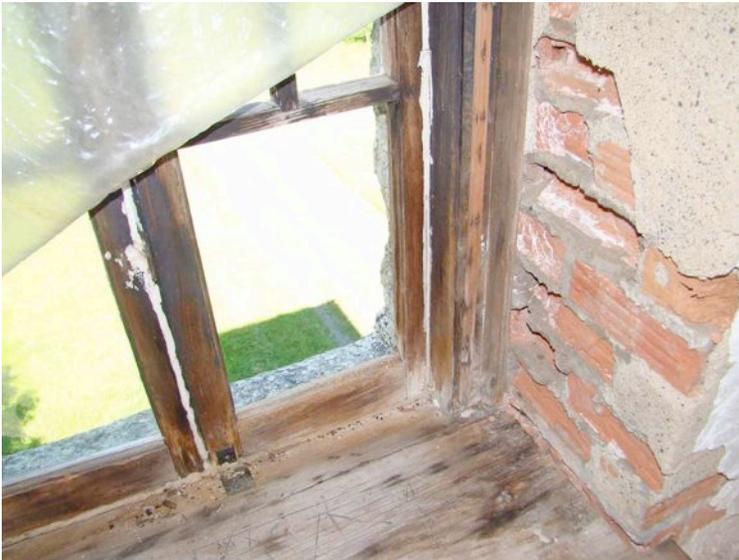
Original, Modified:

Illustrated here is a stair hall window in the west facade. The frame and sash are original and restorable even though the sash has been modified.

- Photograph existing window conditions in detail and remove original sash and transoms where they exist for restoration.

- Restore frames in place, using Dutchmen, epoxy repair and replacement in kind where needed.
- Restore the removed sash, again using Dutchmen, epoxy repairs and replacement of wooden components as needed.
- Prime the glazing reveals of the frames and reglaze using leaded comes and drawn (period) glass in the historic design. The configuration of transoms is as seen in the third-level north-facing tower room window and the casement subdivision is as seen in the one original west-facing window. This is the small window which cannot be accessed from the interior.
- Paint and finish sash and frames, restore casement hardware and reinstall.

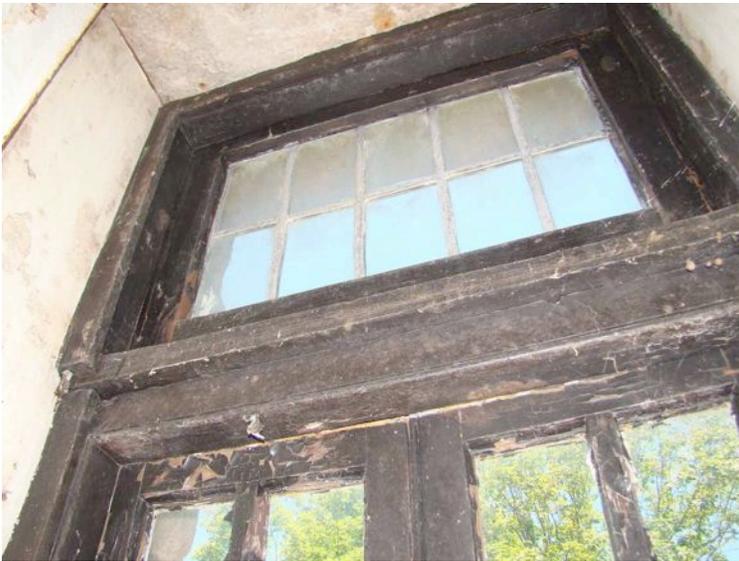
Original, Modified:

This is the north window in the third level tower room. The leaded-glass transom is completely original and the casement sash beneath it are also but have been modified.

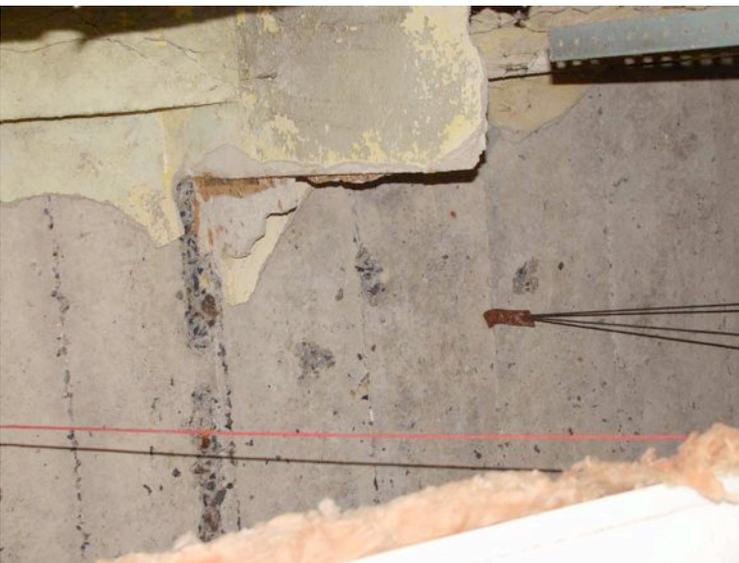
Loss of plaster coating on concrete.

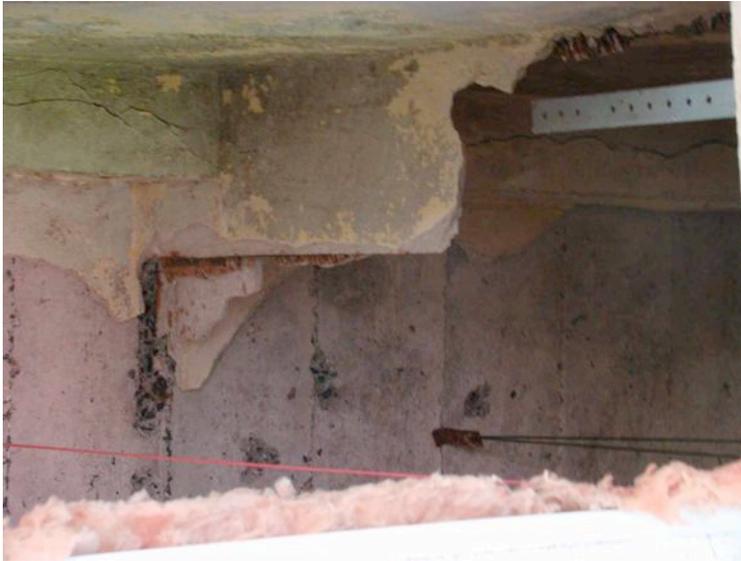
Loss of plaster on concrete ceiling.

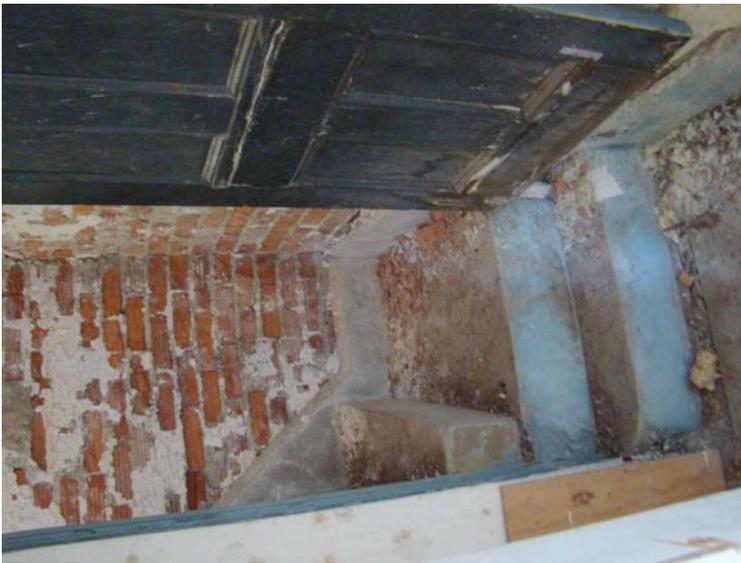
Loss of plaster on brick at upper stair hall.

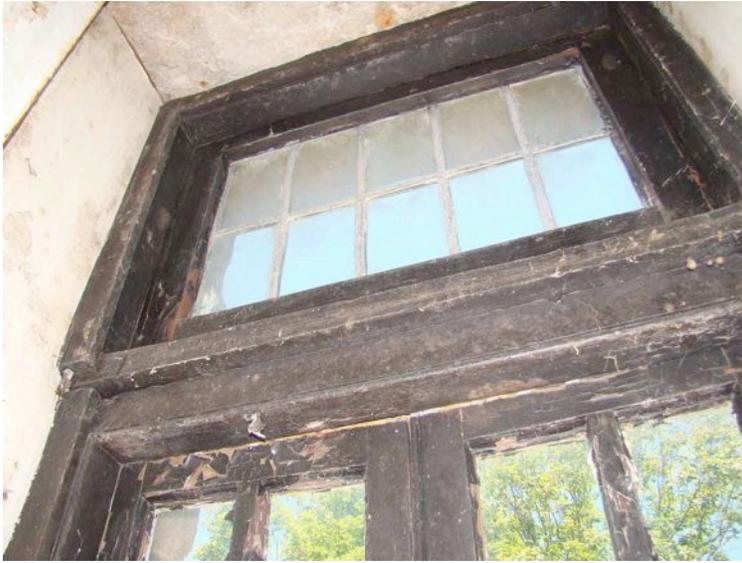
Original Window Components:

Impressively intact, including lead glass, and very important to preserve.

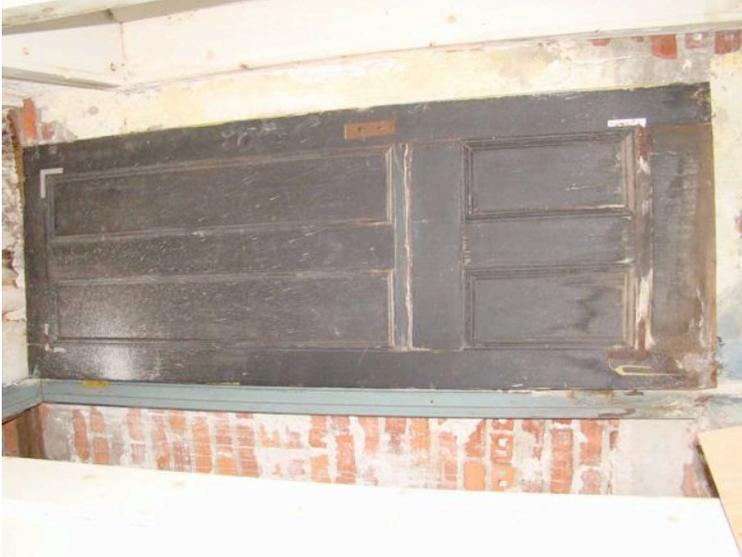
4 Panel Door to Upper Stair Hall:

Original feature to be retained and restored.
