MOHONK TESTIMONIAL GATEWAY

New Paltz, New York

CONDITION STUDY

20 June 2013 Condition Assessment (04 September 2013)

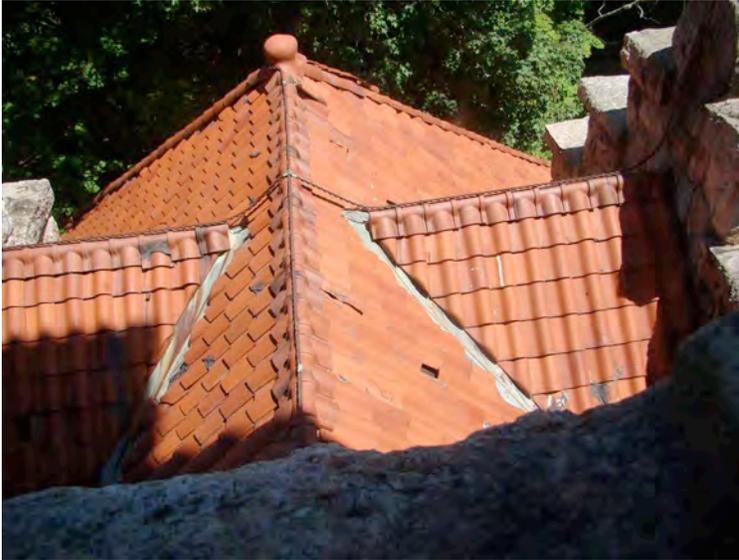
DSC00292

From the third level; Note broken tiles and lightning arresting system, west gable and stepped stone parapet.

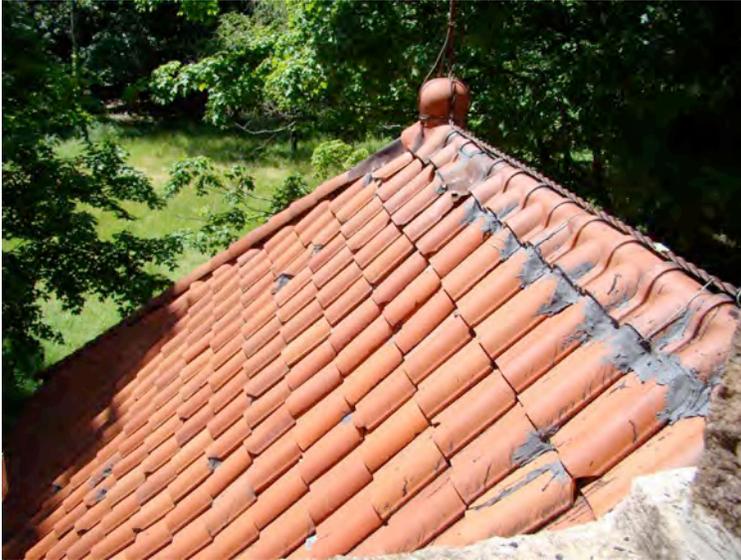
DSC00284

General view of east plane with chipped tiles.

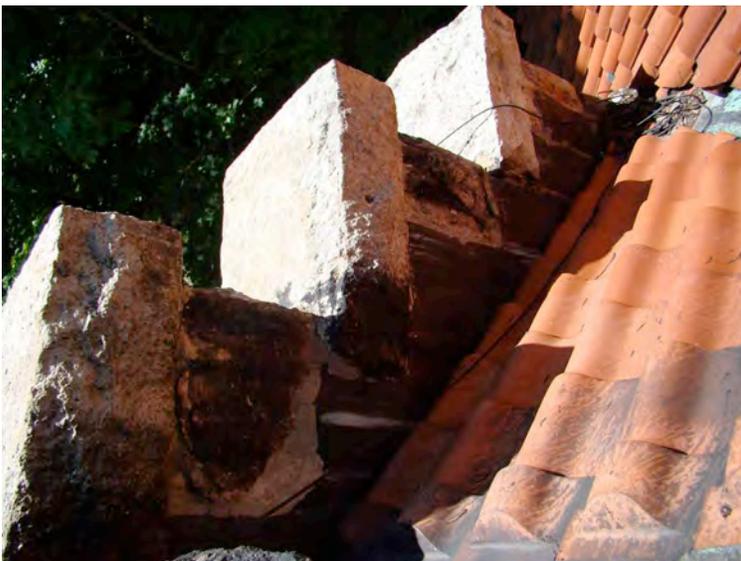
DSC00286

Detail of valley exit and parapet flashing.

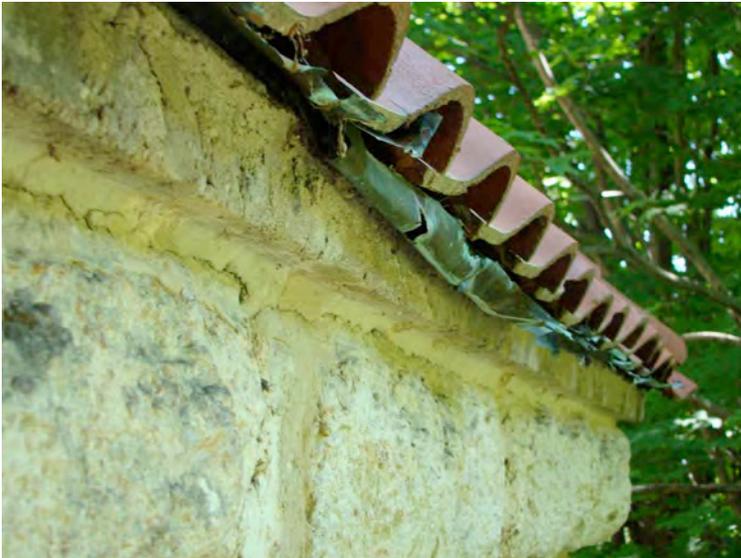
DSC00279

Same as above.

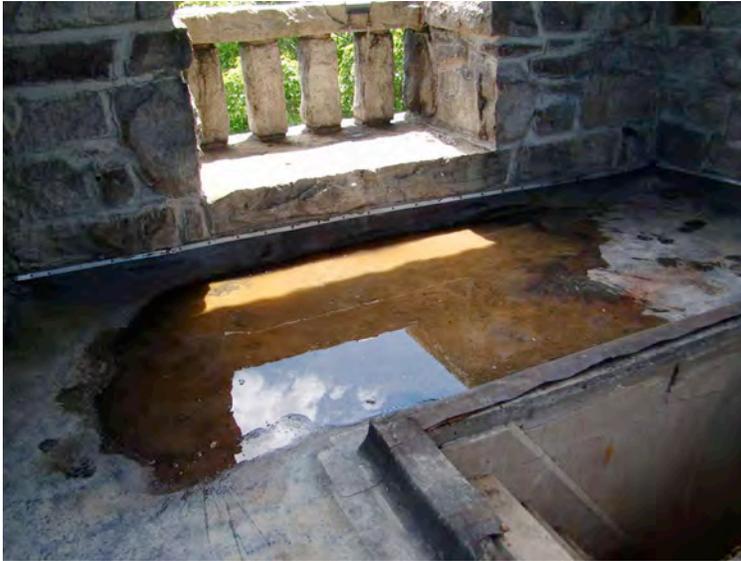
Ponding; It appears that the south drain tube has been plugged and therefore eliminated functionally.

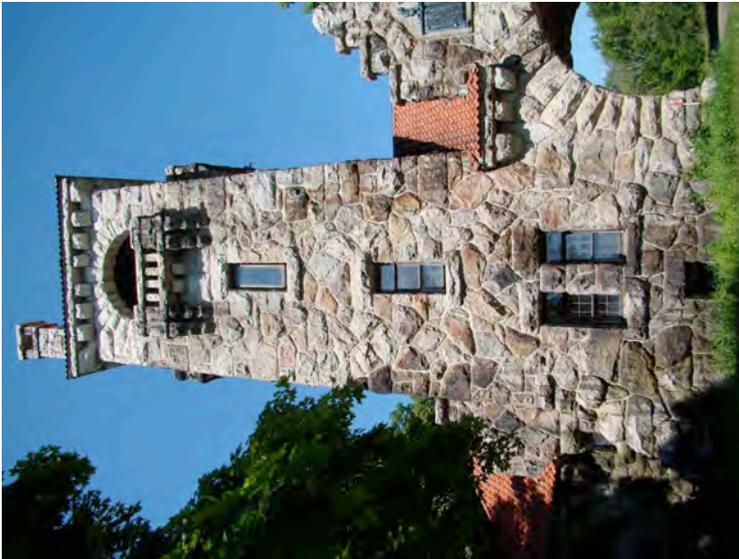
DSC00264

Tower elevation; Note that
observation deck balconies
were constructed according
to revised drawings.

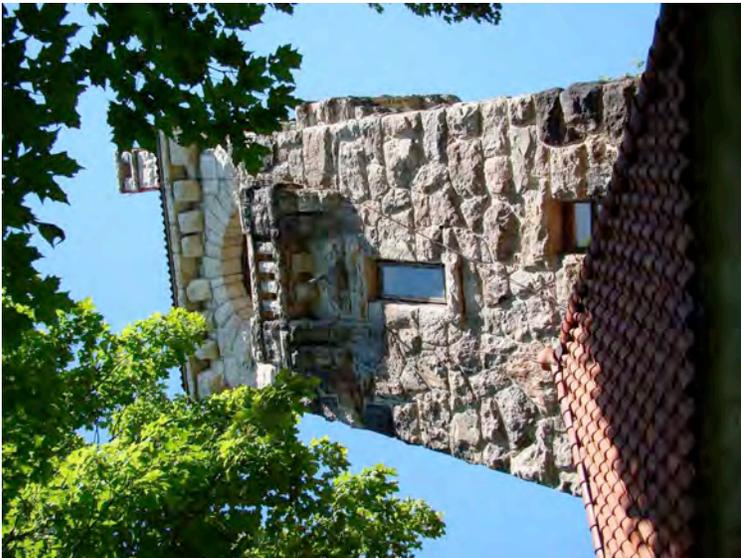
DSC00268

Tower elevation; Note that south drainage scupper (tube) at observation deck level is extant.

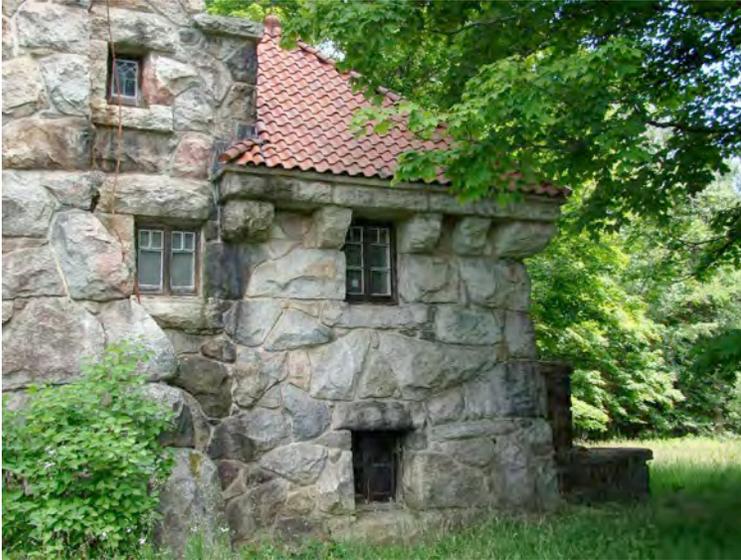
DSC00348

Kitchen wing; window frame and sash at upper left is a complete original.

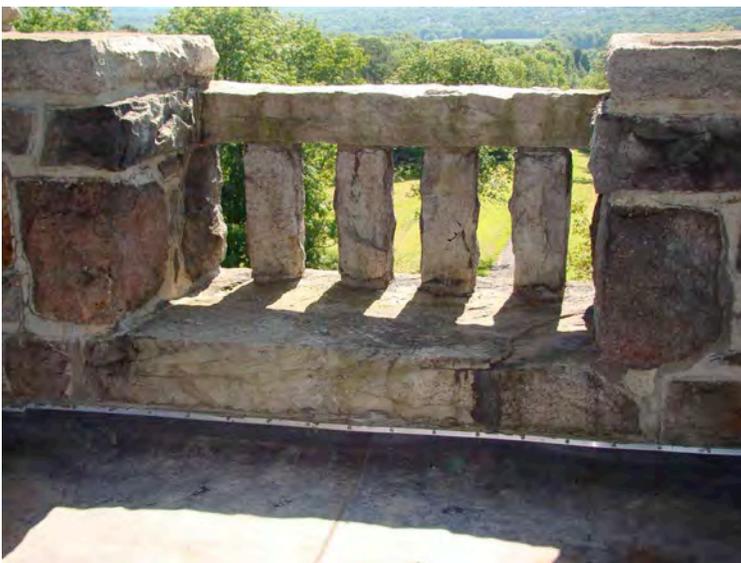
This stone railing balusters are in need of repointing.

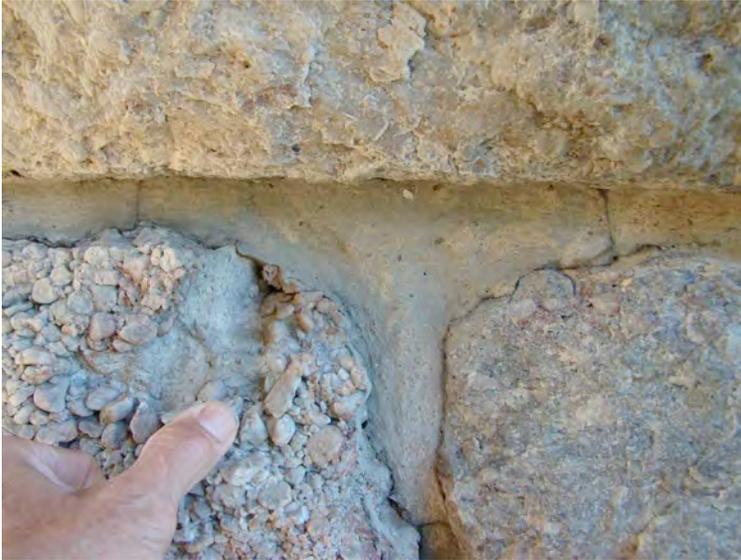
DSC00227

Showing two different colors of mortar mix.

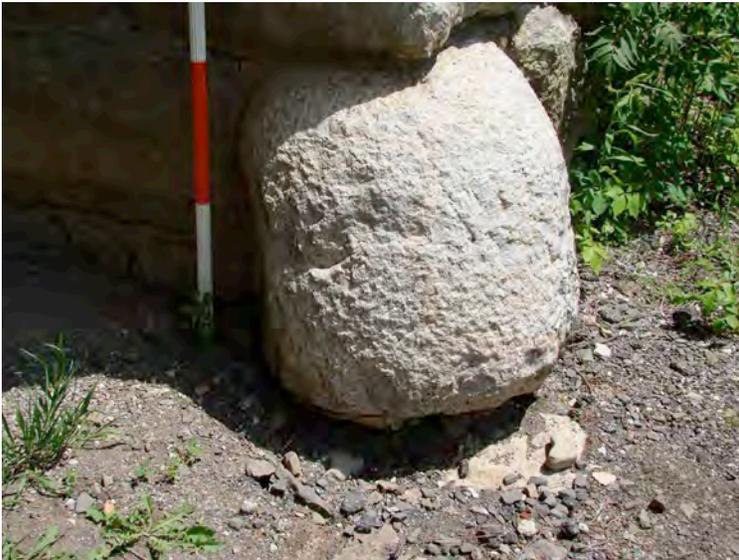
DSC00351

Base mortar has eroded away.

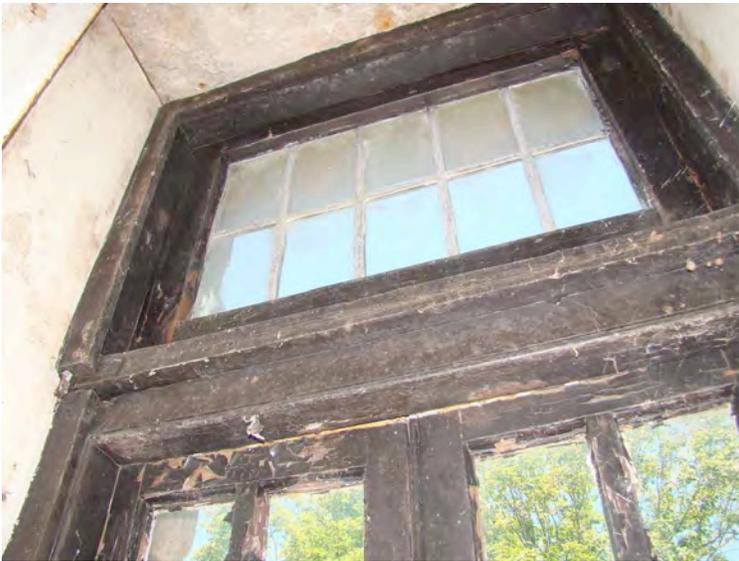
This is the north window in the third level tower room. The leaded-glass transom is completely original and the casement sash beneath it are also but have been modified.

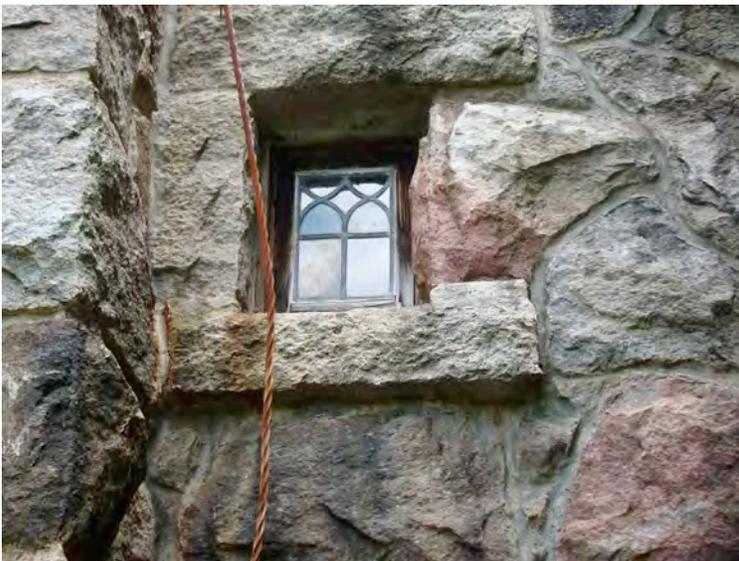
This is the small window in the west elevation over the kitchen. It cannot be accessed from the interior of the building

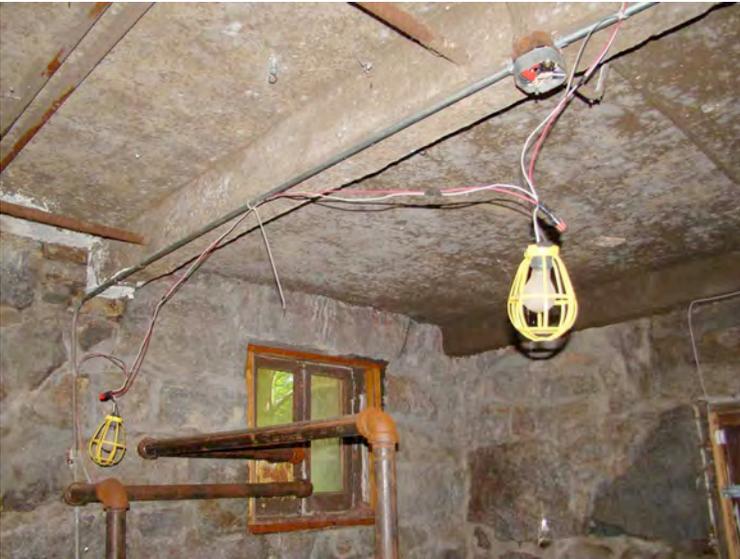
DSC00328

Basement examples of original containment of steel beams within concrete covers while the steel rod bridging (at 90° to the steel beams) was always exposed at this level and is as clearly shown in the original drawings.

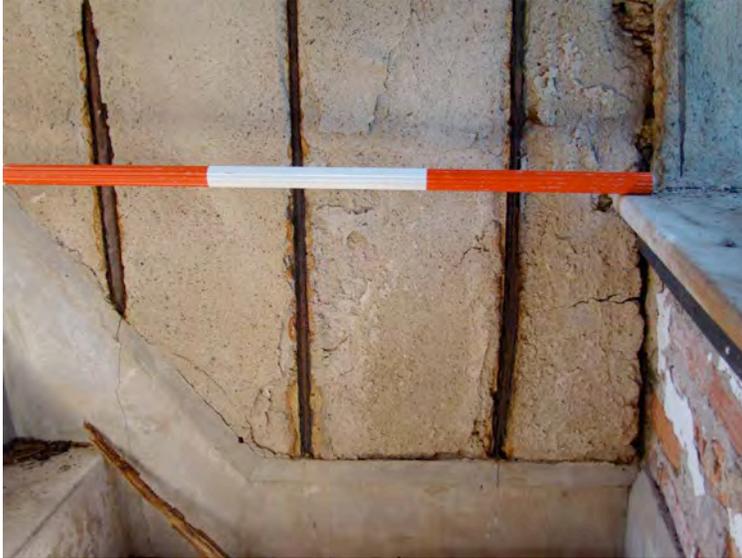
Here in the upper staircase to the observation level the partition survives, but the vertical reinforcing panel ribs have rusted.

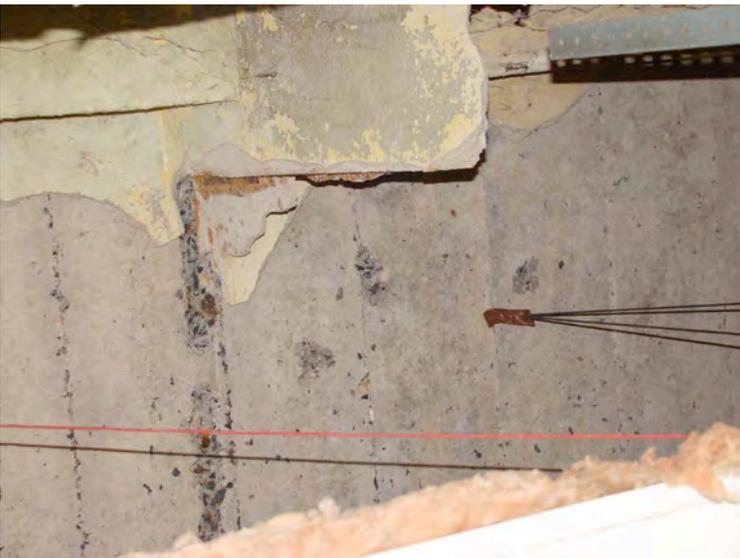
DSC00296

Loss of plaster coating on concrete.

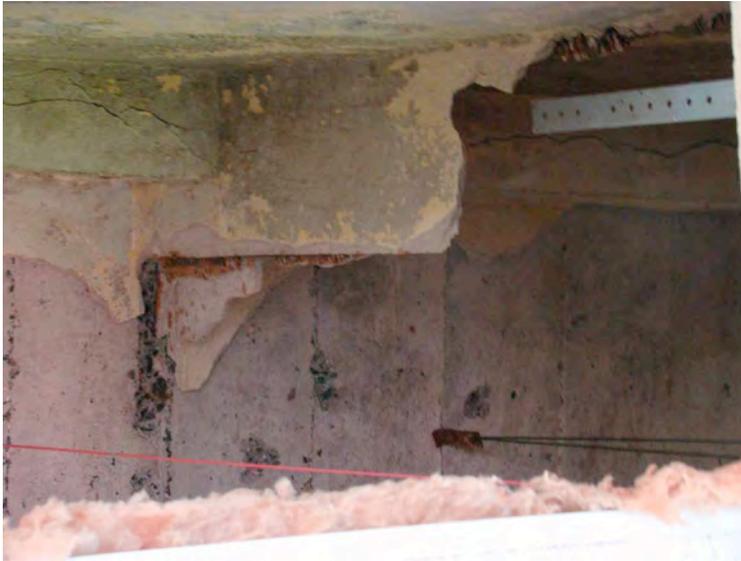
DSC00297

Loss of plaster on concrete ceiling.

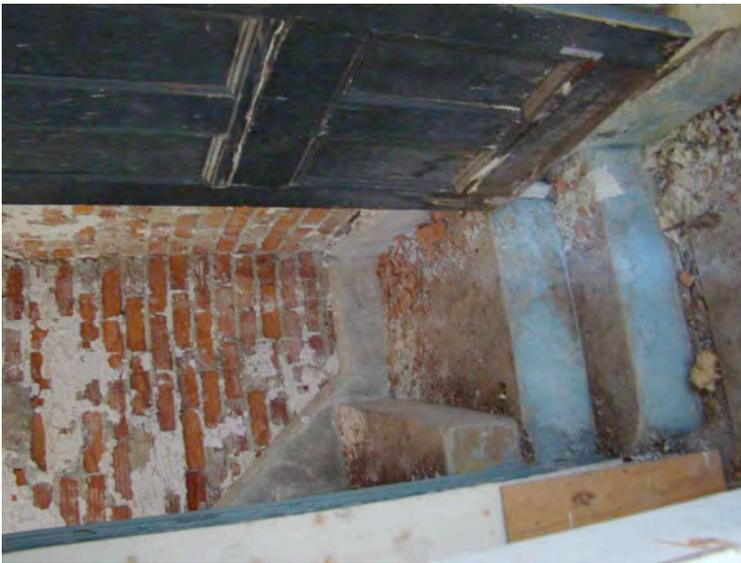
DSC00342

Loss of plaster on brick at upper stair hall.

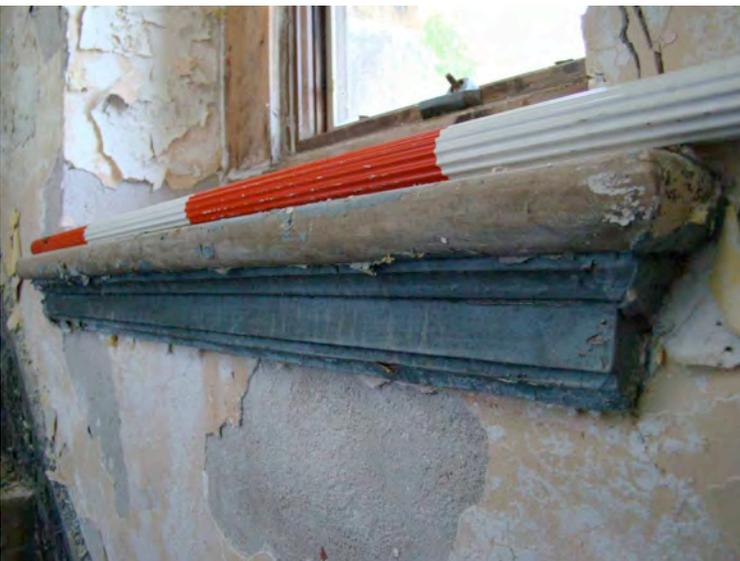
Impressively intact and very important.

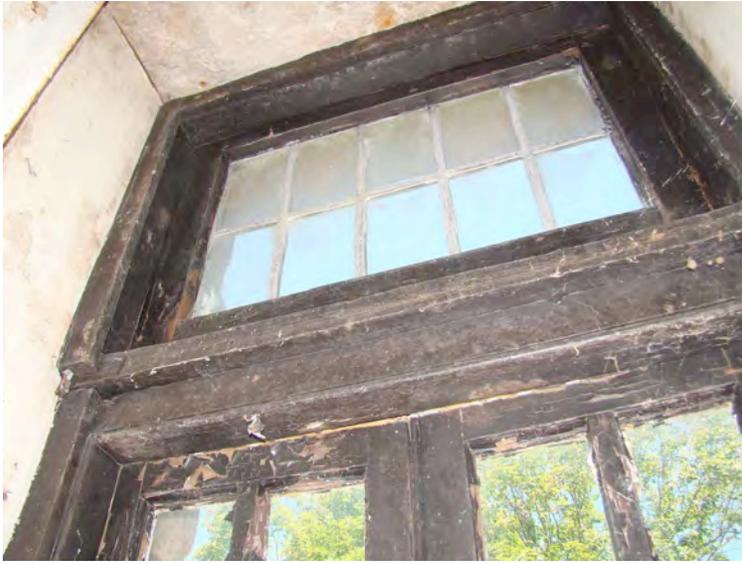
DSC00294

Impressively intact, including lead glass, and very important to preserve.

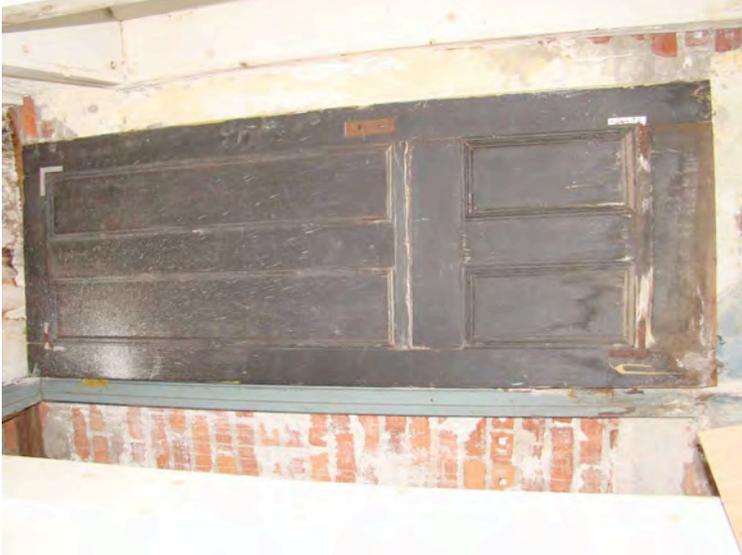
DSC00301

Original feature to be retained and restored.

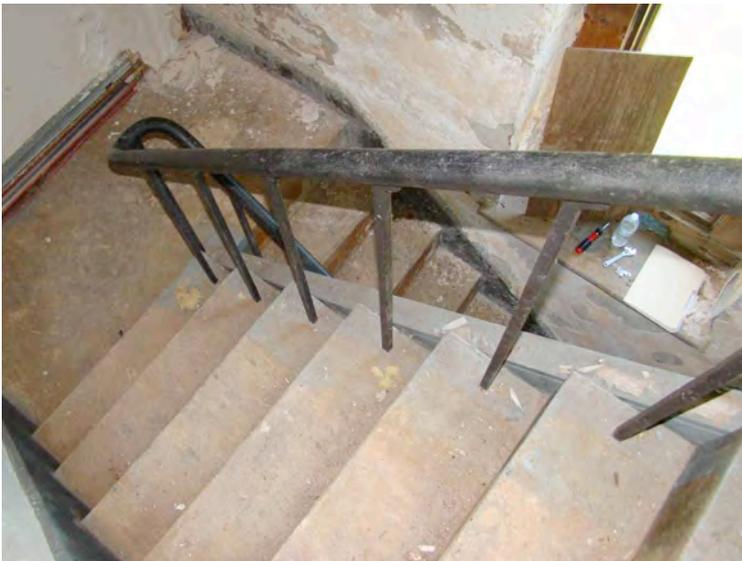
DSC00303

Not made of wood but very intact original feature, well-executed along with precise concrete stairway.

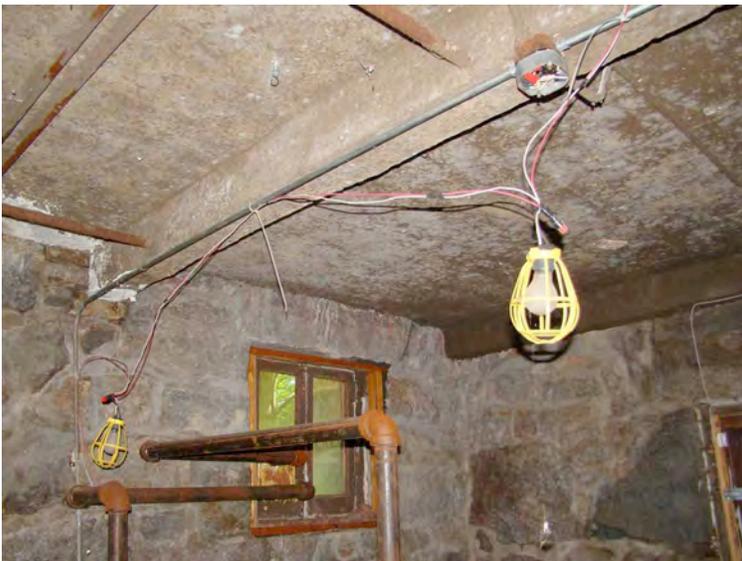
DSC00328

Basement temporary lighting

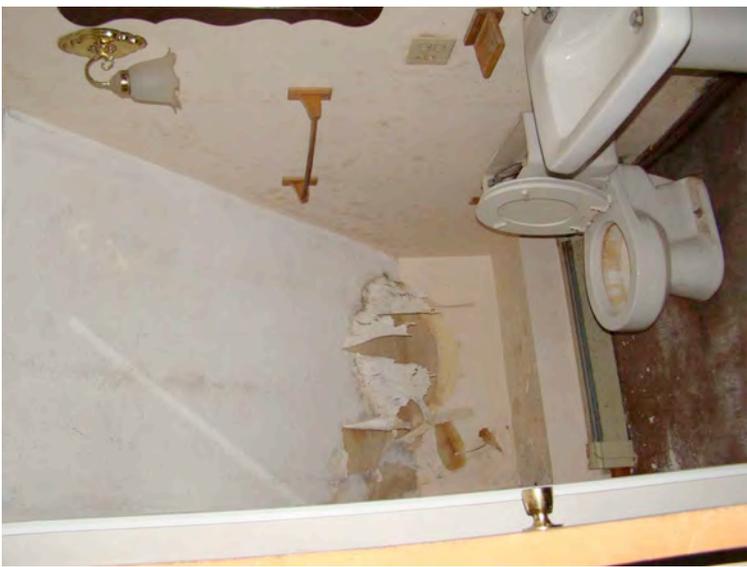
DSC00312

Typical plumbing fixtures. This, the only full bathroom, is built into the southeast corner over the archway.

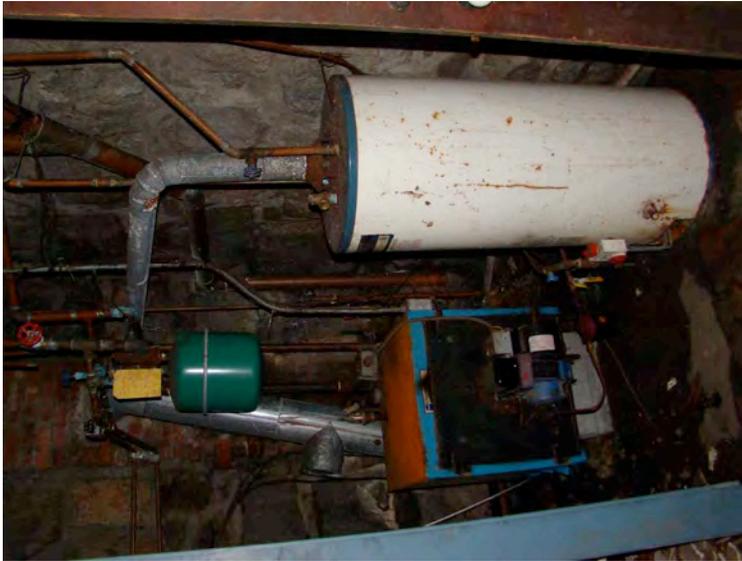
DSC00317

Boiler & hot water tank in basement. Neither has been used for several years.

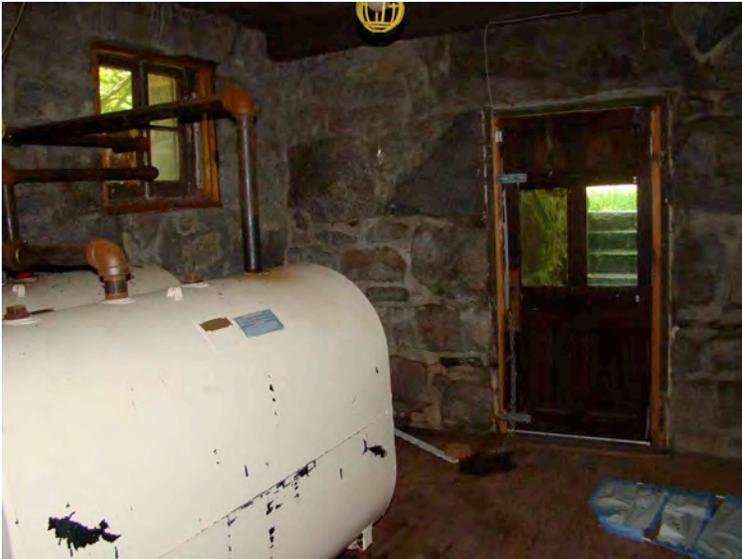
DSC00321

Fuel tanks in basement.

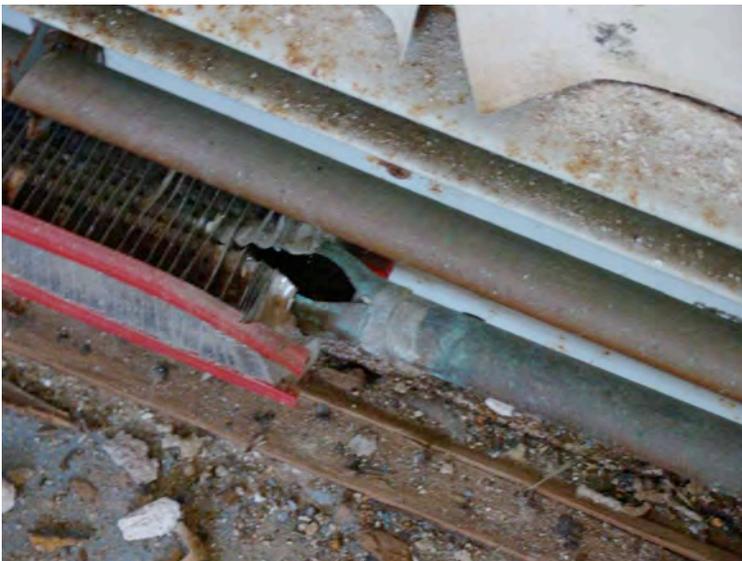
DSC00313

Previously frozen fin-tube in one of the tower rooms above.
