***Town of New Paltz Historic Preservation Commission  
Local Historic Landmark Designation***

***Mohonk Testimonial Gateway  
1 Gatehouse Road, New Paltz, NY  
(Gatehouse Structure and Adjoining Lands)***

***15 October 2013***

20 June 2013 Condition Assessment (04 September 2013)

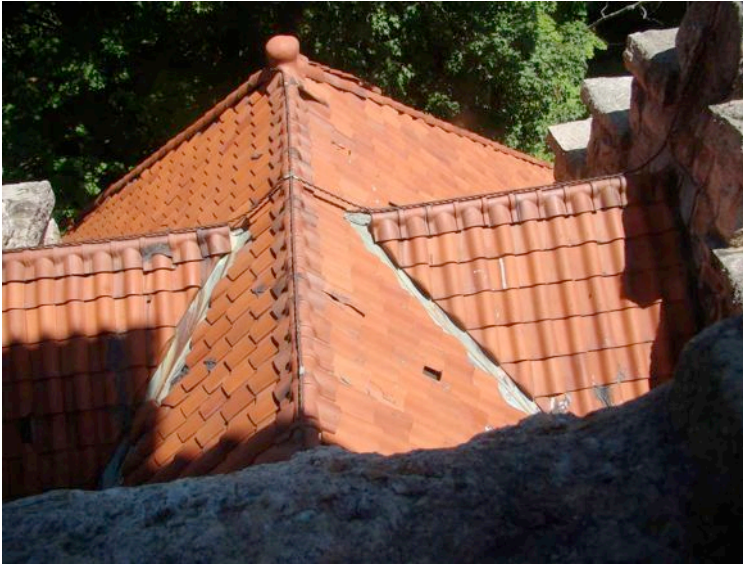
DSC00292

From the third level; Note  
broken tiles and lightning  
arresting system, west gable  
and stepped stone parapet.

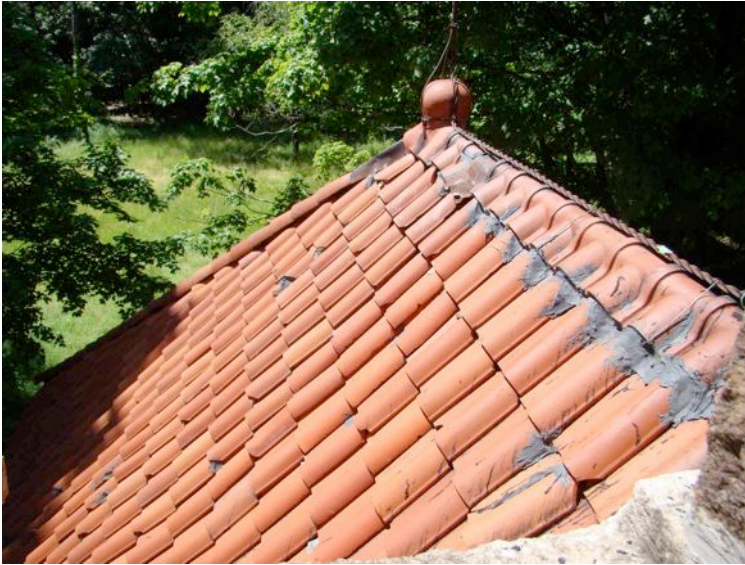
Kitchen Wing Roof:

General view of east plane with chipped tiles.

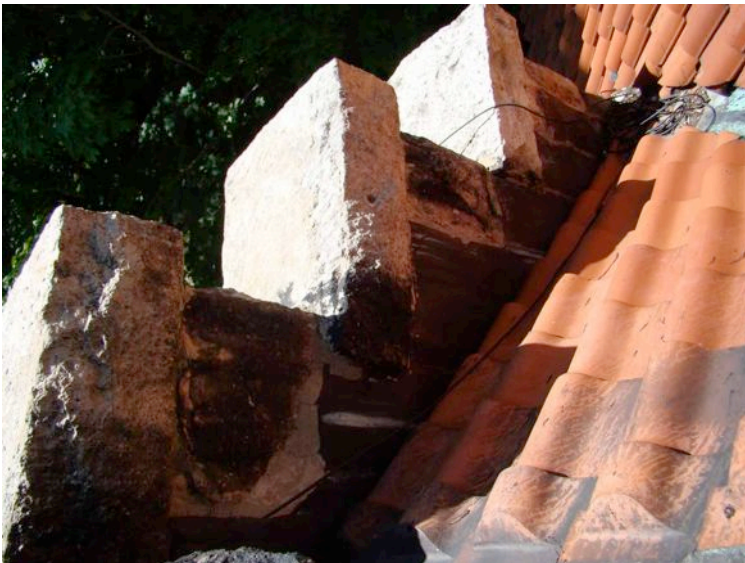
Kitchen Wing Roof:

Detail of valley exit and parapet flashing.

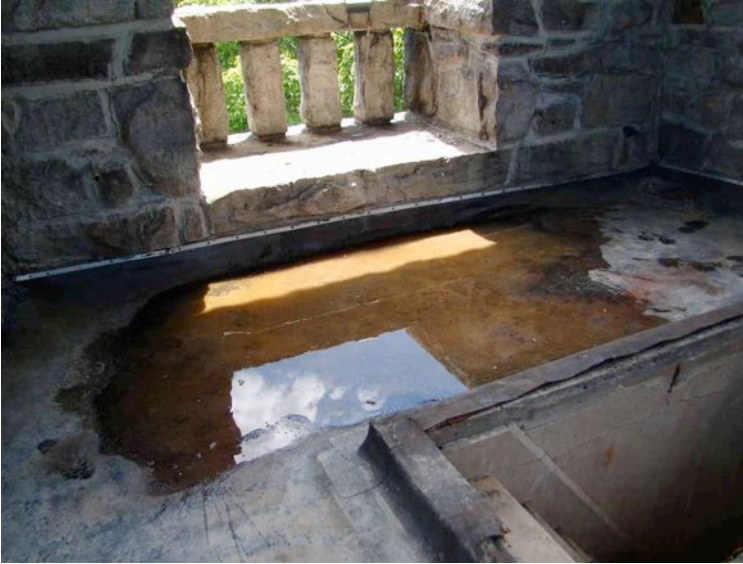
Observation Deck Roof:

Ponding; It appears that the south drain tube has been plugged and therefore eliminated functionally.

- Record and remove all tiles, accessories, flashings, sheet materials and nails.
- Repair all roof decks using matching lumber.
- Install an impervious “underlayment” or membrane beneath all the fields (roof planes) of tile, and the sheet copper must be replaced at all valleys, parapet and wall intersections and at the horizontal drip eaves.
- Reinstall sound tiles, using the existing tiles in coherent roof planes such that they are not mixed with new tiles. Install new tiles on tower roofs and in areas where impact from the tower roofs lands on the lower gables and hips.
- Finish with the historic ridge and hip tiles.
- Restore observation deck/waterproof membrane, reactivate south drain scupper and build new hatch cover and install.

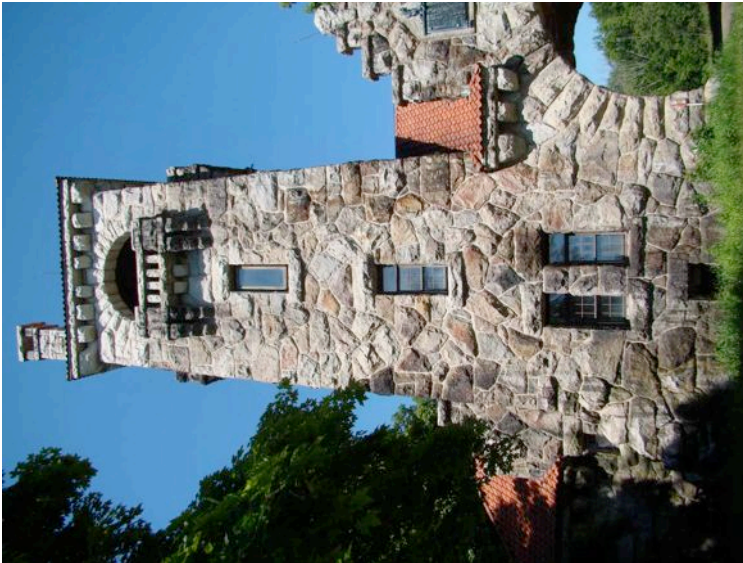
East:

Tower elevation; Note that observation deck balconies were constructed according to revised drawings.

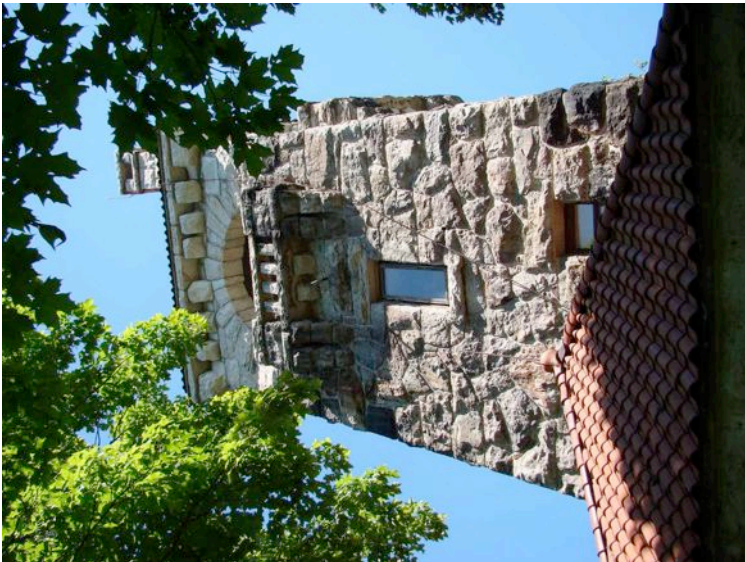
South:

Tower elevation; Note that south drawings scupper (tube) at observation deck level is extant.

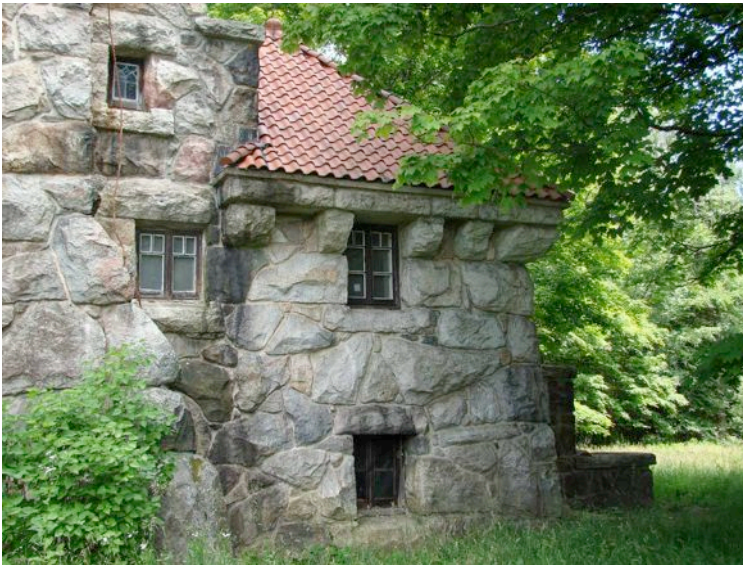
West:

Kitchen wing; window frame and sash at upper left is a complete original.

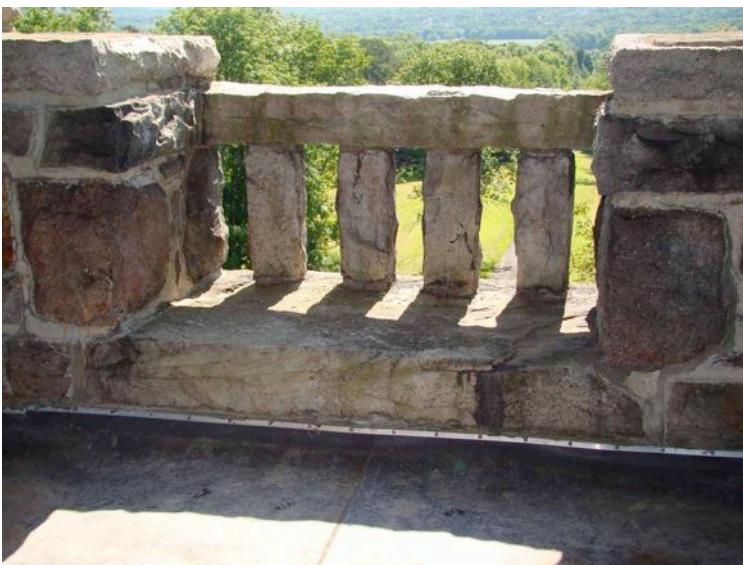
Balustrade:

This stone railing balusters are in need of repointing.

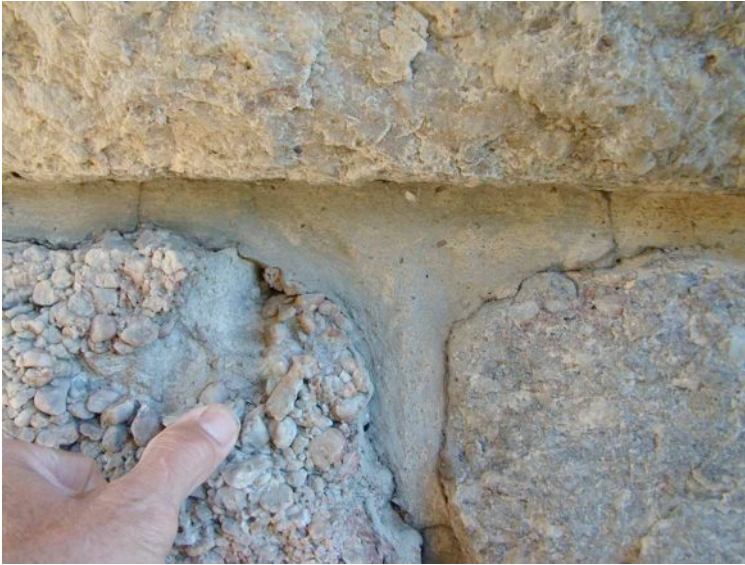
Details: Mortar Joint

Showing two different colors of mortar mix.

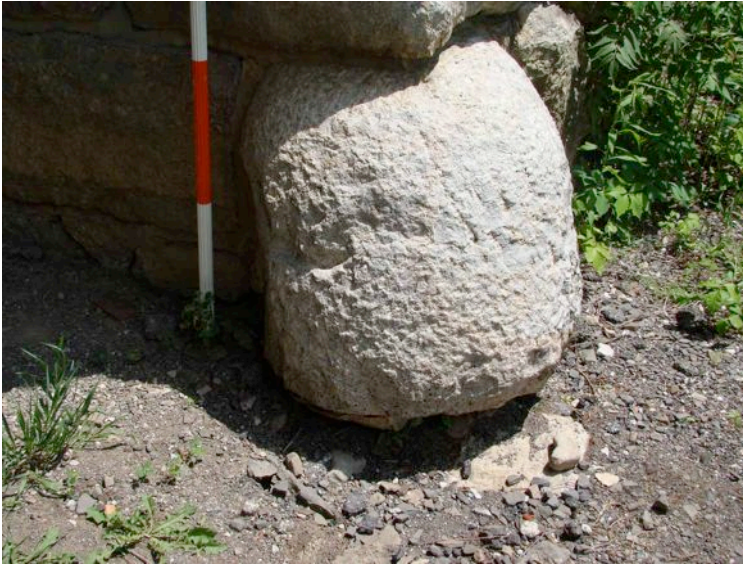
Bollard at Archway:

Base mortar has eroded away.

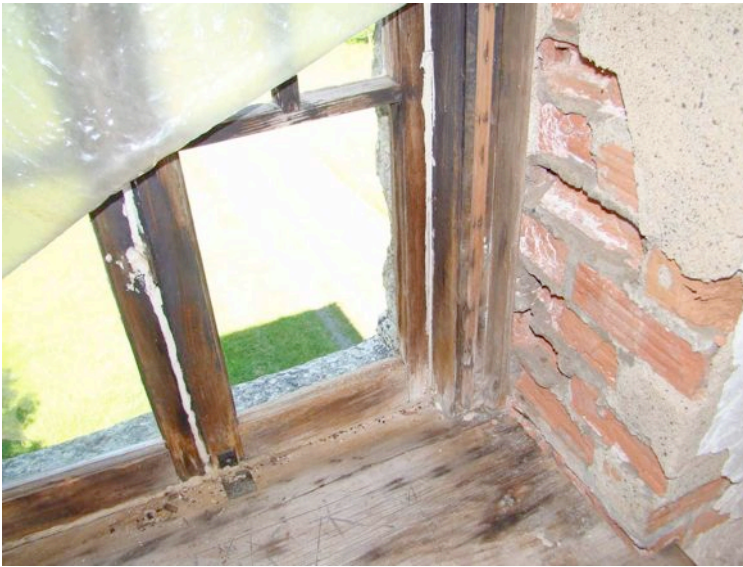
Original, Modified:

Illustrated here is a stair hall window in the west facade. The frame and sash are original and restorable even though the sash has been modified.

Suffice it to say that the proposed work on these windows should now include retention and repair of the original window components that survive. The previous belief that the original windows had all been replaced is no longer an accurate appraisal of this historic system.

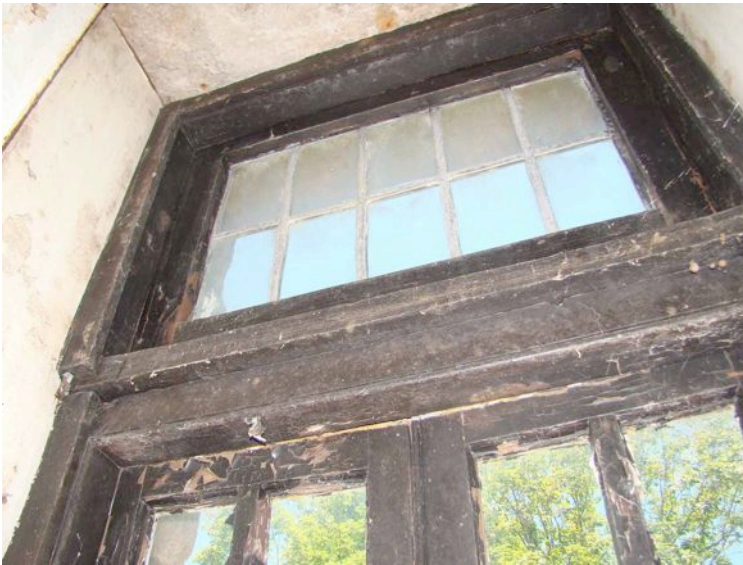
Original, Modified:

This is the north window in the third level tower room. The leaded-glass transom is completely original and the casement sash beneath it are also but have been modified.

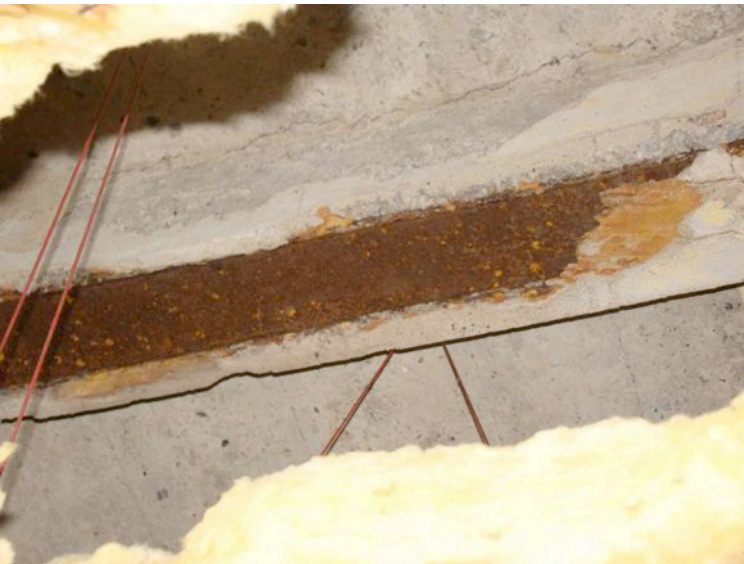
Condition:

Detail of rust.

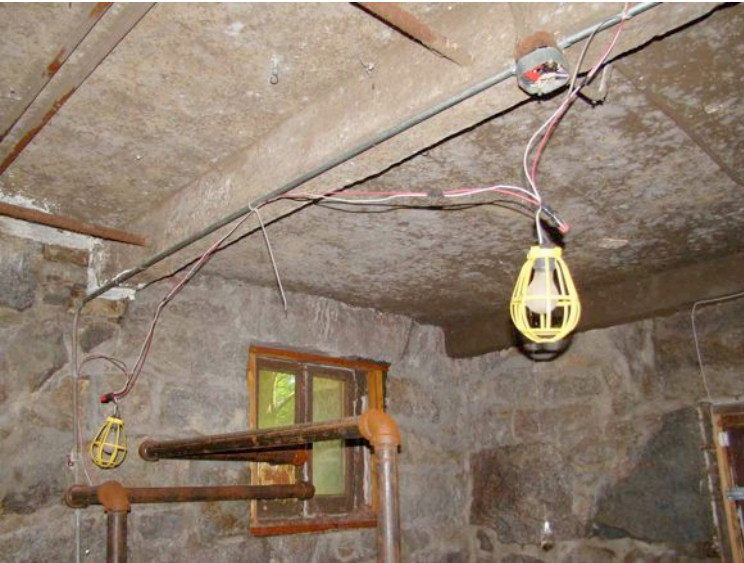
The rods (bridging):

Basement examples of original containment of steel beams within concrete covers while the steel rod bridging (at 90° to the steel beams) was always exposed and is as clearly shown in the original drawings.

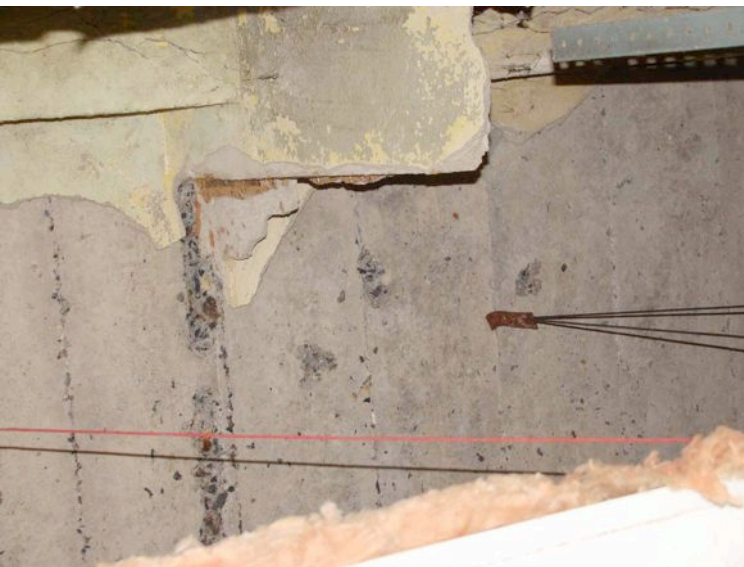
Loss of plaster coating on concrete.

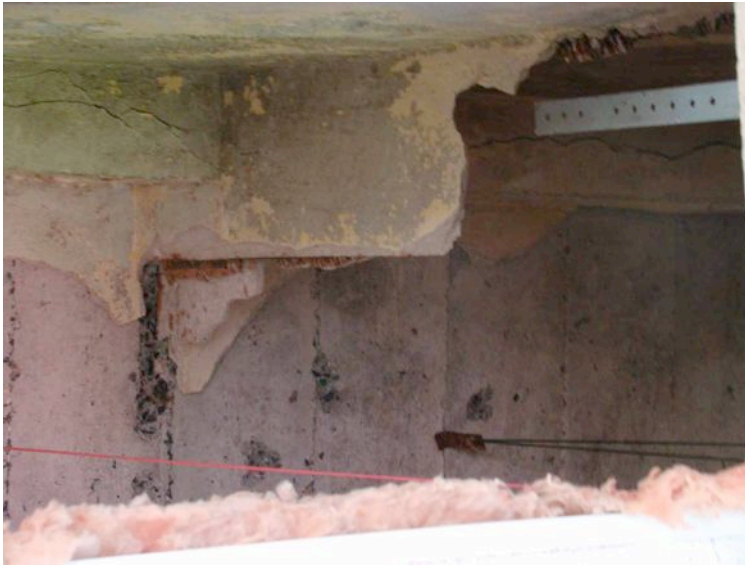
Loss of plaster on concrete ceiling.

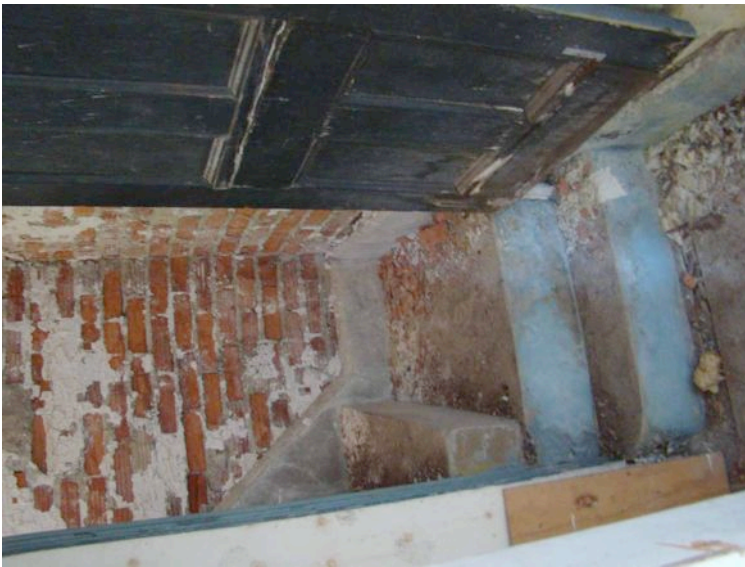
Loss of plaster on brick at upper stair hall.

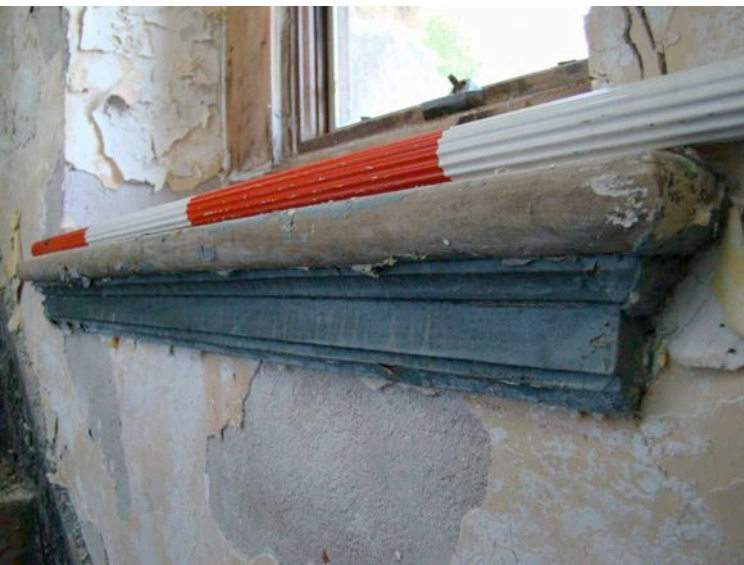
Original Window Stool Complete:

Impressively intact and very important.

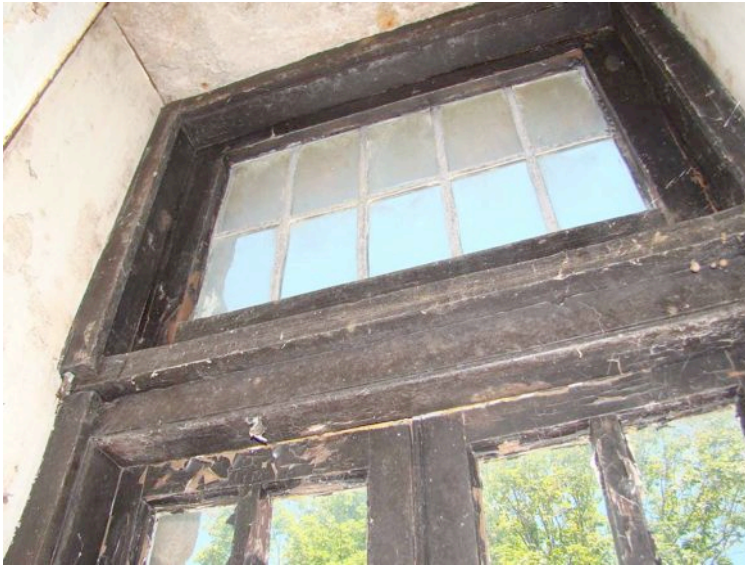
Original Window Components:

Impressively intact, including lead glass, and very important to preserve.

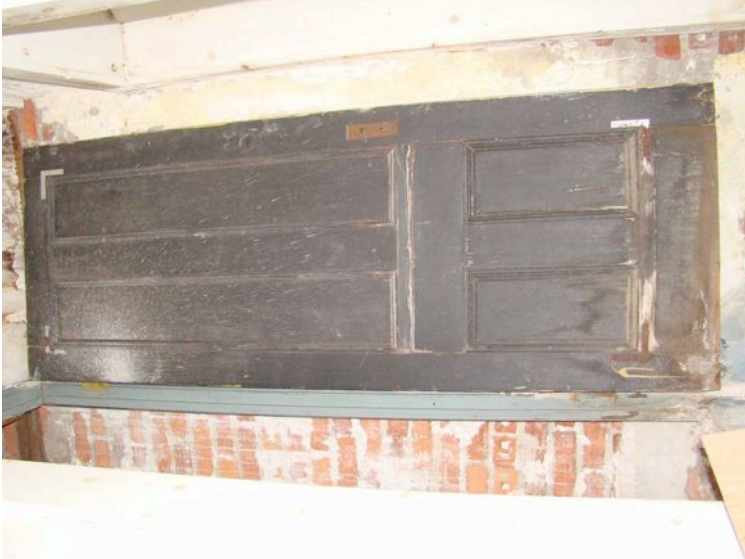
4 Panel Door to Upper Stair Hall:

Original feature to be retained and restored.

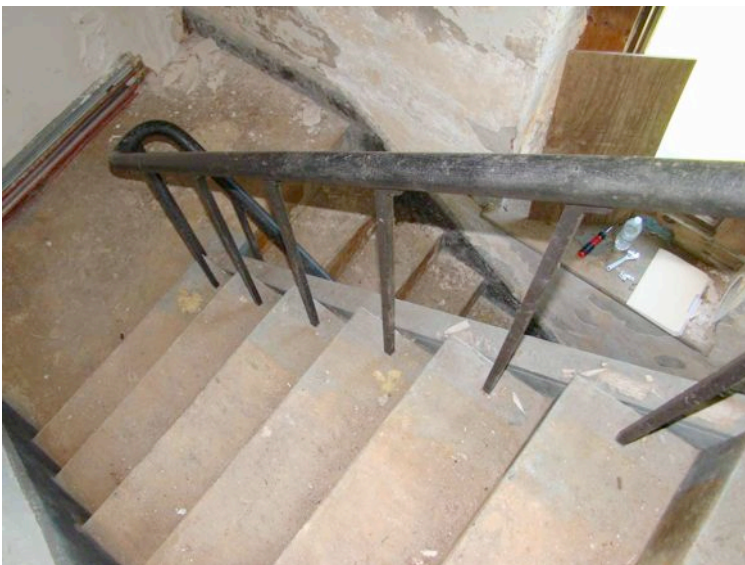
Steel Stair Railing:

Not made of wood but very intact original feature, well-executed along with precise concrete stairway.
